REPORT ON THE AIR RAID SHELTER AT THE SOUTH SCHOOL, ASHFORD, KENT

Historic Building Survey

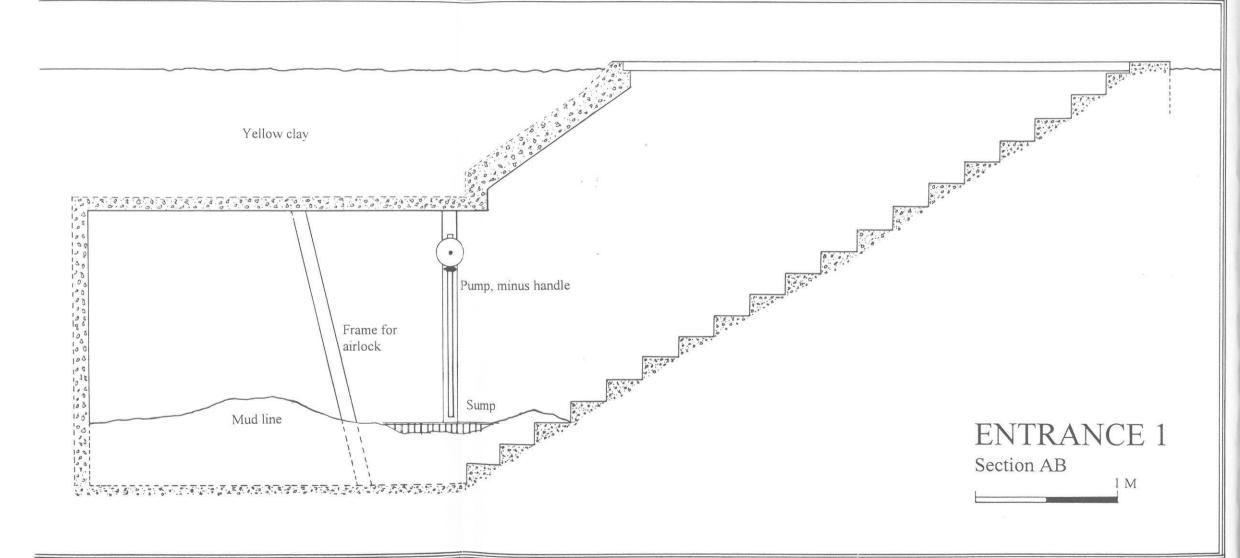
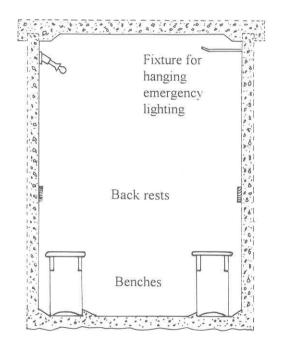
TYPICAL SECTION
OF CORRIDOR,
ELEVATION OF
WALL PANELS AND
FACE OF CEILING
PANEL

The corridor is 1.43 m. wide and appeared to vary between 1.94 and 1.99 in height. Clayey deposits under the water and other debris constrained the obtaining of precise height measurements at all points. The shelter was formed of pre-cast concrete wall and ceiling panels with a poured concrete floor. Ceiling panels were not used at the
