REPORT ON THE
DEFENCE
HERITAGE SITES
AT CHATHAM
COMMERCIAL DOCKS

Victor Smith
February, 1997

DEFENCE HERITAGE SITES AT CHATHAM COMMERCIAL DOCKS, KENT

Historic Building Survey

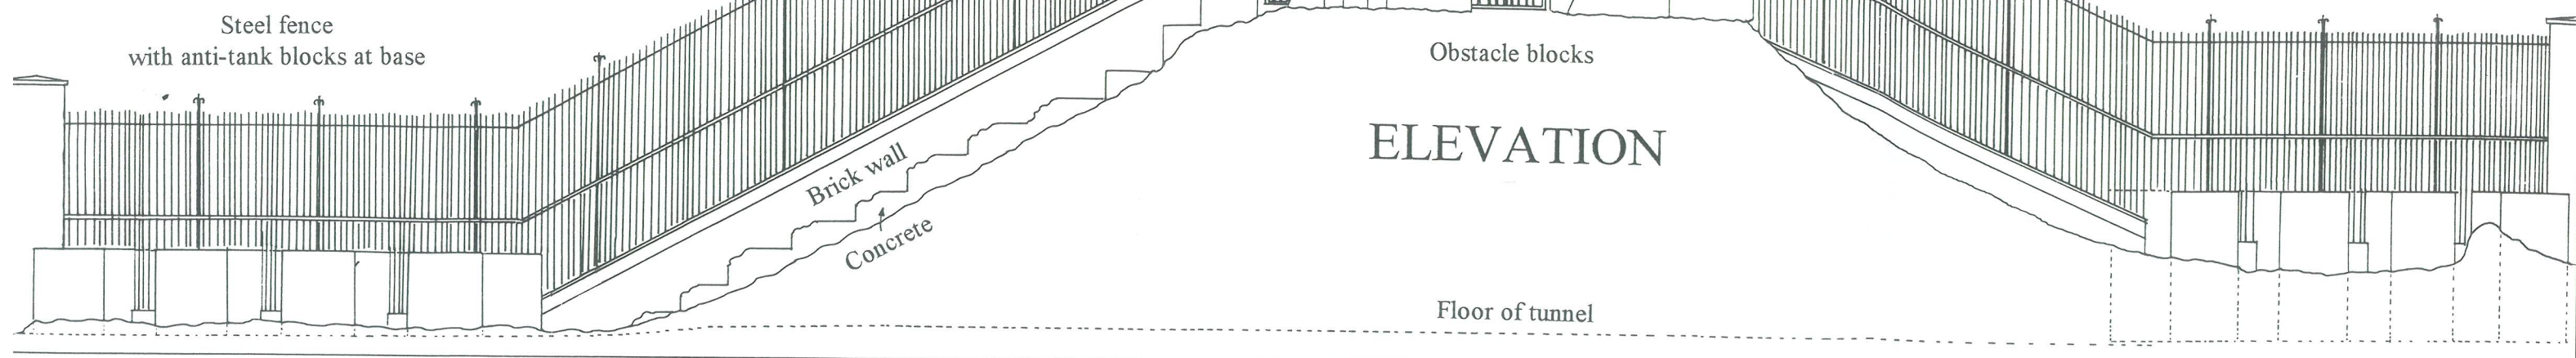
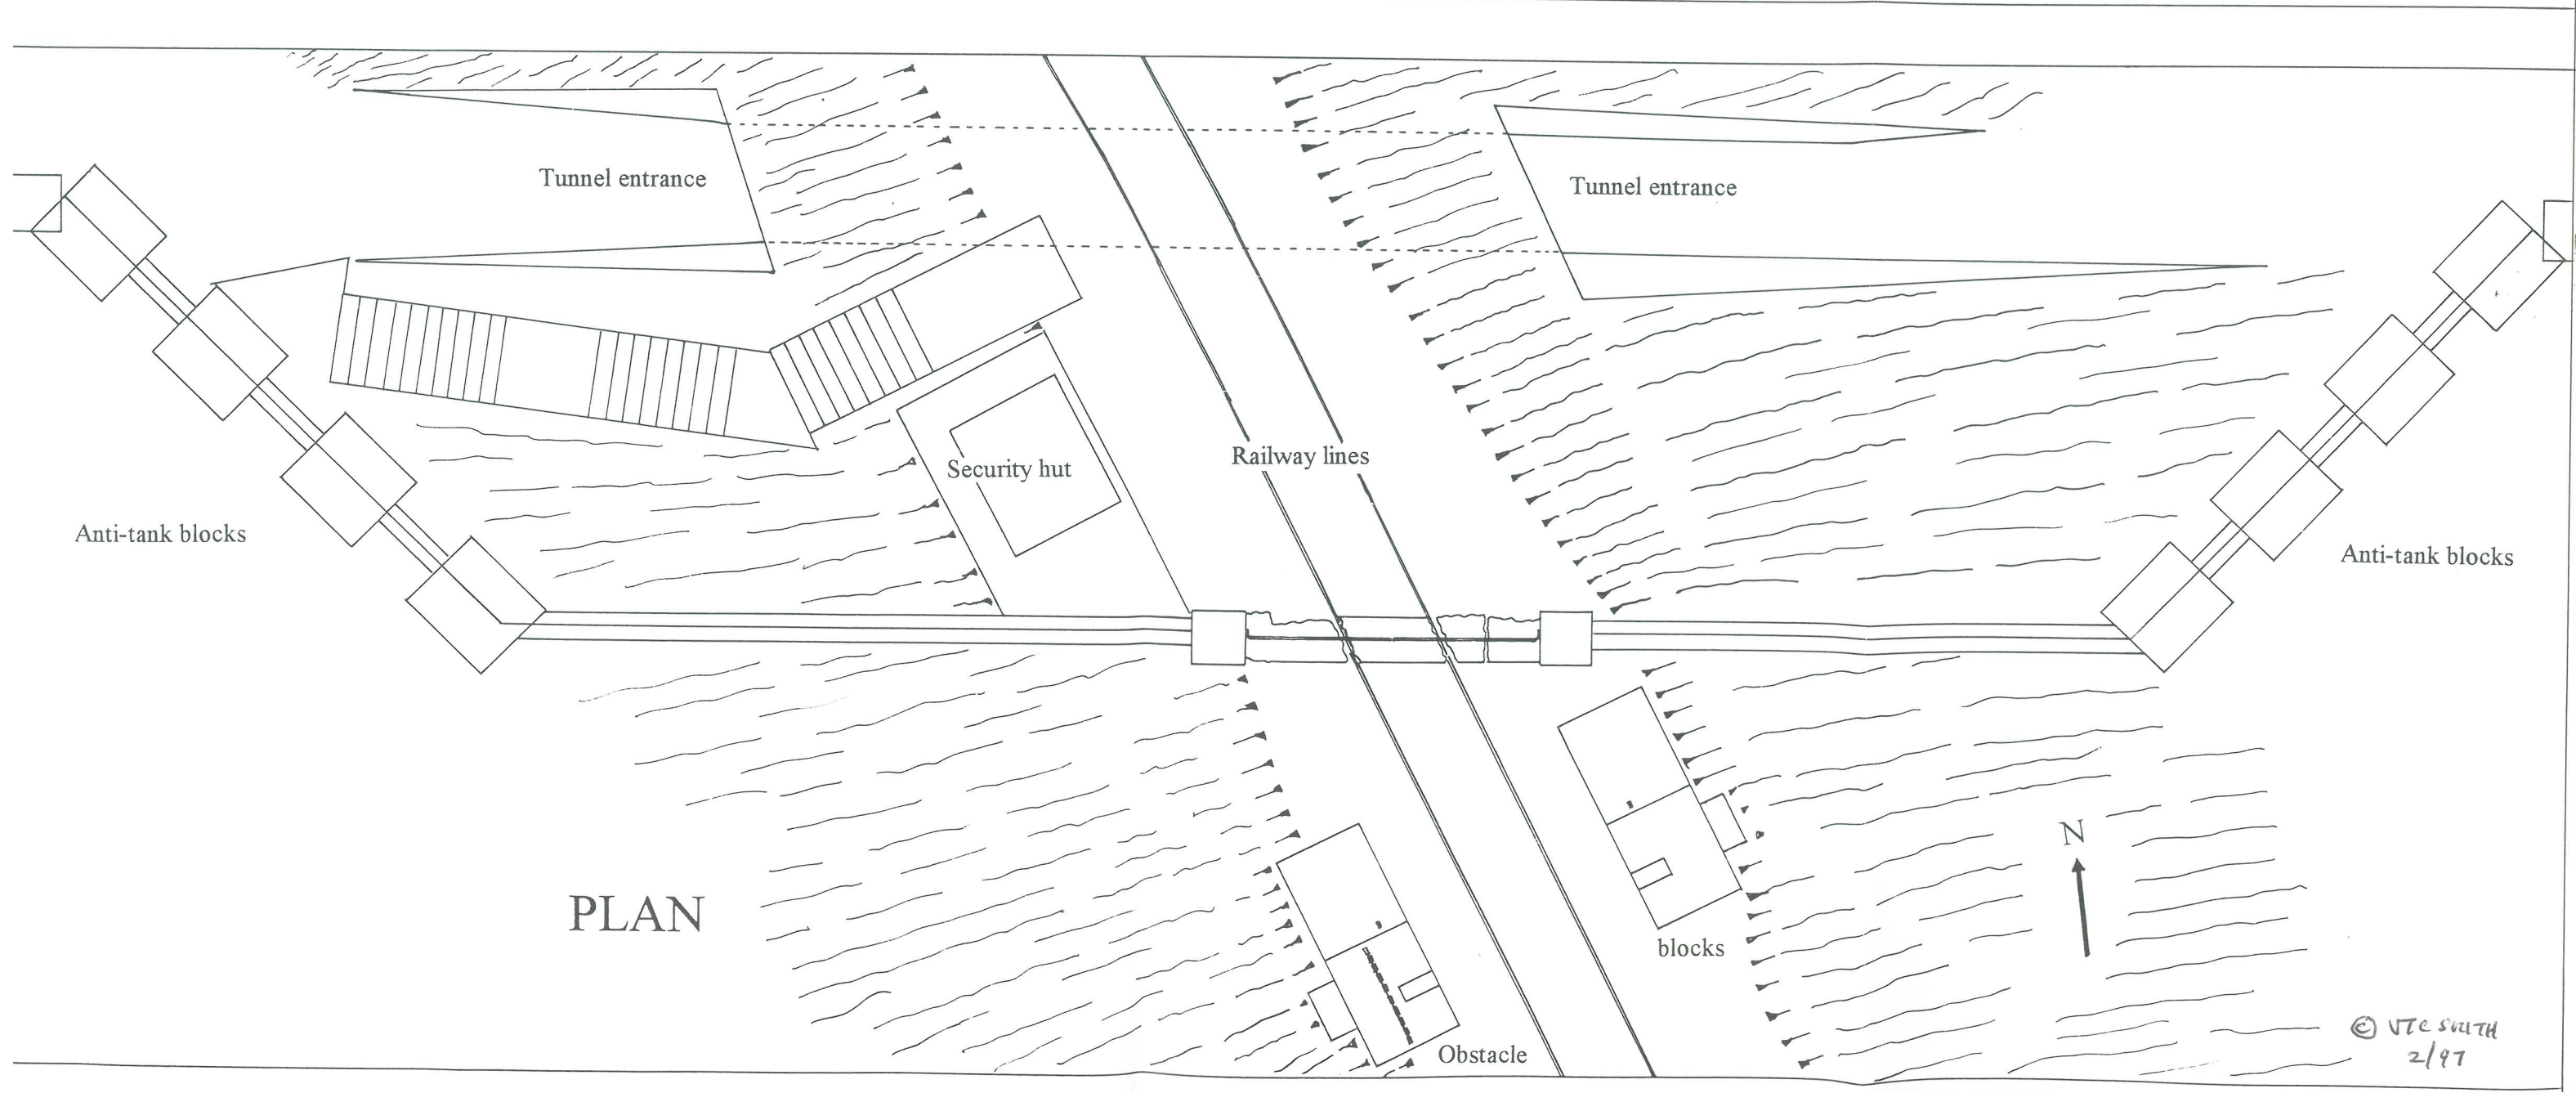
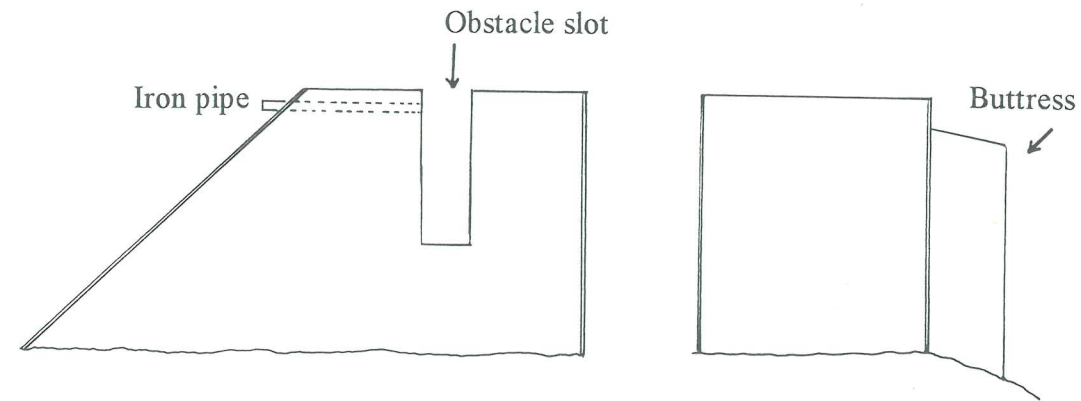
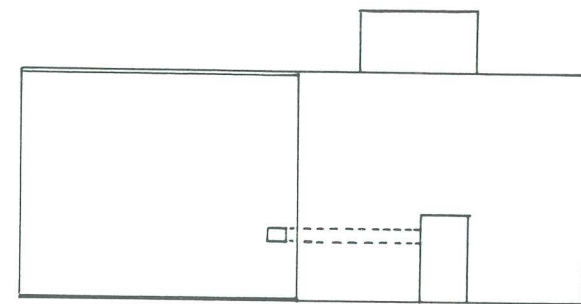
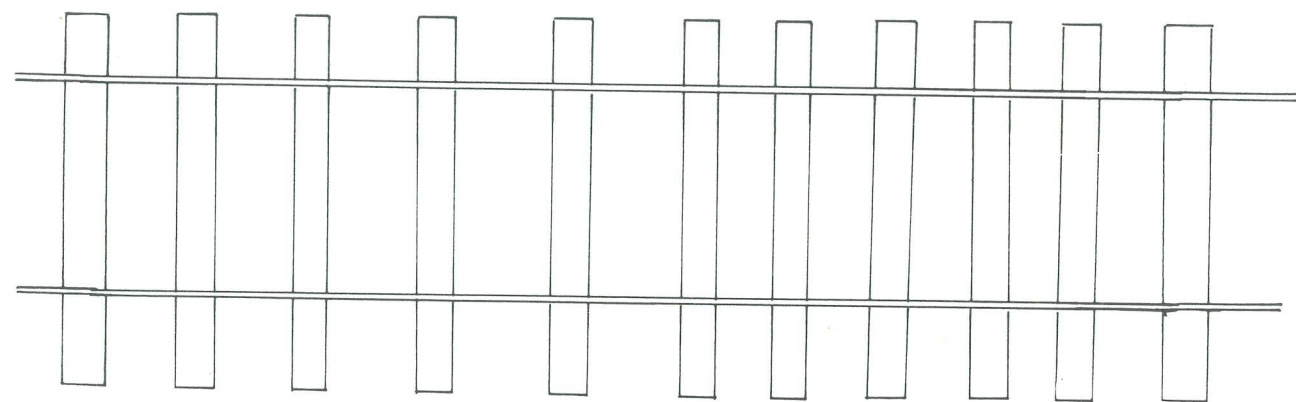
FIG. 1 SITE 'A'
RAIL OBSTACLE AND
ANTI-TANK BLOCKS
Scale 1: 100

The rail obstacle and anti-tank blocks east of the Gillingham Gate (see Figs 1-2 and Plates 1-17.

It consists of a pair of substantial monolithic concrete blocks (1.8 m high and 1.5 m wide) either side of the single-track standard gauge railway. Each block presents a vertical face to the south (the assumed direction from which an enemy would approach) and is sloped down to the rear. The blocks are transversely recessed with a 30 cm wide slot to receive a heavy moveable obstacle (probably a steel rail or joist) to close the way. The western of the blocks is mounted with a line of 8 steel rollers which can only have been intended to assist the movement of the obstacle into position. The purpose of the single 11 cm diameter iron pipe running through the top of the rear slope into the transverse recess of either block is not yet known.

The blocks are in fair condition, although the rollers and pipes exhibit corrosion. Damage to part of the concrete of the western block revealed 3 cm thick steel reinforcement bars used in its construction.

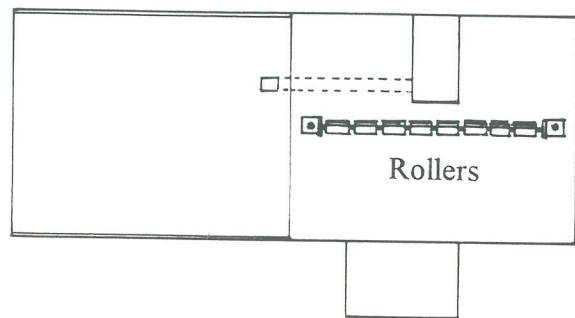
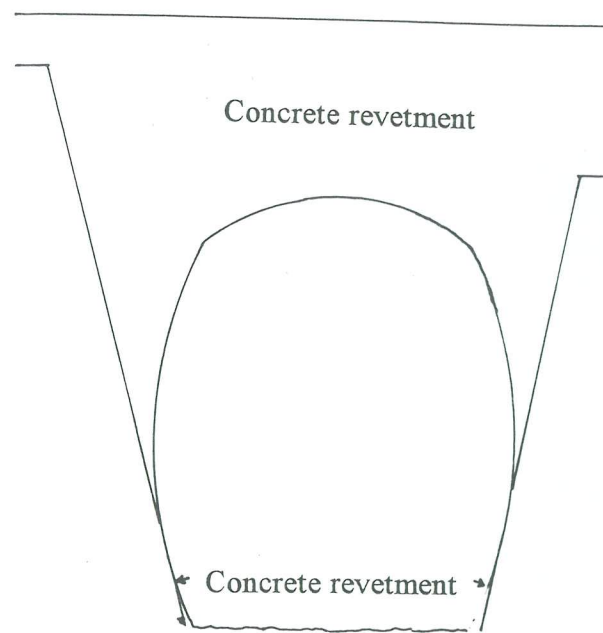
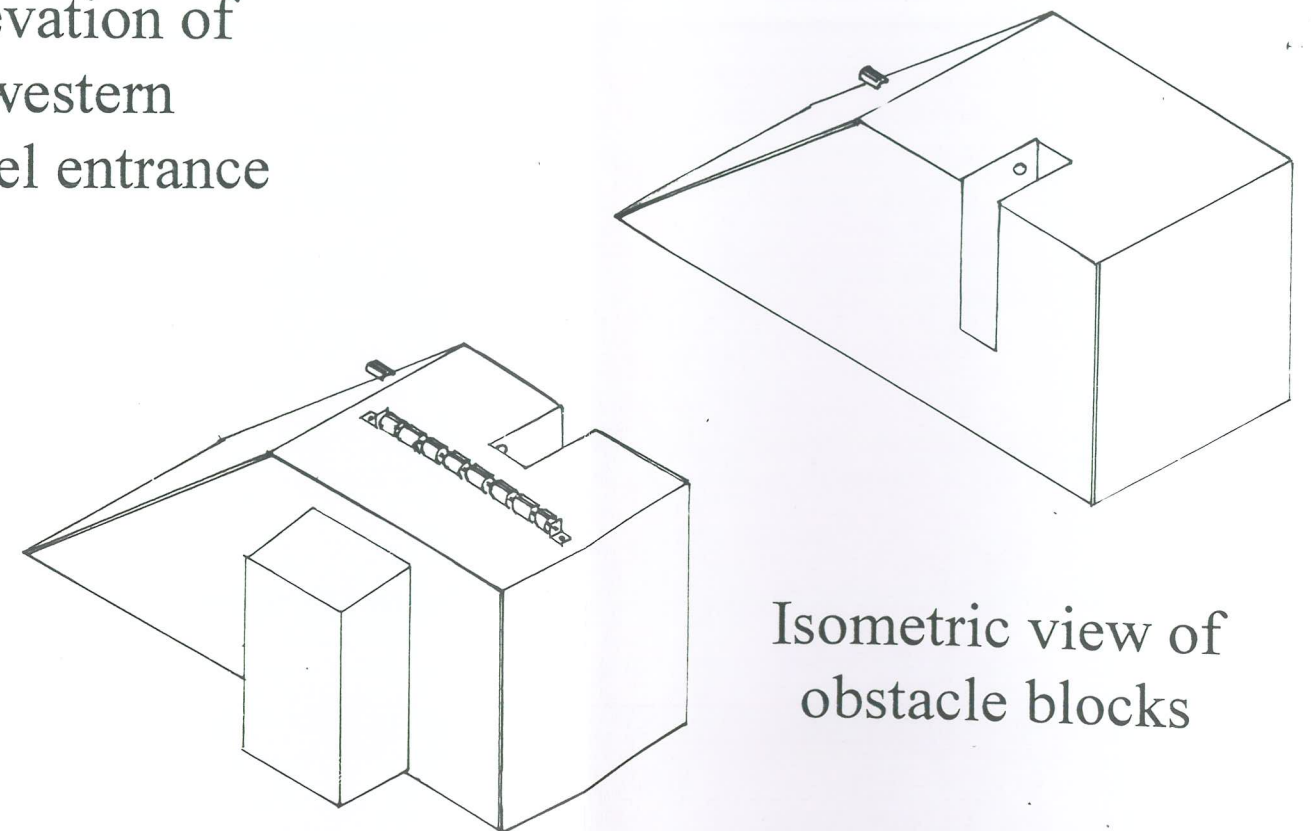
FIG. 2 SITE 'A'
DETAIL OF RAIL OBSTACLE
AND ELEVATION OF
WESTERN TUNNEL ENTRANCE

Passing under and through the embankment is a 2.9 m high concrete lined tunnel of near-horseshoe section. Its interior reveals the marks from horizontally placed timber formwork and shuttering. This probably originates from the date of the construction of the embankment to form as a way through for the internal wall-walk of the perimeter wall. Its role as a defensive communication during the Second World War is likely to have been coincidental.

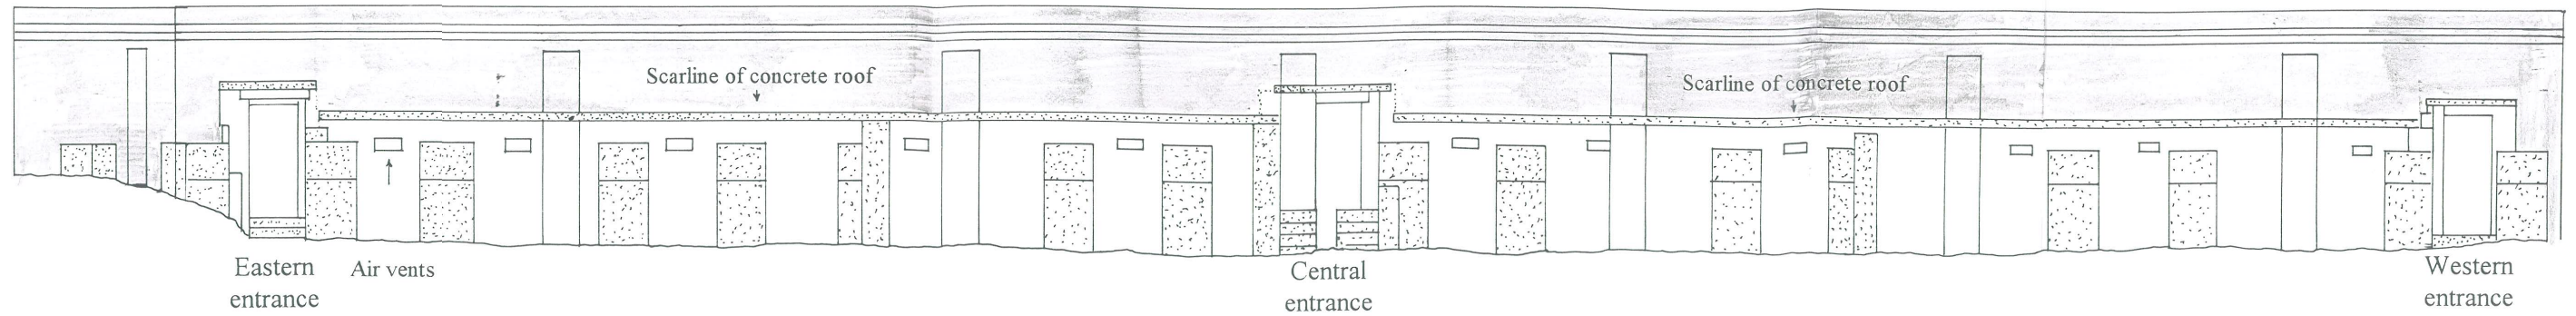
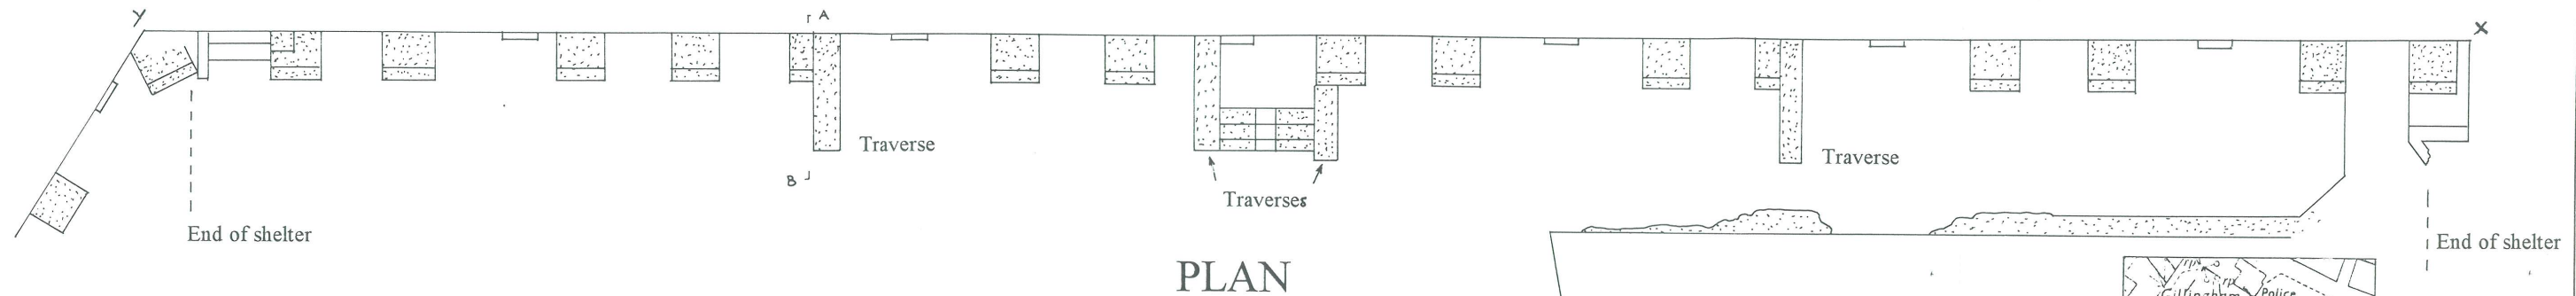
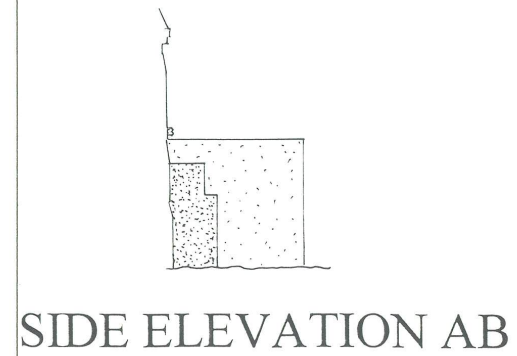
FIG. 3 SITE 'B'
AIR RAID SHELTER
ON EASTERN SIDE OF
THE GILLINGHAM GATE

The former air raid shelter behind the dockyard wall on the eastern side of the Gillingham Gate (see Fig. 3 and Plates 18-33).

From the physical evidence remaining, this had been a 44m long, rectangular surface shelter built against the inside face of the dockyard wall.

The shelter was demolished about 12-18 months before the visit to the site, leaving only the 16 cm-thick scar-line of the remnants of the horizontal steel mesh-reinforced concrete roof let into the brick wall, the white-washed wall below and three transverse internal walls (traverses). Traces of a cable line for internal lighting of the shelter may be seen just below the scar-line of the roof.

The remnants of two courses of brick on top of the transverse concrete walls of the shelter suggest that they made up the height to the ceiling of the former roof of the shelter. The transverse walls divided the shelter into three sections. The process of demolition of the shelter removed all but slight traces of its end walls and all of the dockyard-facing long side wall. The latter was presumably provided with doorways to allow access from within the dockyard. Mr. Bernard Thompson, KCC Surveyor, who saw the building before demolition, recalled that the walls had been constructed of concrete blocks and were in poor condition.

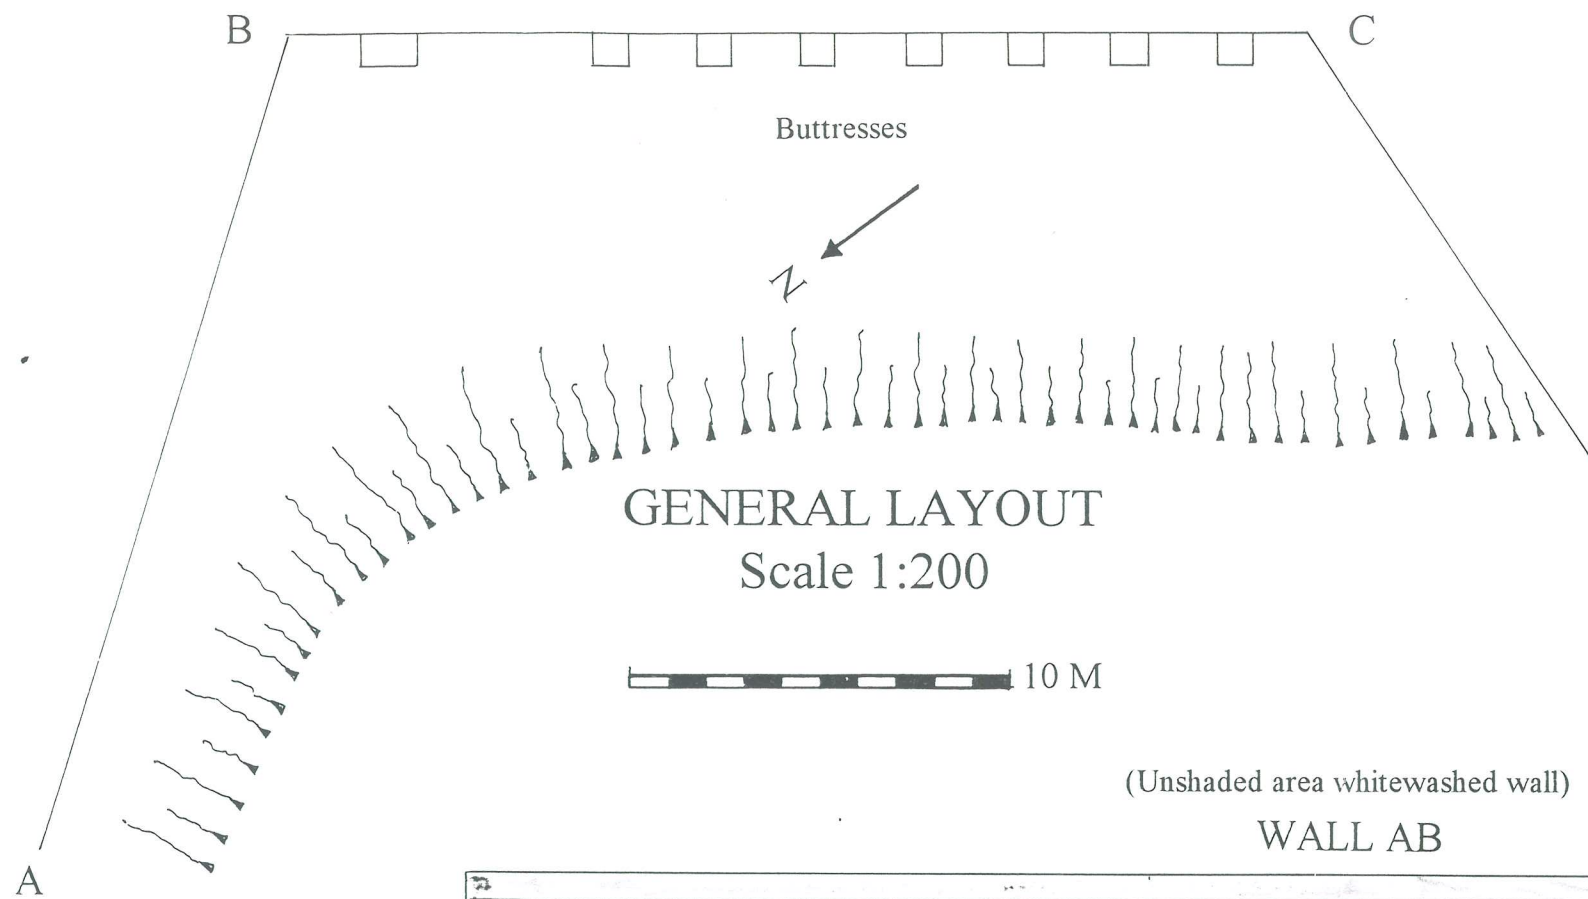
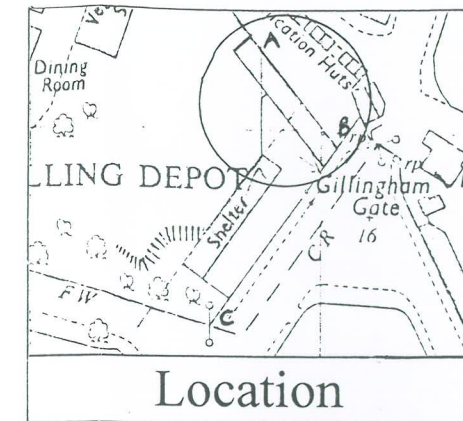
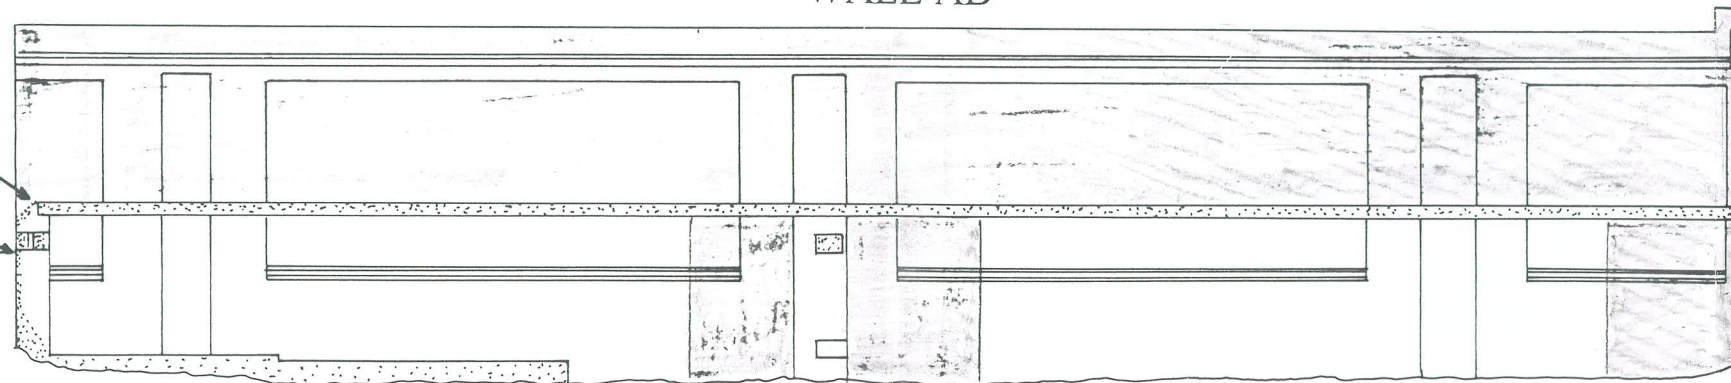
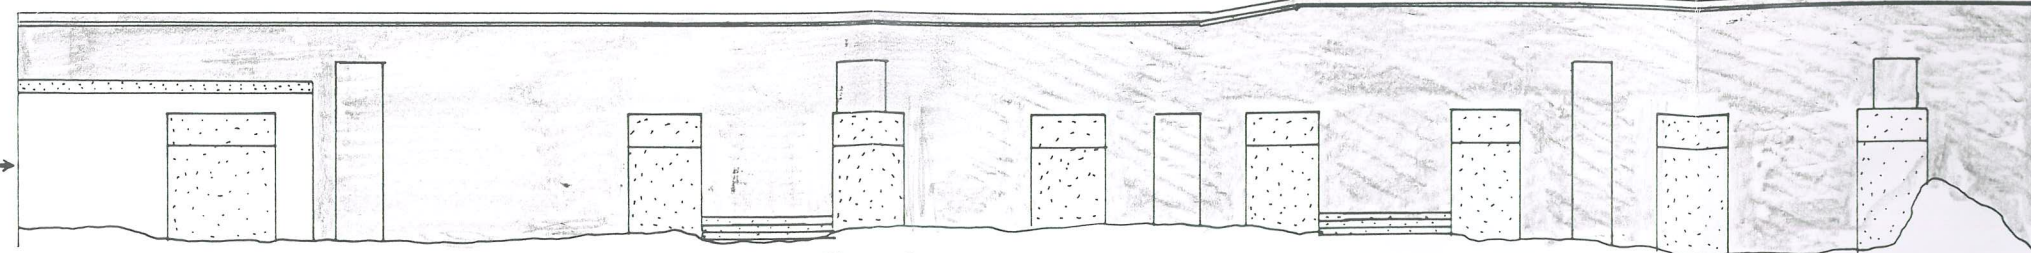
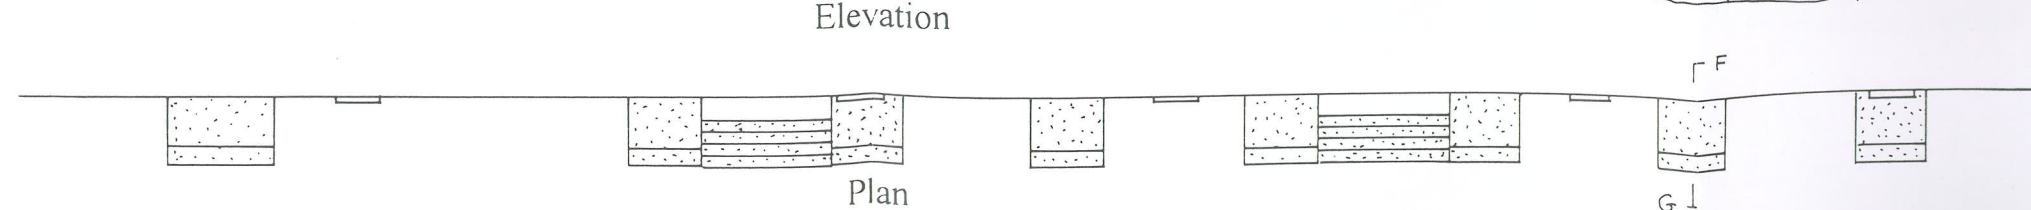
FIG. 4 SITE 'D'
AIR RAID SHELTER
ON WESTERN SIDE OF
THE GILLINGHAM GATE

Former air raid shelters in front of the inner dockyard wall on the western side of the Gillingham Gate (see Fig. 4 and Plates 37-47)

From plan evidence (inset in Fig. 4) there appears to have been two shelters within the re-entering angle formed by the 1870s wall and the later outer wall built to enclose the Victualling Depot.

This also appears to have been a surface shelter and survives as the 16 cm-thick scarline of its concrete roof (also reinforced in steel mesh) let into the 1870s wall, a whitewashed wall below, with some possible traces of a concrete floor at the base of the wall. From the physical evidence remaining, the shelter was 23 m long and its width of 3.5 m may be deduced from the scarline on the north end of the north-south of the angled walls. The western end of the shelter is just visible as the remnants of its concrete blockwork. The process of demolition and of earth movement has destroyed all obvious traces of the other walls which must have been provided with doorways for access. According to Mr. Thompson these were also of concrete blockwork and embanked with earth part of the way up. Any transverse internal walls of the shelter (traverses) are likely to have been

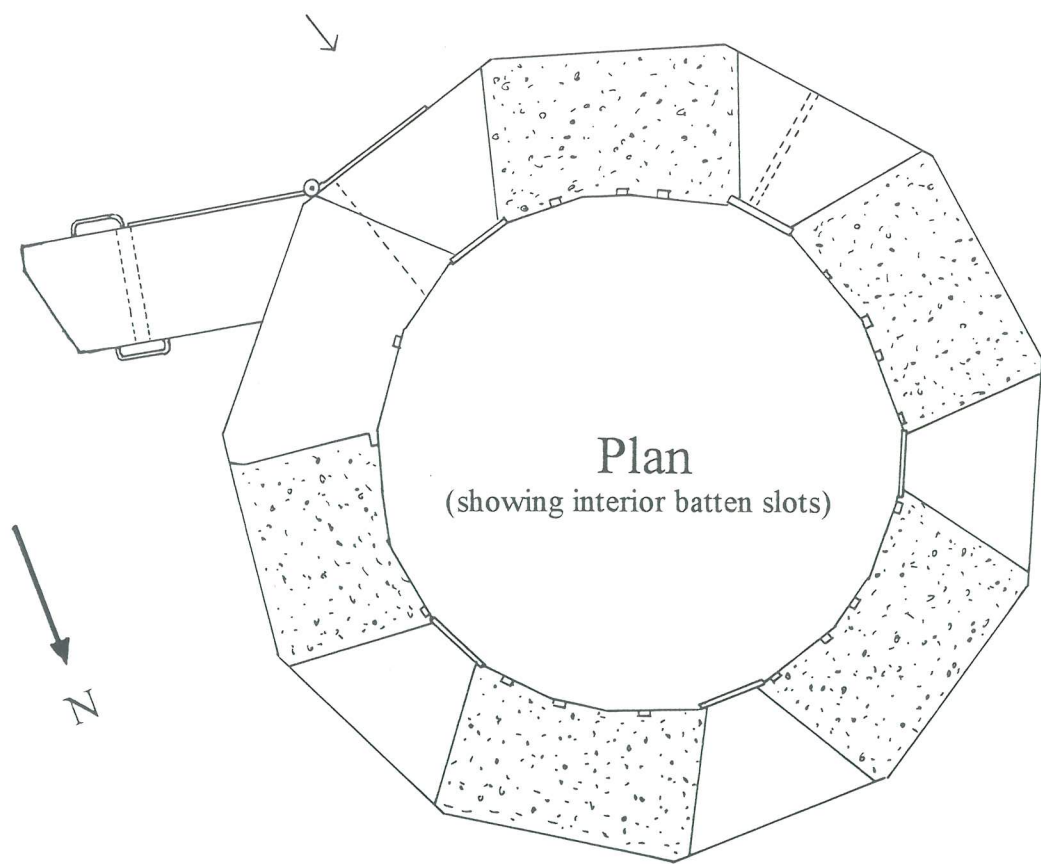
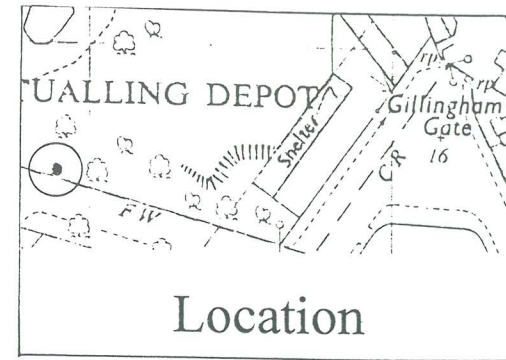
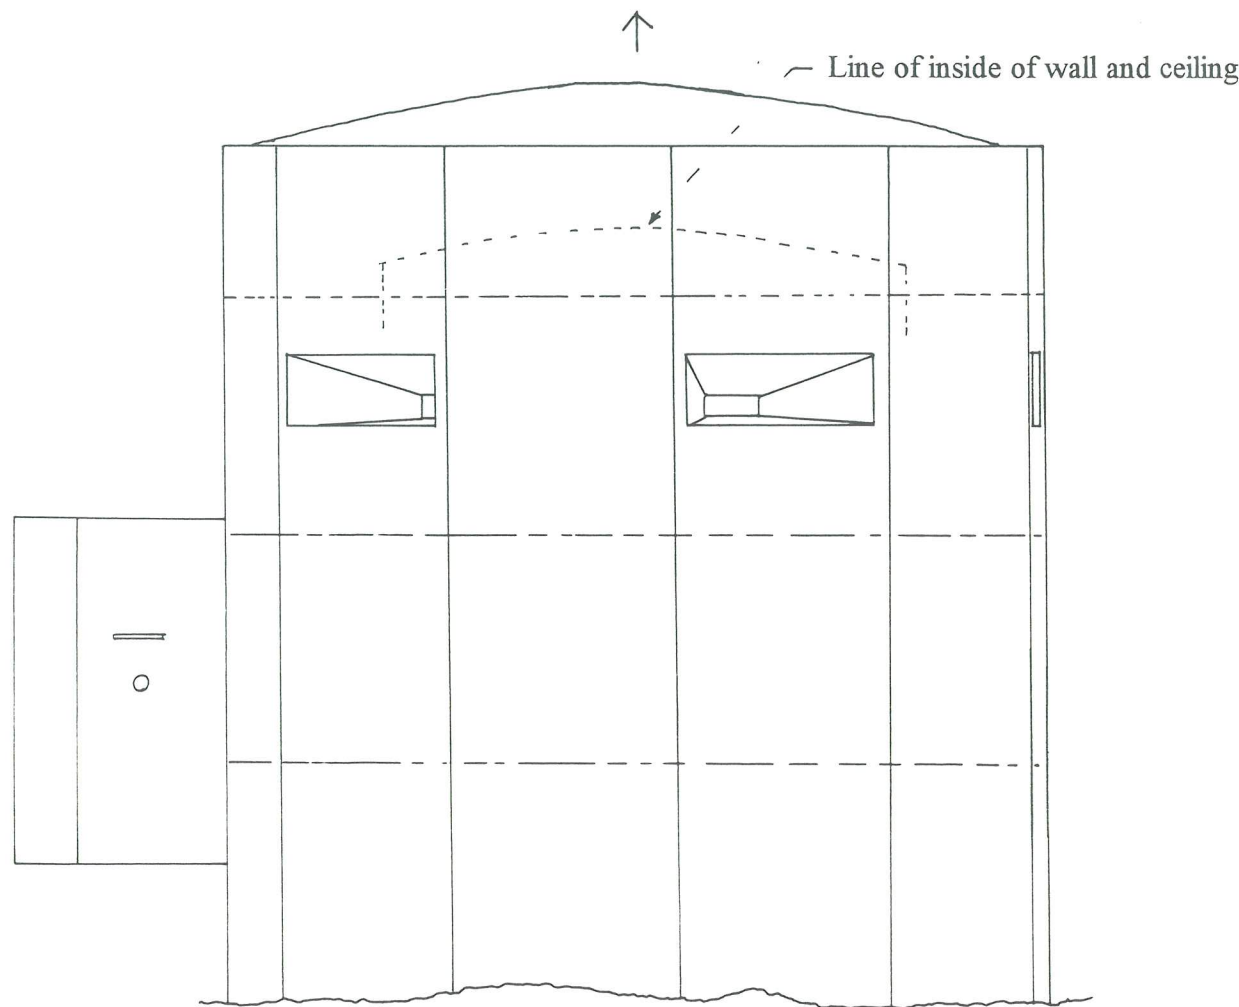
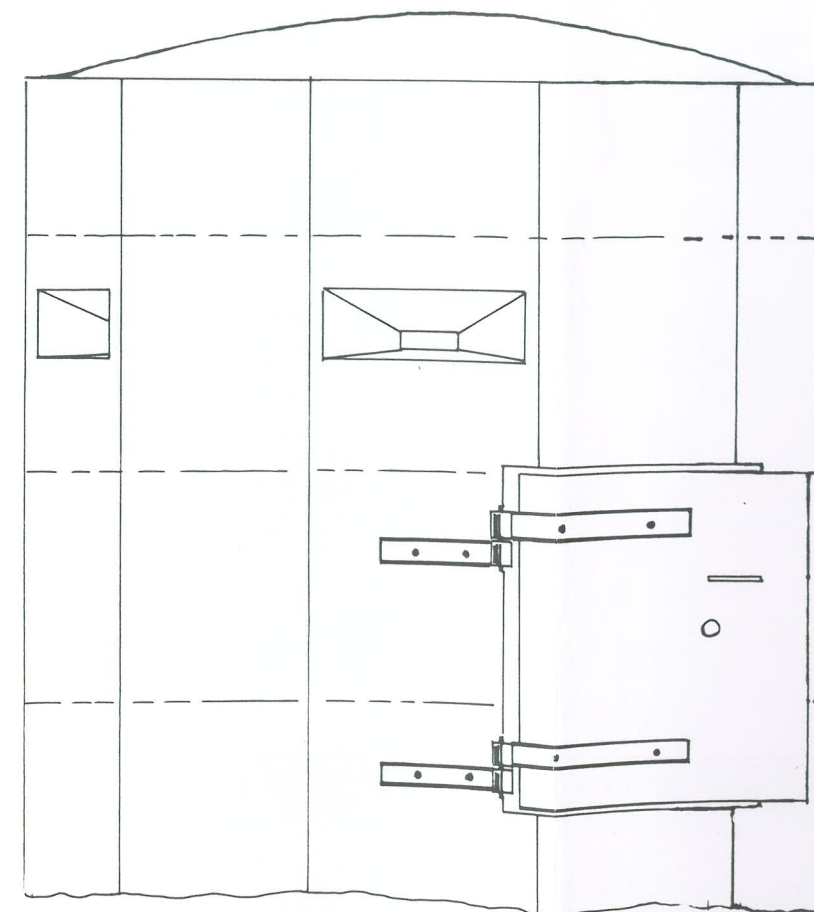
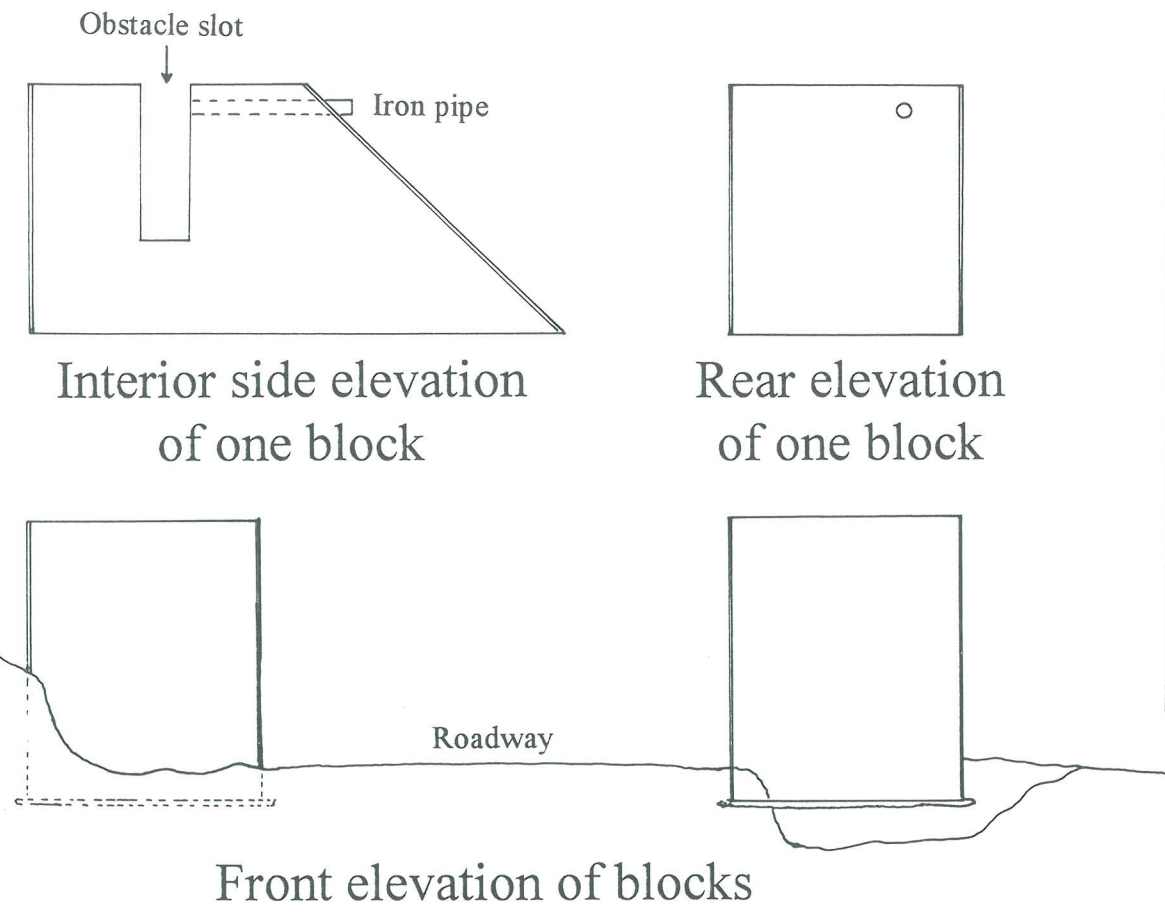
FIG. 5 SITE 'E'
PILLBOX INSIDE
BOUNDARY WALL
SW OF THE
GILLINGHAM GATE

The pillbox behind the outer boundary wall 100m SW of the Gillingham gate (see Fig. 5 and Plates 48-56)

This is a 2.4 m high 11-sided concrete structure with a low-domed top located 2 metres north of the wall built to enclose the Victualling Depot. It has 5 horizontal loopholes through its 34 cm thick walls. It was entered through a low doorway on its eastern side which was closed by an externally hinged 30 cm thick concrete door, with inner and outer steel bar handles. Vertical slots in the inside wall of the pillbox were for the placement of a timber lining of which fragmentary traces remain. Externally, there is a zinc rainwater apron on the top of each loophole, fixed into a timber block recessed into its host concrete. There are also external traces of three layer-stages of concrete casting. The entrance door and the south-west face of the pillbox are pierced by 6 cm circular and horizontal holes. Their purpose is at present unknown. The lower interior of the pillbox was infilled with debris so that the depth of the floor could not be established.

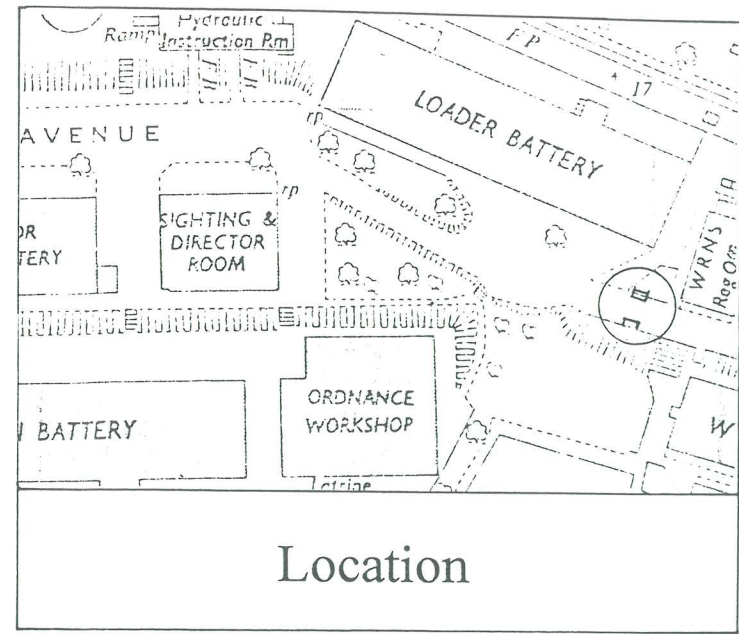
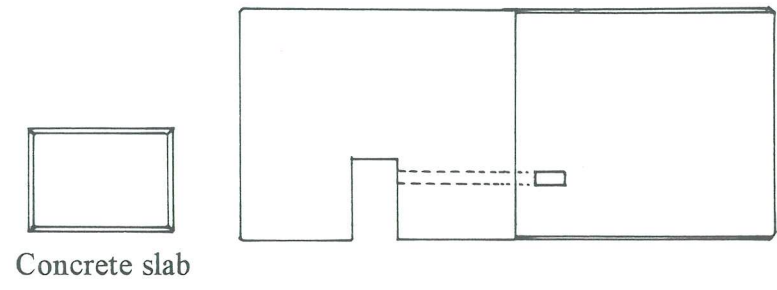
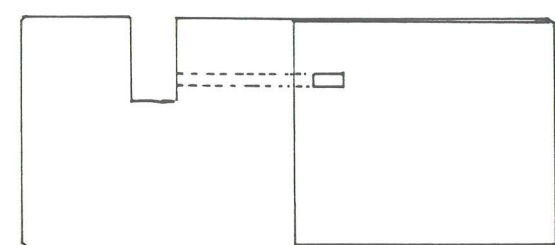
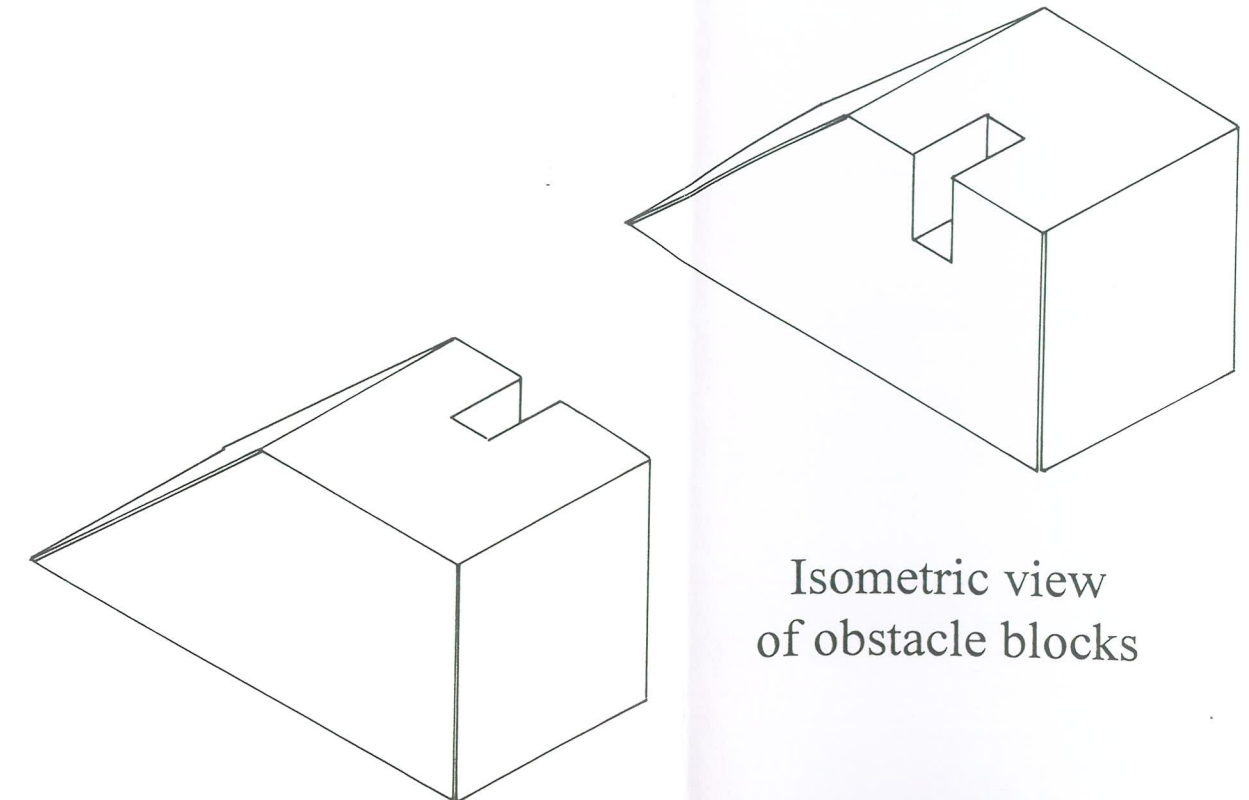
FIG. 6 SITE 'H'
ROAD OBSTACLE
EAST OF FORMER
GUNNERY SCHOOL

Road obstacle 30 m east of the former Gunnery School (see Fig. 6 and Plates 59-67)

This faces east and is located astride the 3m wide internal road at the western extremity of the East Camp (demolished). Its construction, shape and size is the same as the rail block at Site 'A', except that there had never been a roller assembly for the movement of the obstacle into position and it had no side buttresses. There is an excavation in front of the vertical end of the northern of the two blocks which reveals that the block had been built directly on top of a thin layer of brick rubble. The purpose of the two chamfered concrete slabs in front of the vertical ends of the blocks is not known. Painted visibility markings of later date are extant on the front ends of the blocks.
