# TONBRIDGE CASTLE: FURTHER OBSERVATIONS ON AN ANCIENT CASTLE

SYDNEY SIMMONS, F.I.C.E.

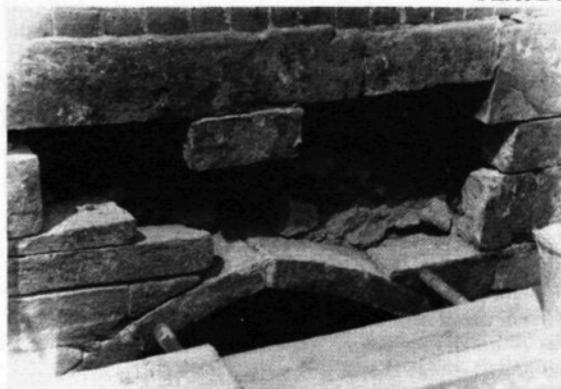
PLATE I

Holes and gaps above the arrow slits in the north face opened into substantial cavities. None was so large as any found near the south windows. They were cleaned out and remade as the others.

Tonbridge Castle: A cavity typical of those found in the upper gatehouse.
