**Cremer & Whiting Brickworks, Sumpter Way,
Ospringe (Nr. Faversham), Kent, M13 7NT**

Historic Buildings Record

**Project no. 170341
Report No. 2017229
Site Code. COW17
OASIS ID. Archaeol6-286456**

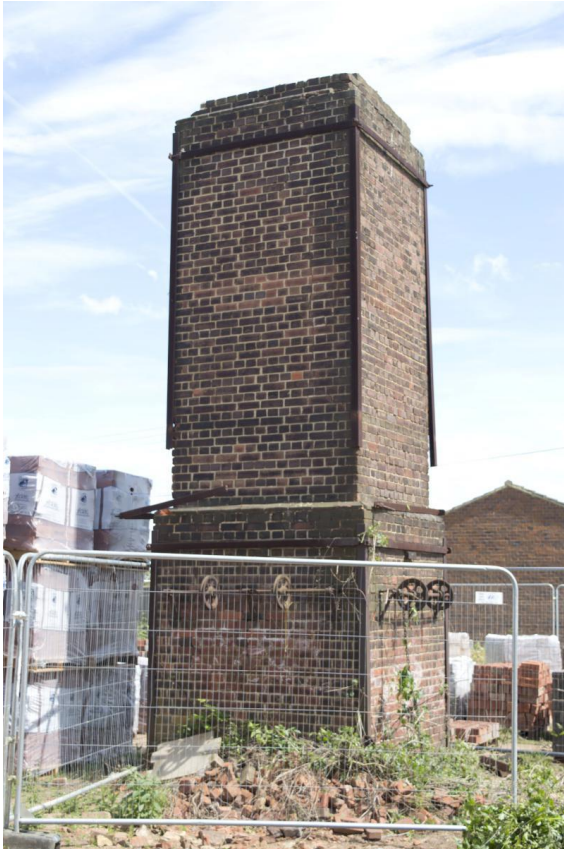
Plate 5: View of the west elevation of the chimney, facing north-east (185)

- 5.2.10 There is stepped cracking through the brickwork and mortar joints, measuring a width of between 50mm – 100mm, which extends through approximately 46 courses of the southern side of the two upper levels, terminating at the south-west corner.

- 5.2.11 Corrosion of the iron brackets has caused radiating and vertical cracking around each fixing. These cracks roughly measure between 50mm – 200mm; the cracking surrounding the northernmost bracket are comparatively more substantial and extend to the top of this lower section.

- 5.2.12 Ancillary hairline cracking extends through approximately 6 courses of brickwork within the central section at the ground floor level.
- 5.2.13 Limited areas of displaced and missing mortar are located on the uppermost level and at ground floor level.

- 5.2.14 The surfaces of the bricks remain in reasonable condition, although the brickwork below the pulley mechanism shows discolouration consistent with salt staining. Staining is likely to have occurred due to the close proximity of the ground level. Also, an associated patch repair in this area using a harder cement mortar, appears to be forcing moisture and impurities out through the brick rather than the mortar.

- 5.2.15 The iron strap work formerly secured at the north-west corner at the join between the lower and upper sections, has become loose and projects outwards from the brickwork in this location, this in turn has caused minor abrasion to the surrounding brickwork through friction caused in windy conditions. The connectivity between the angle straps encasing the brickwork of the north-west corner, has become loose due to pressures caused by climbing vegetation and warping caused by iron corrosion.

Repairs should be undertaken to stabilise, make good and preserve the chimney. Where repairs are required these should be carried out on a like-for-like basis to conserve the character and appearance of the building. Such works should include the raking out and repointing of open and weathered mortar joints. Re-forming and rebuilding the chamfered offset and tiles to the top of the offsets. Where cracks have extended through the brickwork, these should be made good with new brickwork. The lower section of the south elevation will need to be rebuilt. All cast iron material, including fixed and unfixed members, will need to be treated with an appropriate rust inhibitor, painted and refixed. Any work should aim to retain and reuse as much of the original fabric, where possible.

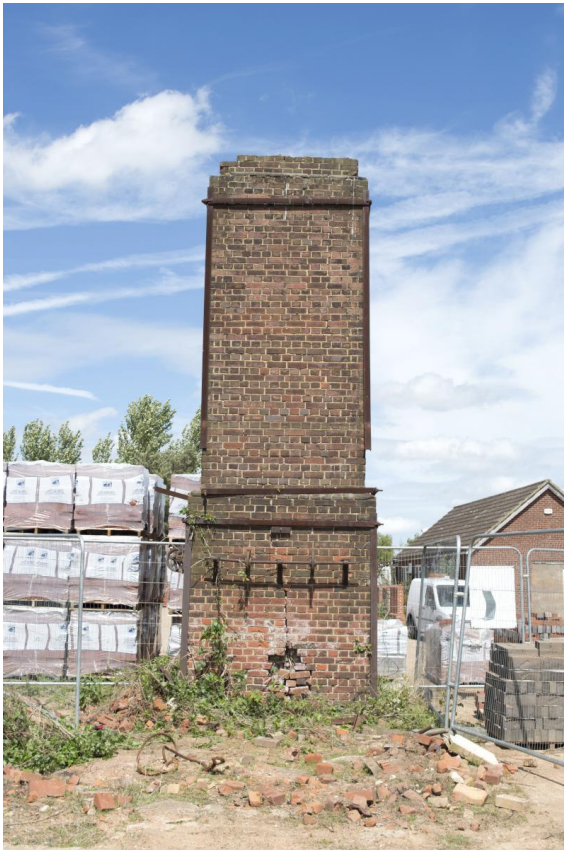
Plate 6: View of the south elevation of the chimney, facing north (184)

- 5.2.16 Vertical hairline cracking extends through roughly 23 courses of the brickwork and mortar joints at the eastern side of the middle section.
- 5.2.17 The lower section is divided at its centre by a large vertical crack which extends throughout the brickwork and mortar joints, both above and below the central corroded iron bracket. The crack was widest just below the bracket, measuring

25mm. The lower section of the crack opens out approximately 10 courses above ground level, into an area of loose and missing brickwork. At its widest point this opening was noted to be 0.46m wide. The cause of the opening appears to be connected to some incursion by climbing plants and the lack of ground level support in the location of the adjacent void.

- 5.2.18 The angle strap securing the upper level of the south-east corner has come away from the surrounding brickwork due to warping caused by iron corrosion. The angle strap securing the south-west corner has also been forced outwards from the brickwork due to climbing vegetation. Additionally, the strap securing the join of the middle and lower sections is no longer secured at its western end.

- 5.2.19 The uppermost section is missing a single brick and tile to the offset at its western end.
- 5.2.20 Much like the west elevation, the lower section bricks show discolouration consistent with salt staining. The general condition of the brickwork is sound at the upper level, although limited areas of the lower level brickwork have suffered from spalling. Areas of pointing are open and weathered in places within the upper sections, despite this the condition of the mortar is reasonably well preserved.

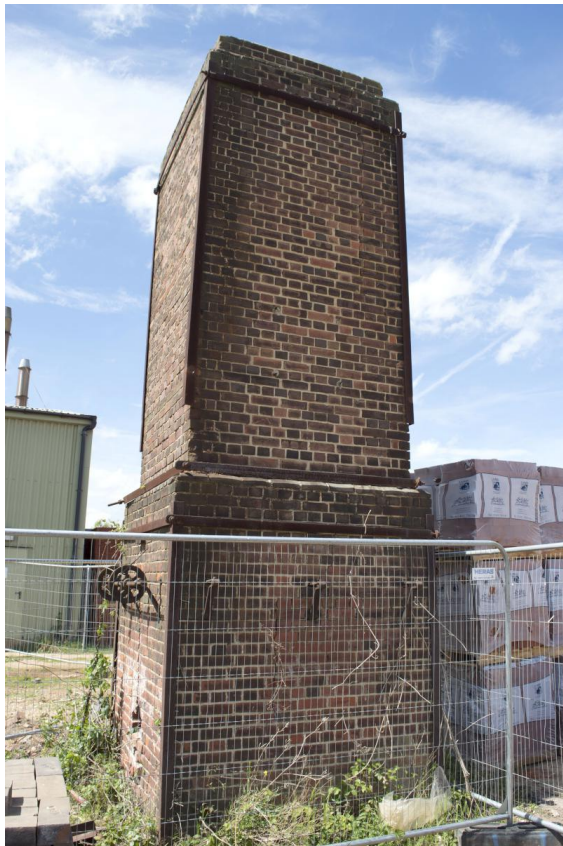
Plate 7: View of the east elevation of the chimney, facing north-west (196)

- 5.2.21 A vertical crack extends from the join of the uppermost offset through approximately 28 courses of brickwork and mortar, in places measuring between 50mm to 100mm thick.

- 5.2.22 A hairline crack runs throughout c. 10 courses along the southern end of the middle section. An additional hairline crack was noted on the lower section, towards the southern end, extending from the section top through the mortar of c. 11 courses.

- 5.2.23 The angle iron strap-work securing the north-east corner is coming loose. The central cast iron bracket is corroded and is most likely the cause of radiating cracking in this location. Resultant cracking situated around the bracket mortar joints most noticeably comprises a stepped mortar crack above, extending through nine courses (measuring 50mm at its widest point), and a vertical crack to the south, measuring between 50mm and 150mm, and extending 11 courses of brickwork and mortar.

- 5.2.24 The surfaces of the bricks are well preserved, despite a limited area of truncation where four screws have been inserted within the central upper section. The mortar joints remain intact, with only isolated areas of weathering. Surface damage was noted on the edge of the southernmost capping tile upon the uppermost offset.

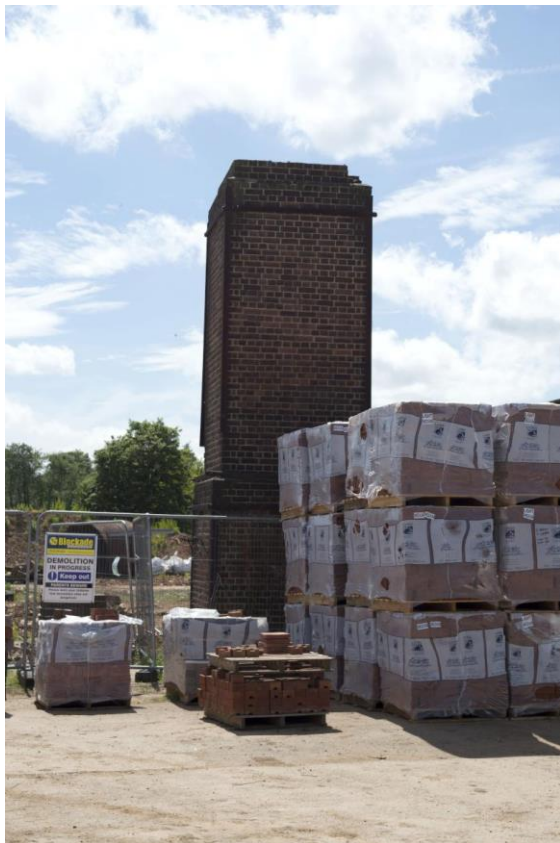
Plate 8: View of the north elevation of the chimney, facing south-west (186)

- 5.2.25 Hairline vertical cracking was noted extending through 13 courses of brickwork and mortar joints on the west side of the central upper section. Within the same section, a stepped mortar hairline crack was noted extended through 12 courses along the eastern side.
- 5.2.26 A vertical crack, measuring approximately between 50mm and 70mm at its widest points, extended throughout the entirety of the mortar and brickwork along the western side of the lower section.

- 5.2.27 The top courses of the uppermost section that were noted as loose within the 2014 report (Gould), have now been lost. Additionally, three capping tiles on the uppermost offset are missing.
- 5.2.28 The condition of the brickwork is generally good, except for a concentrated area of surface spalling at the eastern end of the lower section, and a small area of salt perforation within the centre. The mortar joints are also relatively intact, aside from a weathered area of loose mortar to the western side of the lower section.
- 5.2.29 The iron angle strap level with the lower offset is unfixed at the western end. Incursion of climbing plants has resulted in the angle iron straps to be forced away from the brickwork at the north-east and north-west corners.

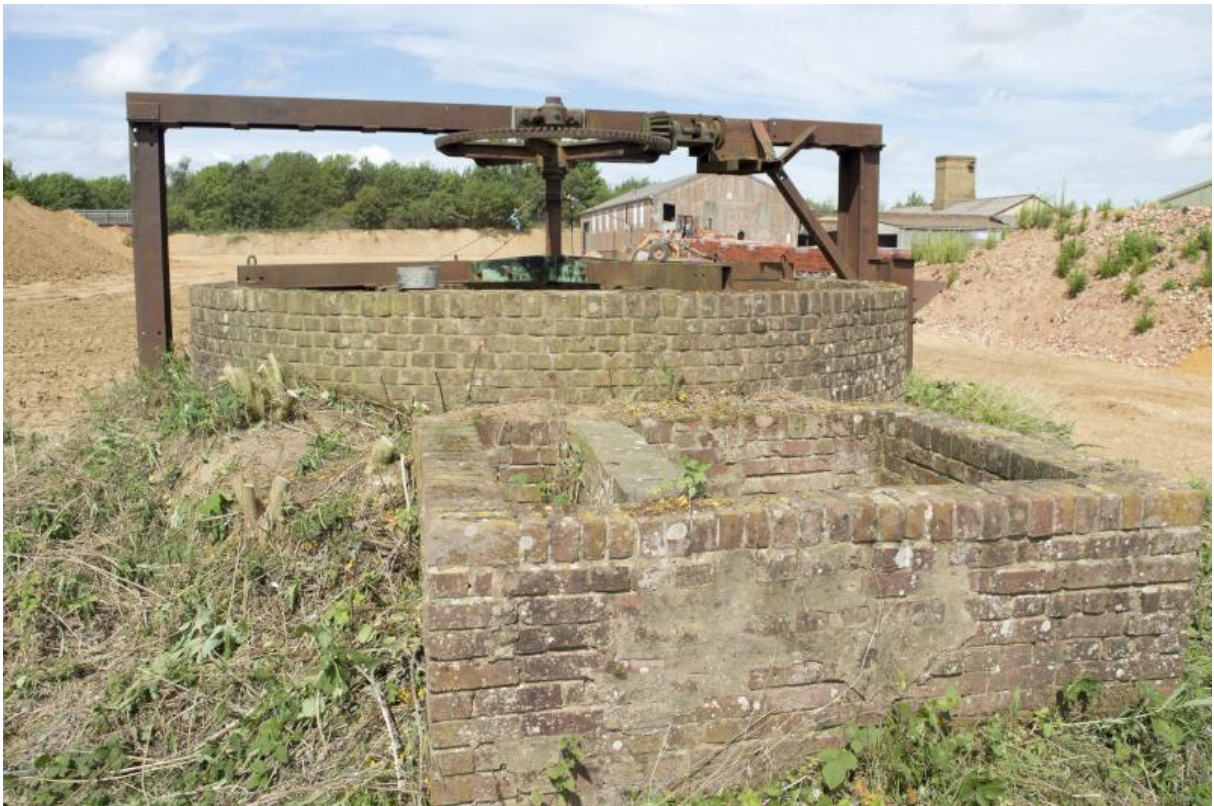
Plate 10: View of the water tank, facing west (162)

- 5.3.17 The water tank walls remain upright with evidence of cracking extending through the brickwork or mortar joints. The surfaces of the bricks remain in a good condition. Areas of cement render capping the walls have suffered from cracking and are now loose. The majority of mortar joints remain in a fair condition, although areas within the south and east walls have been encroached by climbing vegetation.

- 5.3.20 Remedial work should include the raking out and repointing of any open or weathered mortar joints, including the re-setting of the water pump joints. Where cracks have extended through the capping brickwork, these should be made good with new brickwork. The structural stability of the northern side of the wash mill's inner tank should be assessed, and made good with new brickwork if necessary. All metal components to the wash mill mechanism, will need to be treated with an appropriate rust inhibitor and painted. The metal panel door to the electrical switch cupboard should be reinstated, and the restraining wires refixed (where loose). Any remaining existing vegetation, particularly within the water pump interior, should be cleared to ground level and a maintenance programme for keeping vegetation growth down, should be implemented. The concrete lid for the water pump housing should be reinstated with a small ventilation gap, to deter further self-seeding of vegetation. Due to site clearance works, predominantly ground levelling, the surrounding ground level is considerably lower than that of the structures, by around 0.40m. This has the potential to cause an adverse reaction on their structural stability, due to changes in resistive pressure and foundation exposure which could be subject to an increased level of weathering. The immediate surrounding ground levels should be reinstated to reduce any potential harm. Any work should aim to retain and reuse as much of the original fabric, where possible.

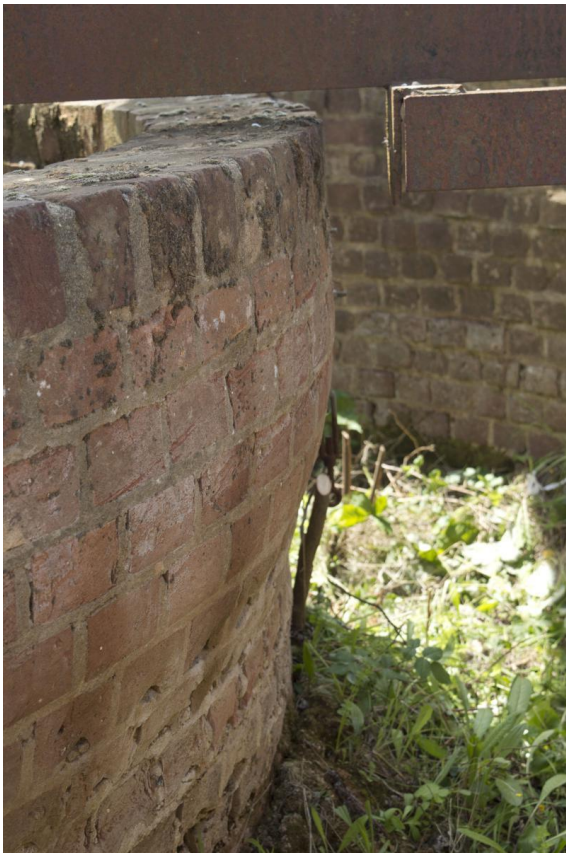
- 5.3.15 The brick walls remain upright with no significant evidence of major structural cracking extending through either the brickwork or mortar joints. The outer face of the inner tank has suffered from substantial wear on its northern side (Plate 14), so that the upper level (measuring c.0.56m) protrudes c.100mm outwards from the lower level. This appears to have been caused by friction caused by passing clay when operational. Despite this worn area, the surfaces of the bricks remain in a fair condition free from spalling. A number of individual capping bricks have suffered from cracking and chipping. The mortar joints remain in a reasonable condition. The mechanism serving the wash mill remains in fair condition, although there is extensive evidence of surface corrosion. The restraining wires connected to the frame are either loose or have become unfixed.

Plate 14: Detail of the worn bricks on the north-east edge of the inner tank within the mill, facing south-east (175)

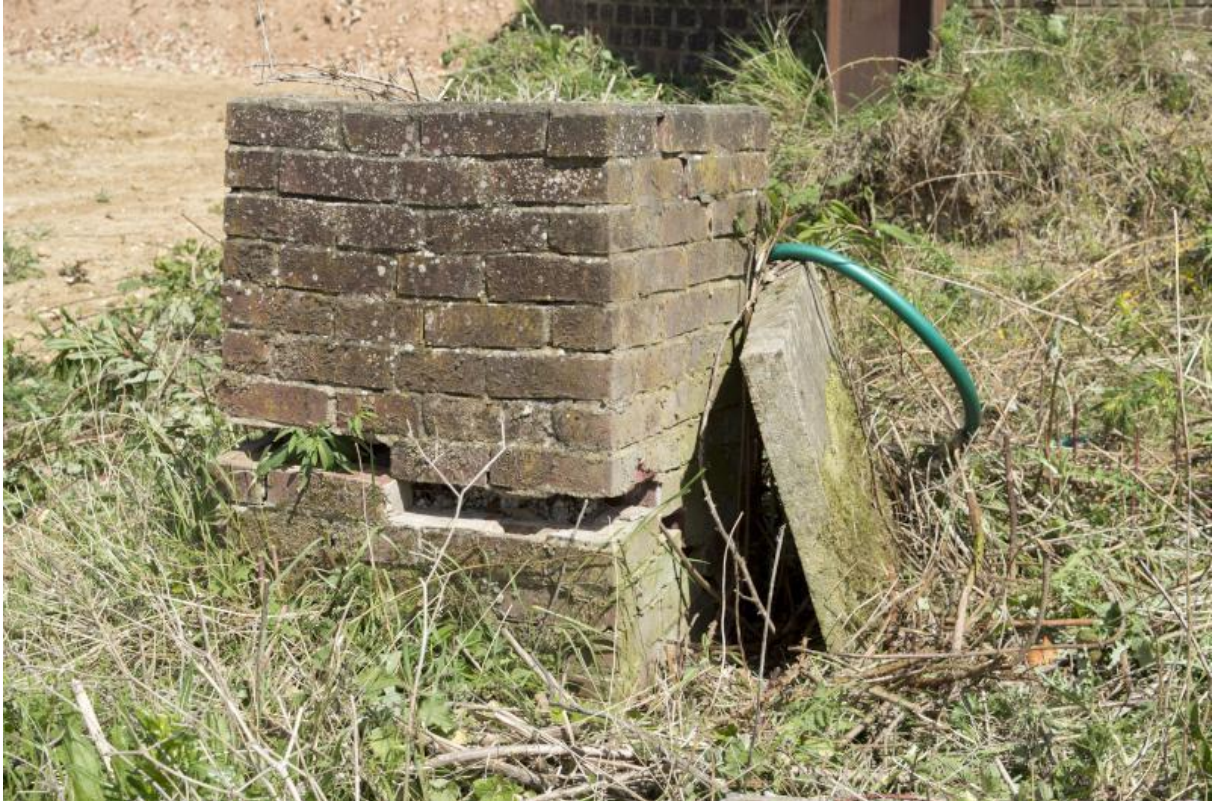
Plate 15: View of the water pump casing to the south of the mill, facing north-west (180)

- 5.3.18 The poor condition of the water pump appears to have been caused by the encroachment of vegetation, which predominantly fills the entire interior. All brick elevations have been subject to extensive cracking around the base (Plate 15), which extends unbroken through the mortar joints. This has caused the top level of the structure to sever from its base, which remains unsecured. The dislodged brickwork causes the entire structure to tilt in a northwards direction. The cracking occurs approximately between c.0.53m and 0.63m from the top of the structure, and in places measures c.110mm. Additional mortar joint cracking extends through six courses of brickwork in the top section of the south elevation, in an eastwards direction. The surfaces of the bricks remain in a relatively good condition, free from spalling. The concrete slab lid is lent against the structure to the east side, its condition bring relatively fair.
