**THE AIR RAID
SHELTERS AT
COBHAM PRIMARY
SCHOOL, THE STREET,
COBHAM, KENT**

Historic Building Survey

Victor Smith
20th June, 2005

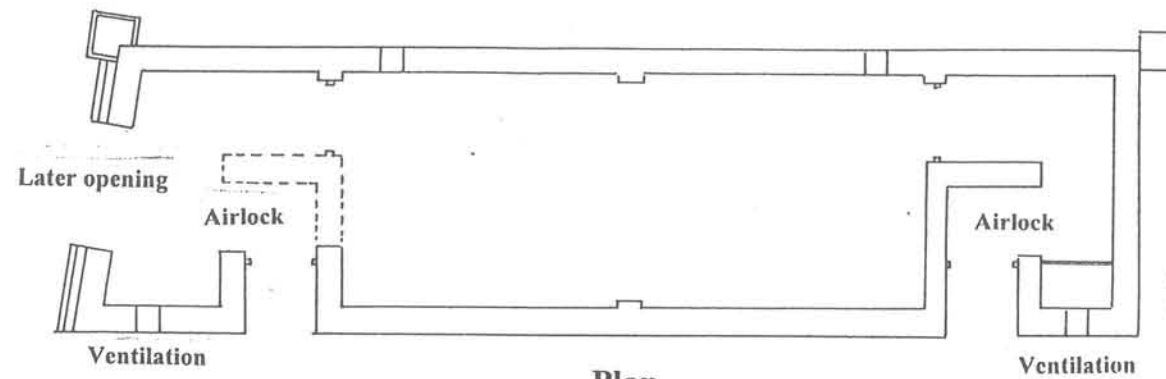
Plan

The building, close to the north of the original school building (erected 1874) is a nearly rectangular surface shelter orientated north-south, its north end wall being slightly angled to match a pre-existing school wall, against which it was built. The shelter measures 14m x 3.8 m. externally, with a height of 2.4 metres and a roof 13-22-cm thick. It contains a single long room, entered from either end of the shelter via a traversed indirect entrance of conventional form. The shelter's 34-cm thick walls are constructed of yellow brick on a yellowish sandy mortar and laid in English Bond, with a double damp-proof course of light grey slate, several cm (variable) above the surface of the playground. The nearly flat concrete roof is slightly sloped from west to east for the run-off of rainwater. The outside of the eastern long wall presents as rendered in cement.

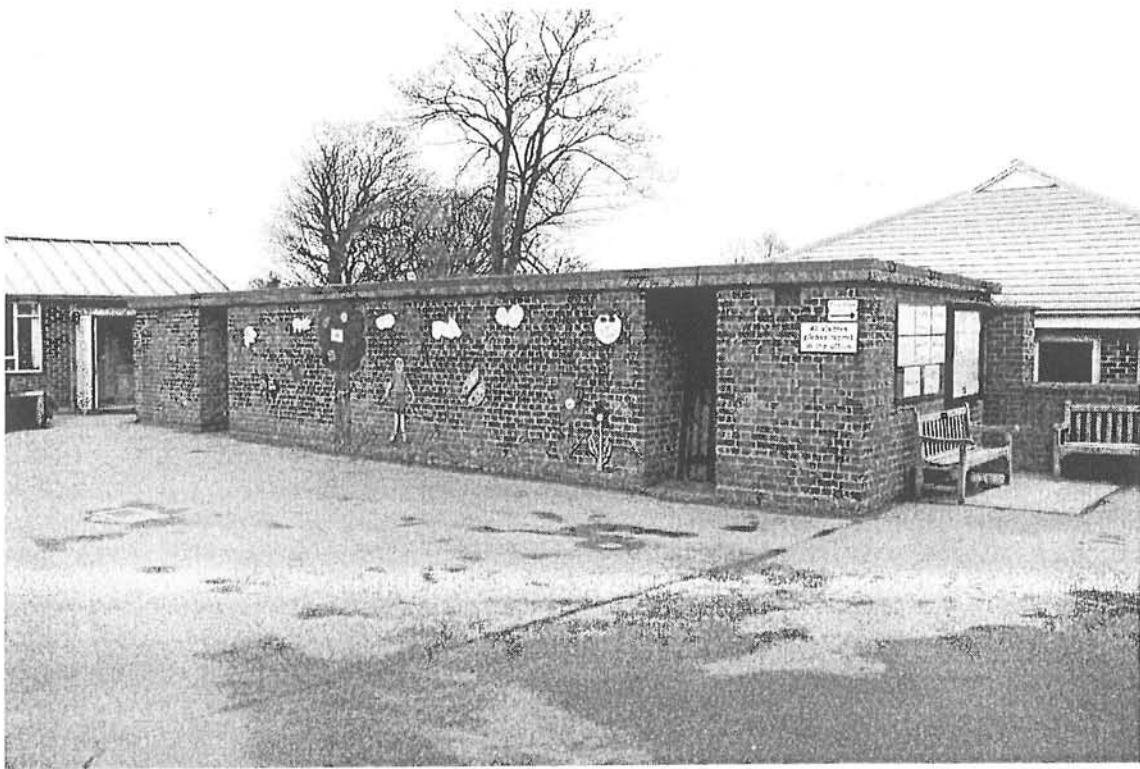
1

1. Western elevation
2. Southern elevation
3. Northern elevation
4. Northern and eastern elevations
5. Airlock frame and later door at the southern end of the shelter
6. The same view with the door open
7. Curtain rail in toilet cubicle
8. General view of the inside of the shelter, looking south
9. Ventilator in eastern wall
10. Inside of outer airlock frame at the northern end of the shelter

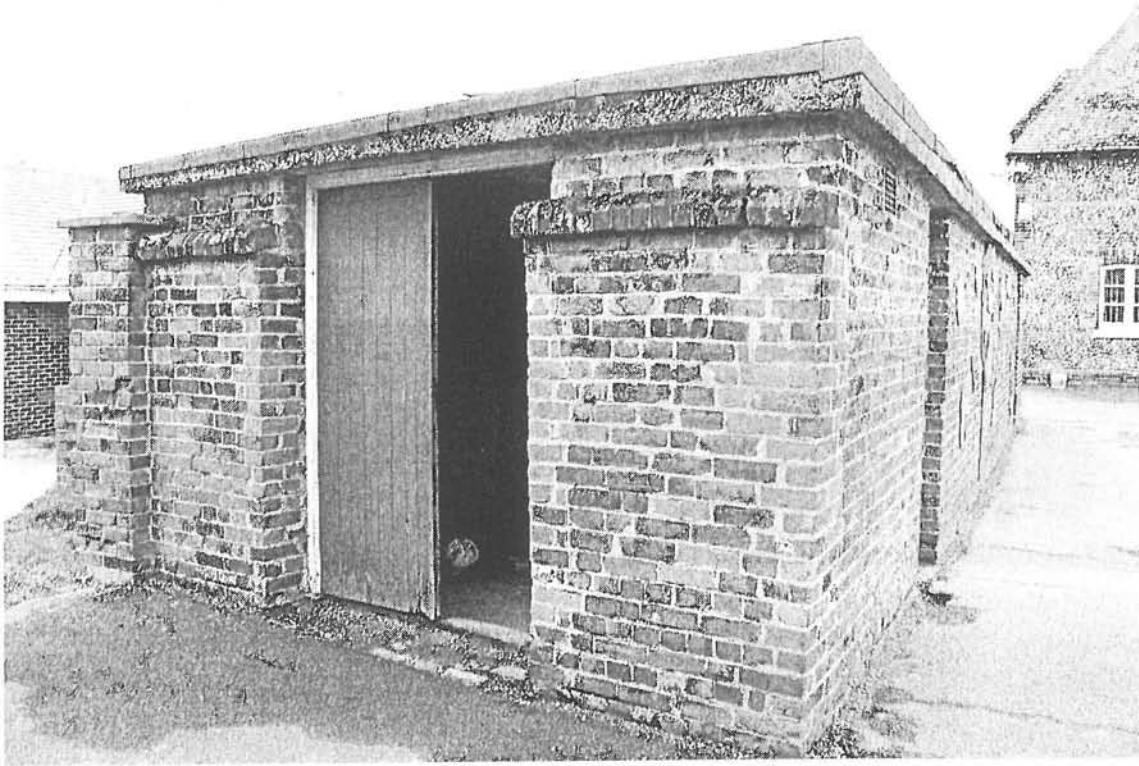
3

north end of the shelter, the end wall itself having also been breached to mount double doors to facilitate use of the interior as a school store, which purpose still applied at the date of survey. The blast wall was intact at the southern end of the shelter.

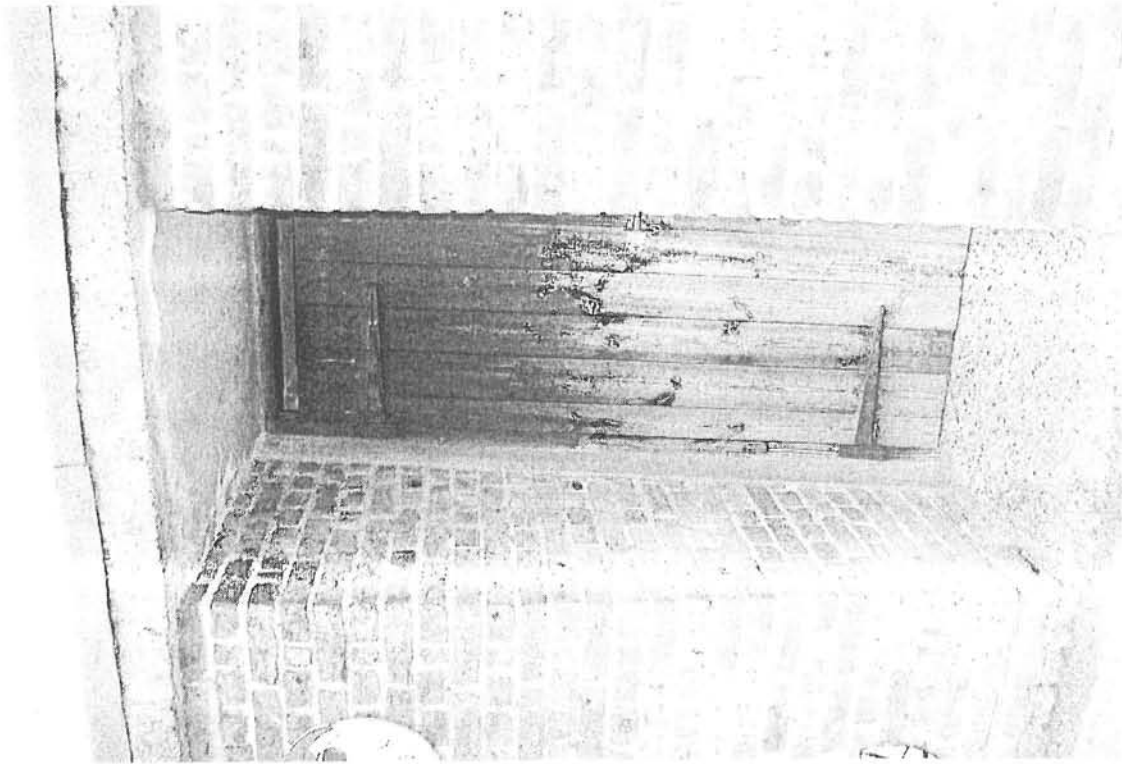
5

Both entrances had been provided with airlocks against gas attack. These consisted of an externally sloped and unpainted timber frame in the entrance from the playground, originally mounted with a chemically impregnated fabric gas screen fixed and lowered from the lintel, with another similarly arranged frame on the inner side of the blast wall. In several places on the lintel of the frames could be seen the fixings for the top of the fabric screen. These frames had been mounted post-war with wooden doors, no doubt for securing the contents stored inside.

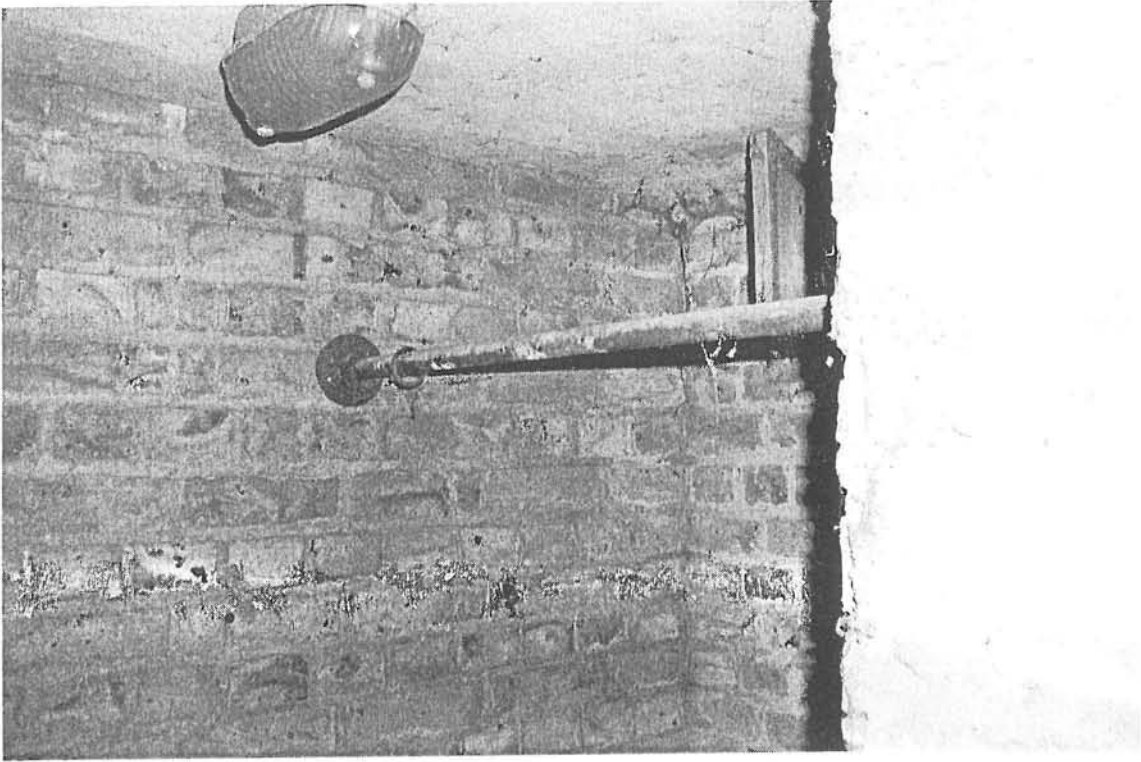
7

The small cubicle inside the south-western corner of the shelter was a latrine, to contain a single Elsan toilet bucket. A 2.5-cm diameter steel curtain rail, on which a movable fabric screen slid on rings, had been provided for giving privacy to the user. In the outside wall above was an air vent.

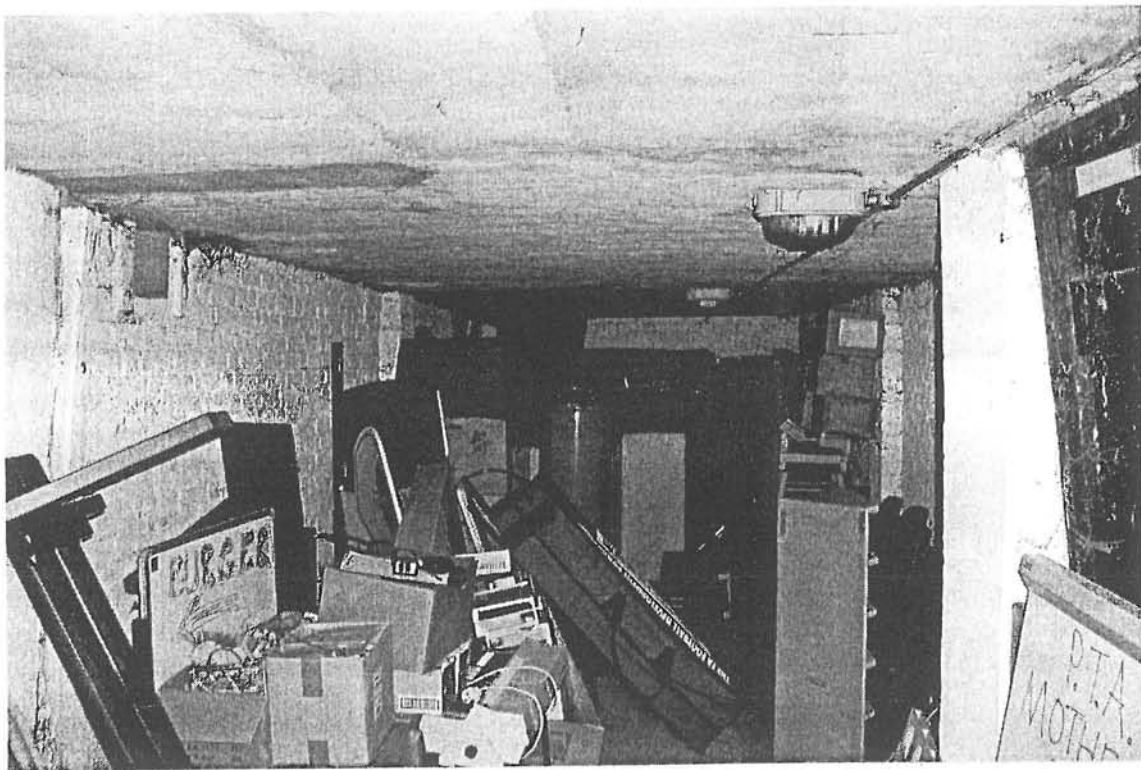
8

The long walls of the 7.m. x 3.1 m. shelter room were relieved centrally by a pair of opposing brick pilasters. The internal face of the wall had been painted white but the date of execution is not known. Under the ceiling at either end of the eastern long wall are two small rectangular air vents, which had been internally fitted with a wooden frame and door, which was to be held shut with a turnbuckle. This enabled the aperture to be sealed in the event of detection of the presence of poison gas outside.

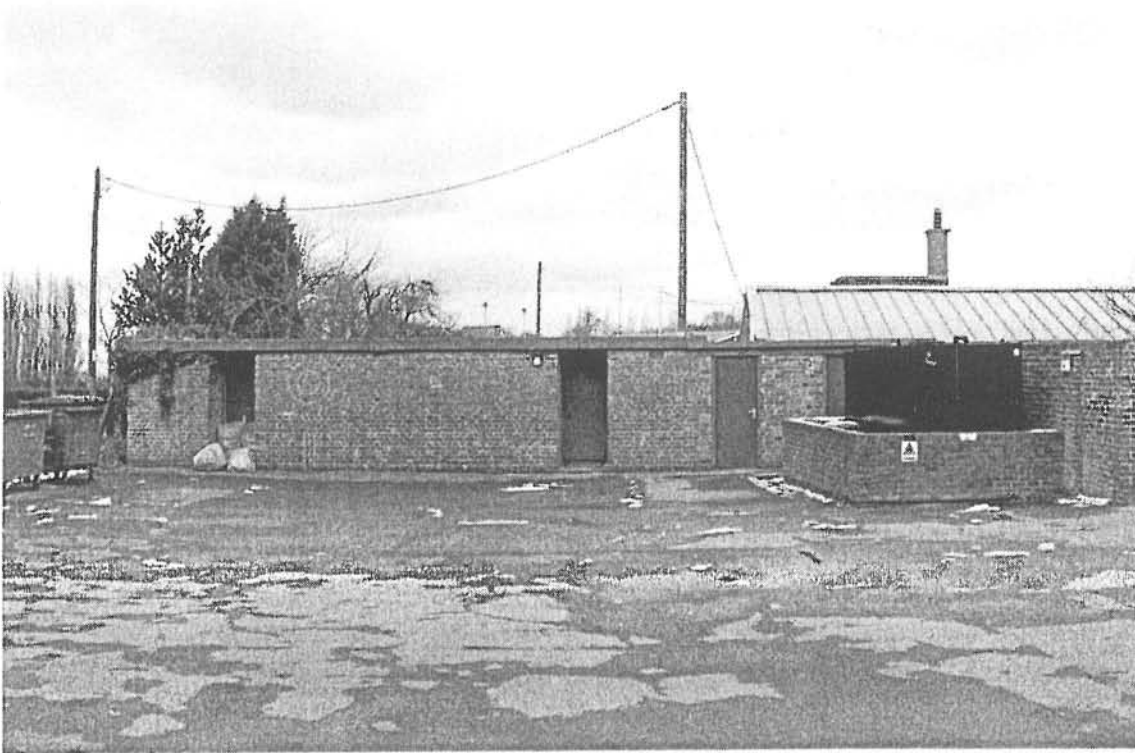
//

11. Southern elevation (Bob Ramsey copyright)
12. Northern elevation
13. Airlock frame and later door at the western end of the shelter
14. The same
15. Airlock frame and later door at the eastern end of the shelter
16. Top of the same

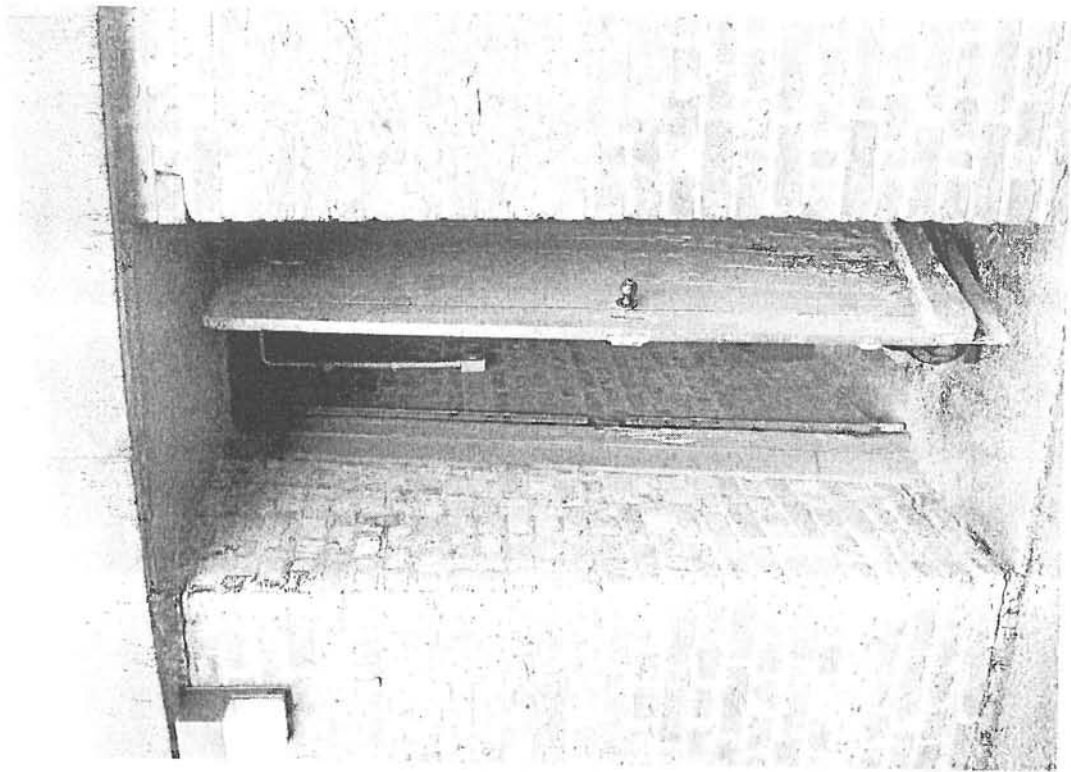
15

The only current planned alteration to this shelter is to widen the doorway into the eastern airlock area. The doorway contained the standard timber airlock frame.
