**THE AIR RAID SHELTER
AT PLUCKLEY SCHOOL, KENT**

Historic Building Survey

**Victor Smith
28th February, 2002**

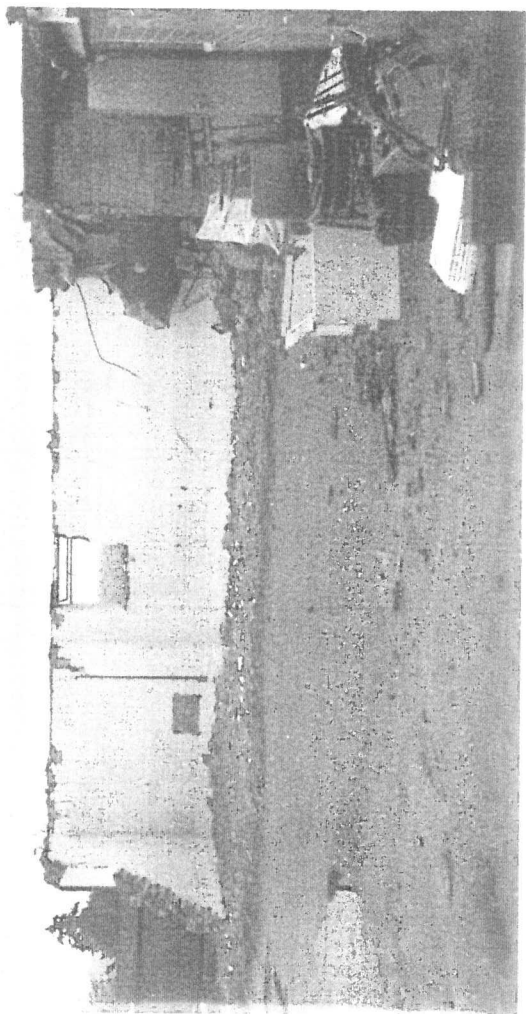
4

The partly demolished state of the southern room was instructive in displaying details of roof construction, showing that its concrete had been poured on to steel reinforcing rods, underlain by a thin metal grid formed of parallel half rounds joined by a 'ladder' of metal chevrons. This had been subsequently rendered underneath in cement.

1. The shelter from the west.
2. The northern end and north entrance of the shelter
3. The northern end of the shelter in profile
4. Interior of the southern end of the shelter, showing its demolished state
