THE VANISHING HOUSES OF KENT

1. DURLOCK GRANGE, MINSTER-IN-THANET

By E. W. PARKIN

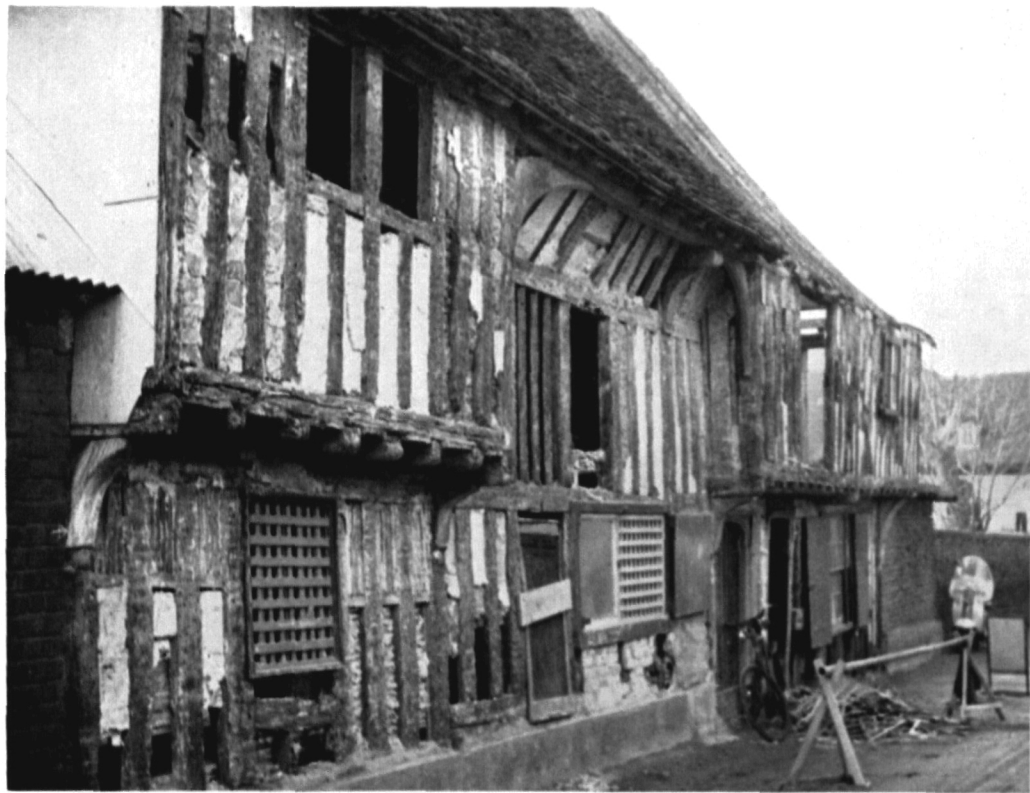
View from N.E. after stripping of plaster.

When all plaster had been removed from the outside of the house, a fine timbered front was revealed. The original hall house had had a frontage of 38 ft. which had been extended to 50 ft. later in the fifteenth century. The hall formed a cove or recess, with the upper rooms on each side of it jettied out.

The great hall window was now exposed. This was some 10 ft. high by 7 ft. wide, and was divided into four quarters with three vertical oak bars in each quarter. It had not been made to take glass but had been fitted with sliding shutters to cover the two lower lights, and with two hinged shutters behind the upper lights.

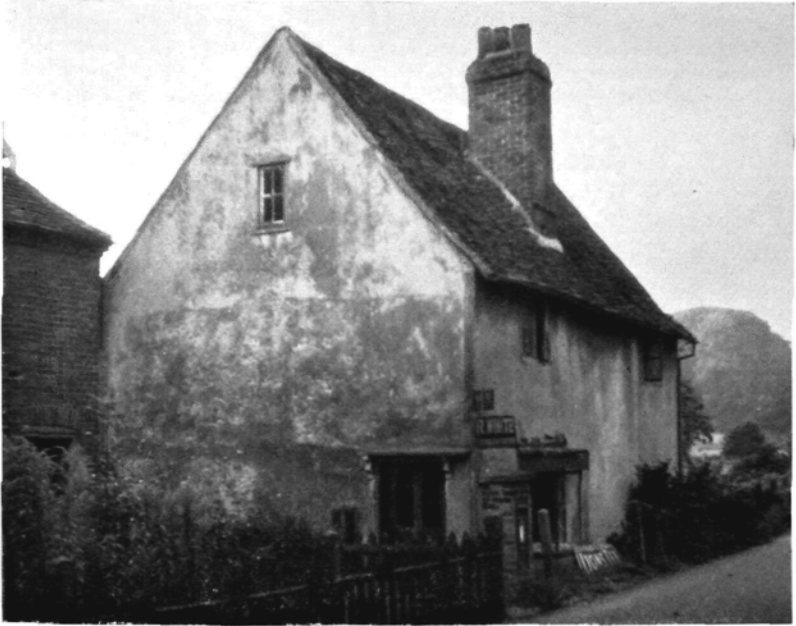
North-east view of the Darenth house, shortly before its demolition.
