## THE VANISHING HOUSES OF KENT

### 6. THE OLD COTTAGE AT UPPER HARDRES

By E. W. PARKIN

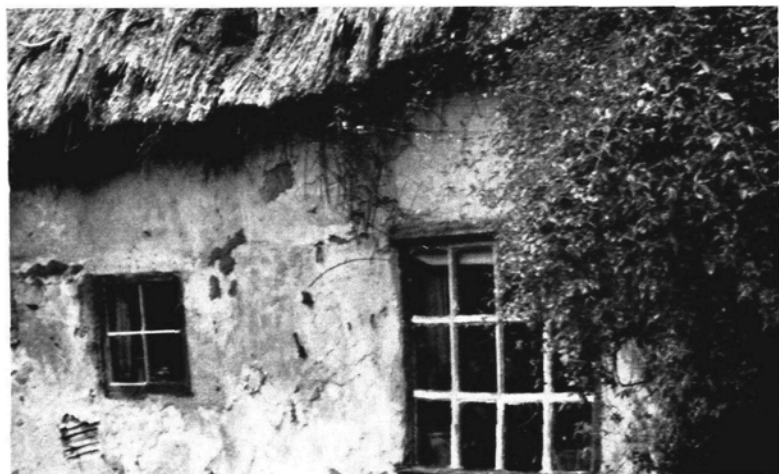
A. Windows on East Side.

pantry, the latter without any window. The only window on the ground floor of the north-west side was WW, and this is seen with its small eighteenth-century panes and hinged shutter in Plate IB. Plate IIA shows two of the windows marked W, and all three of these were found to have the diamond mortises of earlier windows beneath their frames.

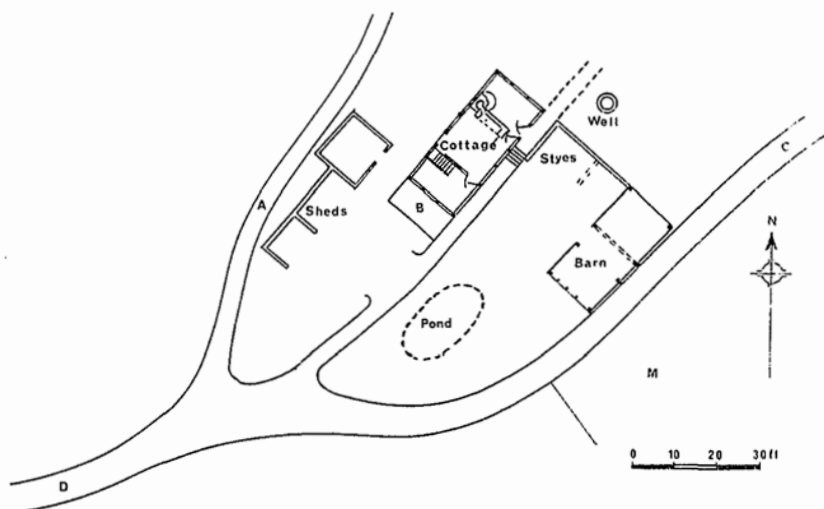
FIG. 1a. The Site at Upper Hardres.

Returning to the cottage, Fig. 1a shows a plan of the site. The narrow lane D, from the direction of Hardres Court and the church passes downhill towards C and to Bursted Manor. A is a woodland track, and B an old lean-to seen in Plate IA. The woods to the north and west have now blotted out the whole site, and nothing except the remains of the barn can be seen from the lane. All around is woodland, except M which is meadowland.

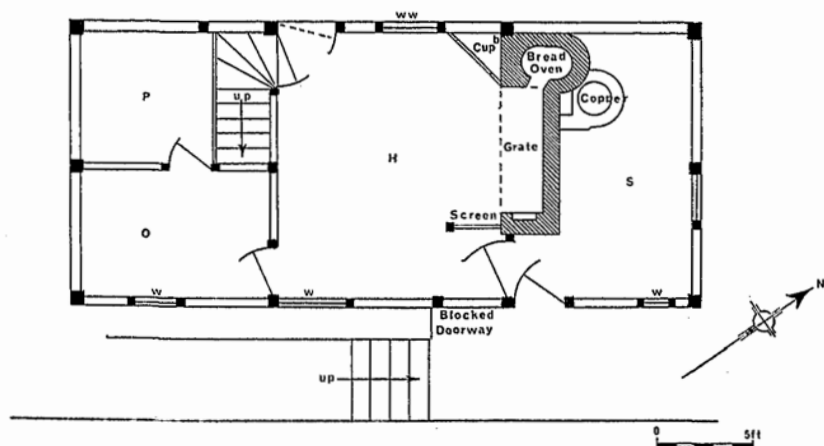
FIG. 1b. The Cottage in 1960.

Fig. 1b shows a plan of the cottage as it was before demolition. H was the sitting room, originally the open hall. S was once a store, but had now become a scullery. O and P had been one room originally, the parlour or sleeping room, but had been divided into a store and

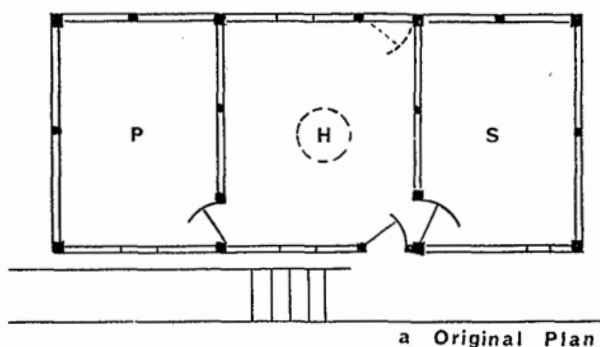
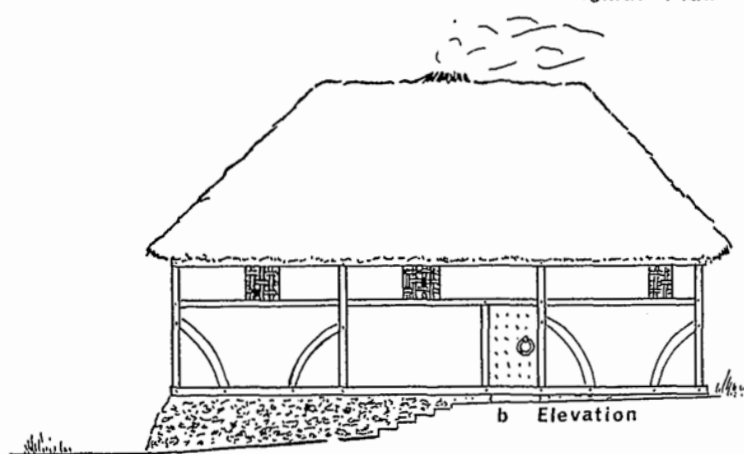
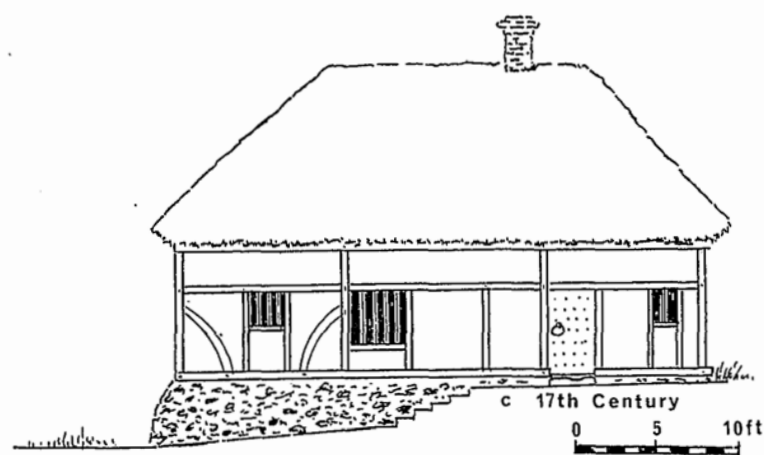
FIG. 2.  
b. Elevation of original House.

Fig. 2a shows a plan of the house as originally built. It had three rooms only, the central hall H, with an open hearth, the parlour P and the store S.

Fig. 2b shows the appearance of this house from the south-east. The three rooms were divided by wattle and daub partitions which were complete right up to the ridge, thus confining smoke from the hearth to the central room. Some sort of vent or outlet was provided in the thatch to allow smoke to escape, and this may have been a 'headless barrel' referred to by some early writers.

Fig. 2c shows the house in the seventeenth century, after the insertion of the fireplace and chimney, and after the door had been moved to the right. The unglazed windows shown with oak bars were probably still in use until the early part of the eighteenth century.

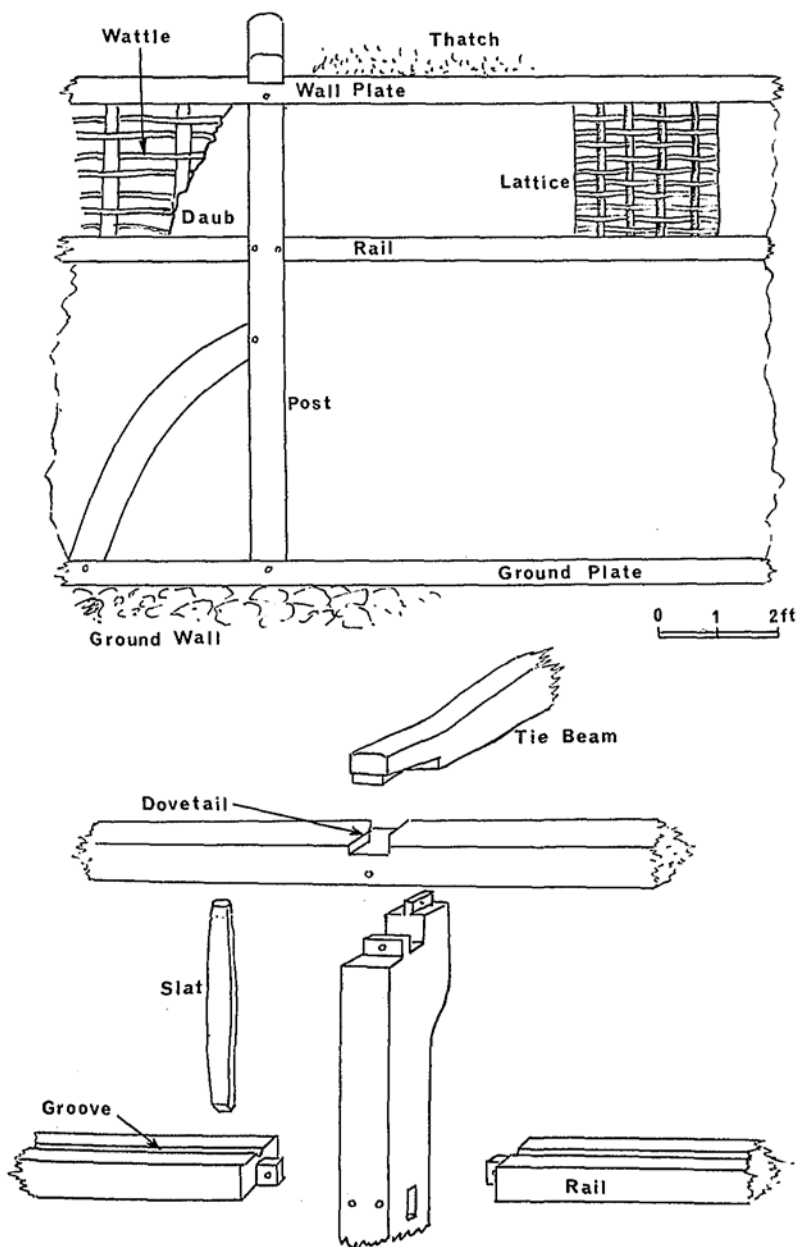
FIG. 3.

Such windows have not infrequently been mentioned by early writers. Harrison's *Description of England*, published in 1584 says: '... of old time our countrie houses, insteade of glasse did use much latisse, and that being made of wicker or fine rifts of oak'. Again, we find in W. Horman's *Vulgaria*, printed in 1519 the following: 'I will have a latesse before the glasse for brekynges . . .' Taverners were said to have red lattices, and when they are shown in medieval illustrations the wicker canes of the windows are set diagonally, and this indeed may have been the precedent for the small diamond panes which were so popular in the sixteenth and seventeenth centuries. At Upper Hardres, however, it would appear that the main rods were sprung in vertically and then hazel canes woven horizontally through them (Fig. 3).
