EXCAVATIONS ON THE SITE OF ST. MARY'S HOSPITAL, STROOD*

By A. C. HARRISON, B.A., F.S.A.

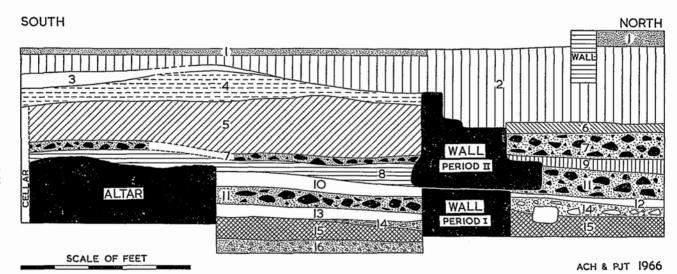
Fig. 1. Section, across Part of East End of Chapel. 1. Modern concrete Floors. 2. Accumulation of modern Material. 3. Chalk Floor. 4. Domestic Refuse. 5. Grey Clay containing Tiles and seventeenth-century Tobacco Pipes. 6. Yard Floor, composed of Clay and domestic Refuse. 7. Demolition Débris. 8. Brown Mortar. 9. Clay and Chalk. 10. Chalk Floor. 11. Demolition Débris from Period I Building. 12. Soil with Tiles and Chalk. 13. Chalk Floor. 14. Débris from Construction of Period I Walls. 15. Clay. 16. Waterlogged sandy Gravel containing Roman Pottery.

Stratification. Fig. 1 shows a section across the east end of the Chapel parallel to the east wall and 4 ft. 6 in. from it. The lowest level reached at about 5 ft. 6 in. below the present surface was a layer of sandy vellow gravel of alluvial origin and was almost completely waterlogged (16). A piece of a mortarium of third- or fourth-century date was recovered from this. Above it was a layer (15) of clayey earth containing much occupation material. This layer varied in colour from grey to black and in depth from a mere 6 in. at the east end to more than 2 ft. further west. The pottery from this included fragments of flanged bowls and is also suggestive of a third- or fourth-century date. Laver 15 is interpreted as being domestic refuse derived from buildings along the line of Watling Street some 75 ft. further south.

The walls of the Hospital had cut through layer 15 and into layer 16 to a considerable depth (beneath the floor of a cellar we found them 9 ft. below the modern surface and still above foundation level), which suggests that the water-table must have been considerably lower in the thirteenth century. The building débris and earliest floor of the Hospital Chapel (layers 14 and 13) lay directly on top of the Romano-British occupation material, so evidently the surface had been levelled and any later material removed prior to the building of the Hospital. In this earliest medieval layer were several complete roofing-slates (Plate IV, B), measuring 6 in. by 101 in., and with a single peg-hole.

On top of the chalk-floor (13) was a mass of débris (11) containing many architectural fragments as well as pieces of plaster, slate and both floor- and roofing-tiles. A knife-blade and a bronze buckle (Fig. 6 A and B), were also found. To this a further layer (10) of similar rubble mixed with lumps of chalk had been added and then several inches of brown mortar (8) which formed the bedding for a tiled floor. A few of these tiles were found in situ at the west end of the chapel but most of the sound ones had been removed at the time of the final destruction of the building. The débris (7) of the second demolition which contained a sixteenth-century Nüremberg jetton of Hans Schultes¹⁰ was covered by a mass of grey clay containing roofing-tiles and clay pipes of c. 1640.11

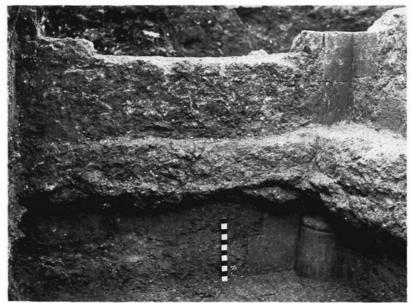
A. North-east Corner of Chapel, showing Vaulting Shaft.

- 4. (Plate VI, B, right.) Circular base discovered in situ built into the internal north-east angle of the Chapel at floor level and obviously forming the base of a vaulting-shaft. Radius of the plinth is $4\frac{3}{4}$ in. and the diameter of the seating for the shaft, which rose from inside the upper round, was 4 in. The profile does not show the 'water-holding' recess, but is clearly derived from the Classical Attic base, consisting of two rounds separated by a hollow. This served as a model to twelfth-and thirteenth-century masons, 23 and appears in a form almost identical with that at Strood in the late-twelfth-century work in Canterbury Cathedral quire. Firestone. Period I.

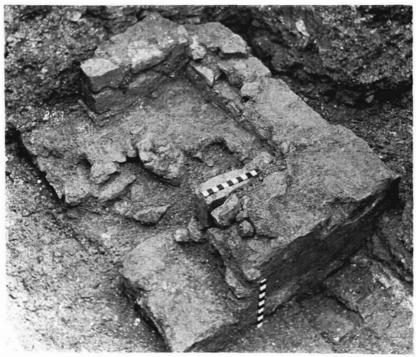
B. The Altar.

The Altar, which measured 6 ft. 4 in. by 2 ft. 10 in., and survived to a height of 2 ft. 1 in. (Plate I, B), was placed centrally at a distance of 3 ft. 2 in. from the east wall of the Chapel. Its south end had been damaged by a cellar wall. It was constructed of rubble masonry with ashlar corners and was plastered on the outside. At the rear was a rectangular space, 3 ft. by 1 ft. 10 in., the purpose of which was not established. It may have been merely a constructional device to save material or it may have been a cupboard to hold sacred vessels or even relics. For what it is worth, two fragments of human bone were found in this recess.

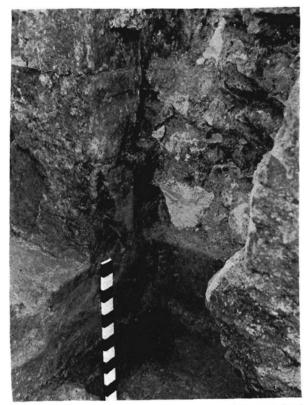
A. Original Doorway of Hall.

foundation ran across the opening. In the west wall were two entrances each 7 ft. 2 in. wide. These had been constructed of firestone ashlar and in the better preserved southern entrance the hinge-pins survived on both sides (Plate II, A), clearly indicating double-doors. These pins had been set 2 ft. from floor level and recessed 4 in. into the doorrebate. There was a 2-in. chamfer on the outside edges of the doorways and a 2-in. bevel on the first projecting course of masonry. Along the inside of the west wall was the footing, just under 1 ft. wide, of a stone bench. This was interrupted by the doorways on each side of which the bench terminated in a carefully squared ashlar block. Immediately above this bench the wall surface was ragged indicating that the slabs that formed the actual seat had been robbed (Plate II, B).

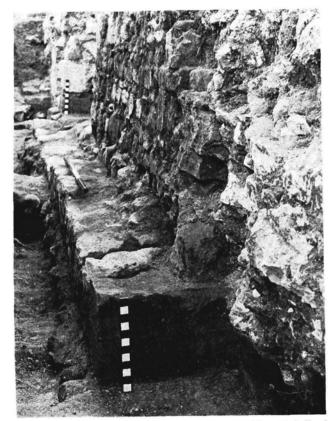
B. West Wall of Hall.

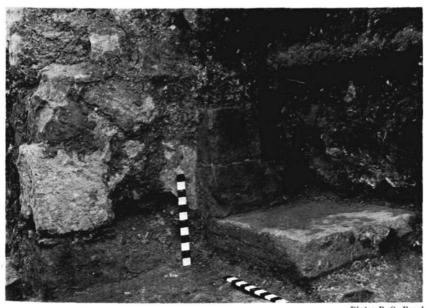
B. Later Entrance to Hall.

a red-brown mortar, the central dividing wall was demolished and a new entrance made, of which the southern jamb and part of the threshold survived (Plate III, B). This doorway was 5 ft. 4 in. in width and the surviving jamb had a stopped chamfer on the outside. The bench along the west wall was partially demolished and the floor of the Hall raised by a build-up of rubble and brown mortar 1 ft. 4 in. in height to the same level as that of the threshold of the new doorway. No tiles belonging to this floor were found in situ, but numerous fragments showed that these must have been similar to those forming the first floor of the Chapel. On the outside of the entrance the foundations of a wall 15 in. wide butted up against the west wall of the Hall to the south. This may well indicate a porch, but this could not be definitely established as the north side of the doorway had been destroyed by an eighteenth-century pit, and further investigation to the west was impossible because of a telephone cable.

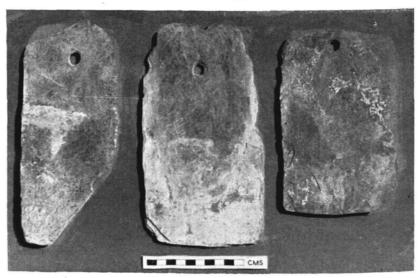
B. Medieval Roof Slates.

(Plate IV, B.) Examples of unused roof-slates found sealed under material of Period I floor in Chapel. Grey slate which the Institute of Geological Sciences considers may have had an origin in Devon or Cornwall. Medieval use of West Country slates in south-east England is well attested (see $Sx.\ A.C.$, Vol. 103, and $Arch.\ Cant.$, lxxxii (1967), 152). The Strood specimens had a single nail-hole and measured $5\frac{1}{2}$ —6 in. in width and $10\frac{1}{2}$ in. in length. One had been cut to $6\frac{1}{2}$ in. long. Bricks

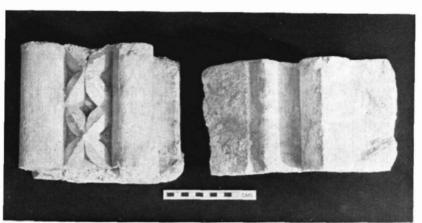
A. Architectural Fragments.

- 5. (Plate V, A, left.) Section of moulding consisting of two rounds separated by a deep hollow occupied by the curiously-styled 'dog-tooth' ornament. This was common from the late twelfth century to at least the middle of the thirteenth. This piece of moulding had been re-used as wall material in Period II, but was undoubtedly derived from the Period I chapel. Material is firestone.

- 6. (Plate V, A, right.) Early English moulding with pointed bowtel, similar to an example from Haseley, Oxfordshire, figured by Parker²⁴ and dated c. 1220. There the suite includes dog-tooth ornament.

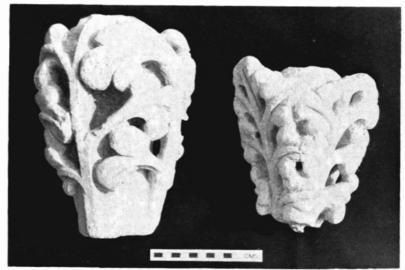
A. Capitals.

- 1. (Plate VI, A, left.) Echinus of Early English capital with stiff-leaf carving, height 9 in. The diameter of the shaft to which it was attached was about $3\frac{1}{2}$ in. Dowel-holes occur in both lower and upper ends, the former being for the attachment of the separate moulded abacus, of which no trace survives. The lower dowel secured the capital to the top of the circular-sectioned shaft. One side of the capital is less carefully finished than the other, indicating that it was attached to a shaft that was not free-standing. Its possible uses are, therefore:
- (a) At the head of a vaulting-shaft, the abacus supporting the springers of the vaulting ribs.
- (b) On one of the shafts of a wall-arcade forming mural seats, as in the Early English churches at Alkham, Cheriton, and Stone, near Dartford.
 - (c) On a shaft set in the jamb of a window or doorway.

2. (Plate VI, A, right.) A similar fragment to the last, height 7 in.

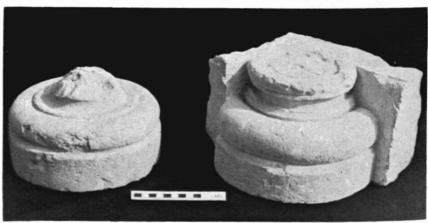
B. Bases.

- 3. (Plate VI, B, left.) Circular base, diameter $8\frac{1}{2}$ in. It has the hollow between the upper and lower rounds found in Early English work of the first half of the thirteenth century. Francis Bond²² observed that this 'water-holding' base originated as early as c. 1150 and was still not wholly discarded by 1260. Period I.

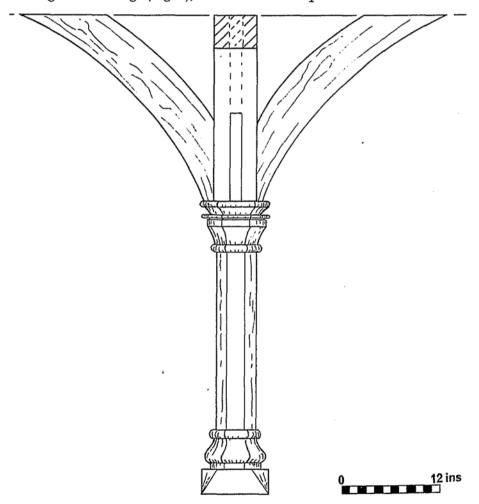
Fig. 5. Crown-Post in Rochester Museum. (Drawn by E. R. Swain.)

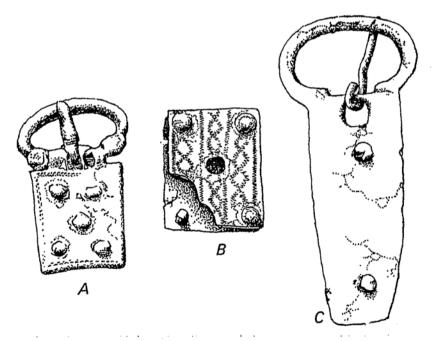
Fig. 6 (1). Bronze Belt Fittings. (Drawn by G. G. E. Shaw.)

The bronze strap-end buckle and belt ornament shown in Fig. 6, A and B, were found in the demolition débris of the first Chapel. Both are decorated with rouletting, and the buckle was originally gilded; it is very similar to the one shown as Plate LXXV, 6, in the London Museum *Medieval Catalogue*, London, 1954.

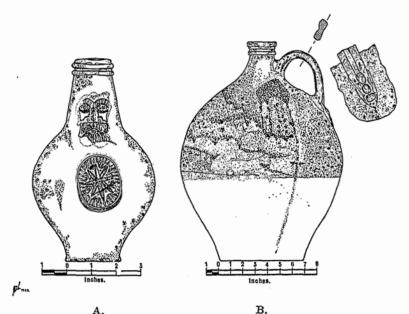
Fig. 7. Salt-glazed Stoneware. (Drawn by J. E. L. Caiger.)

Salt-glazed stoneware Bellarmine jug. $8\frac{1}{4}$ in. high. The mask broadly conforms to Holmes's type VIII, with typical hour-glass-shaped mouth. The coarsely moulded mask displays a most disagreeable expression, the teeth being represented by stylized lines. The waist of the jug bears a roughly applied oval medallion, $2\frac{1}{4}$ in. high. It is late in form and consists of eight sprigs arranged in a petaloid. This medallion is fairly common and together with its outer banding could be taken to represent the Star and Garter motif. The base of the footring bears the customary series of concentric circles indicating the method of parting the vessel from the wheel. From its general characteristics, it appears to be of Rhenish origin, probably manufactured at Frechen, in the mid-seventeenth century. The body of the jug is of an even drab brown colour with only a slightly mottled appearance. The handle is missing but its lower terminal remains showing the usual lizard's tail finish to the body. When found, the neck of the jug was sealed with

Large salt-glazed stoneware jug, 17\(^3\) in. ×13 in. diameter, capable of holding approximately four gallons of wine or other fluids. The body of the jug is bulbous and bears a short neck reinforced with cordons. The top half of the jug is of a mottled brown colour produced by dipping the upper part of the vessel into an iron salt wash or slip before firing. The lower part is of a natural buff colour and the demarcation line between oxide stain and the undipped portion is sharply defined. The sturdy strap-handle bears three decorative finger indentations where it joins the body of the jug and has the characteristic twist in it so often to be noted on these jugs. Its general appearance suggests it may have been made at Fulham in the early eighteenth century.
