## EYNSFORD CASTLE: THE MOAT AND BRIDGE\*

By S. E. RIGOLD, M.A., F.S.A., F.R.Hist.S. and A. J. FLEMING, M.A.

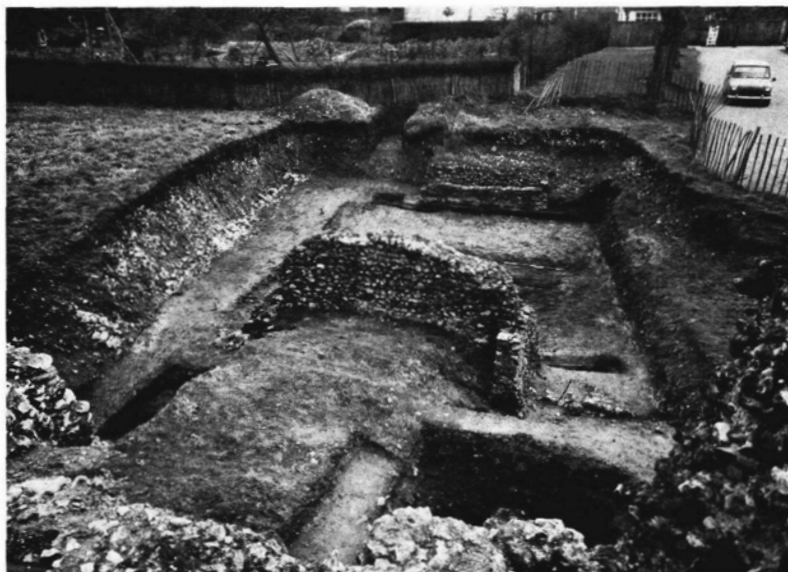
A. Bridge-area, from Curtain, showing inner Abutment.

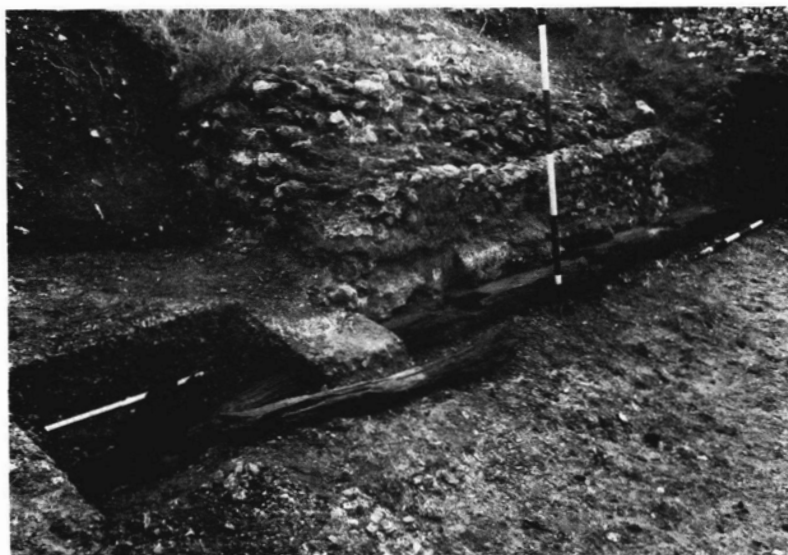
B. Wall Z, Plate A3 and Foot of Brace.

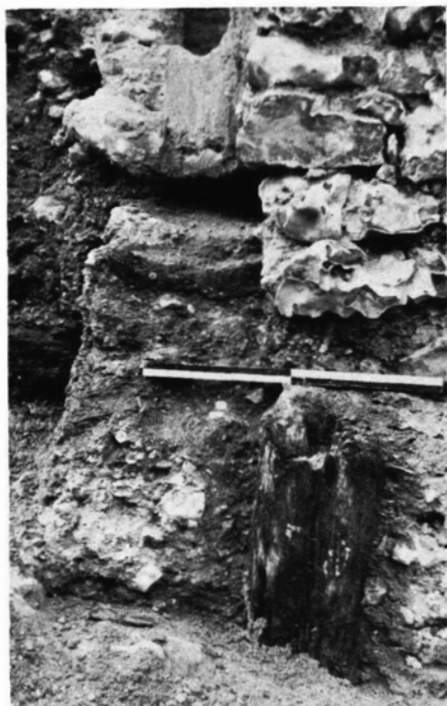
Base of V2, showing Matrices for Timbers and Post (W).

the timbers were intended as a lacing or just a shuttering. The topmost edges of the flintwork follow the expected alignment of a bridge carried on wall Y and the footings do not penetrate much below the well-drained layers of the 'dump' against the wall. Both builds may be accepted as late. The masonry, as found, was dry, leached and crumbly, and the matrices of the timbers quite empty (Plate III).

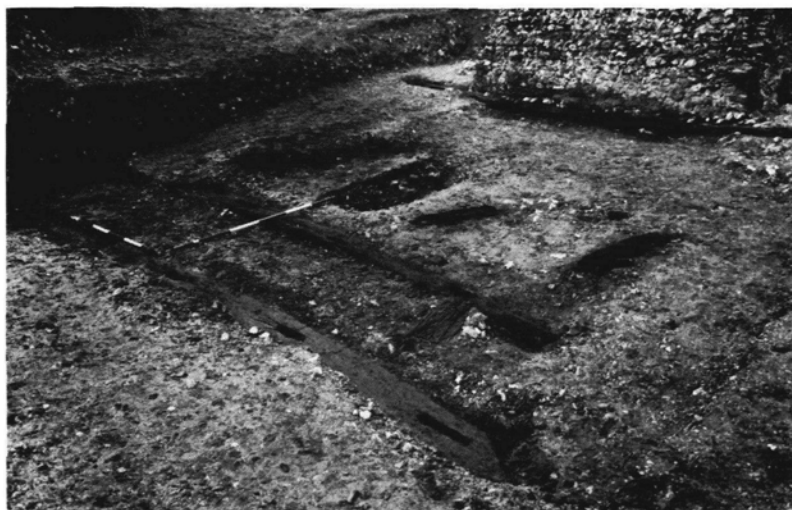
Plates B2, B3, A3 and Wall Y.

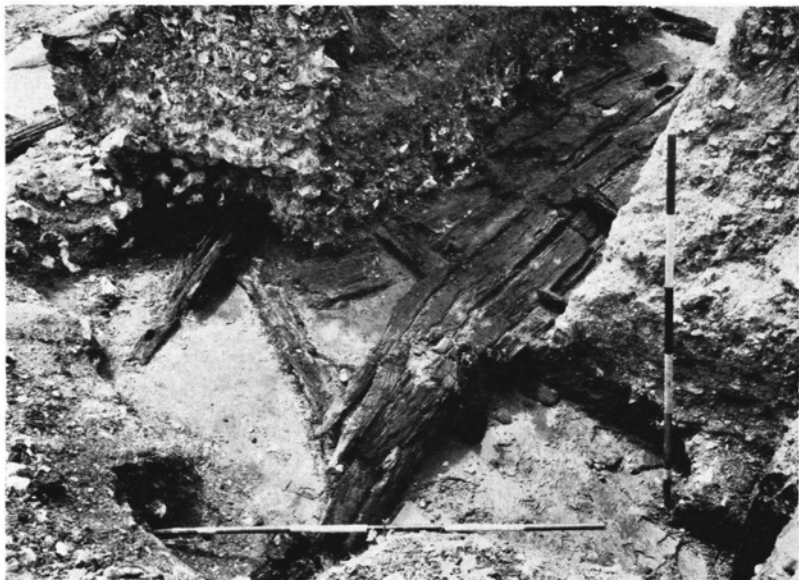
PLATE IV. Planking on felled Trestle. *Crown Copyright reserved*

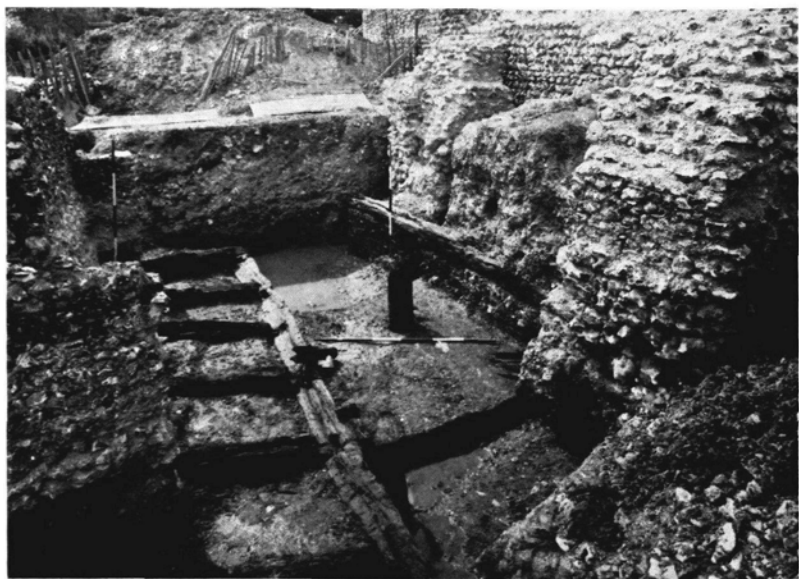
PLATE V. Felled Trestle on D1, between Y and VI-V2. *Crown Copyright reserved*
