EXCAVATIONS ON THE SITE OF LEEDS PRIORY

PART II — THE CLAUSTRAL BUILDINGS AND OTHER REMAINS

P. J. TESTER, F.S.A.

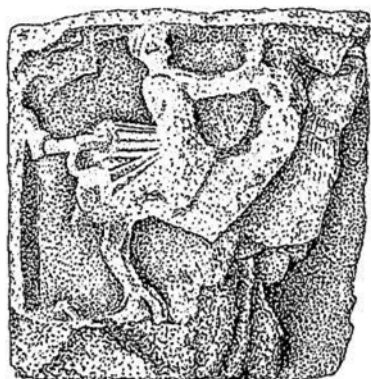
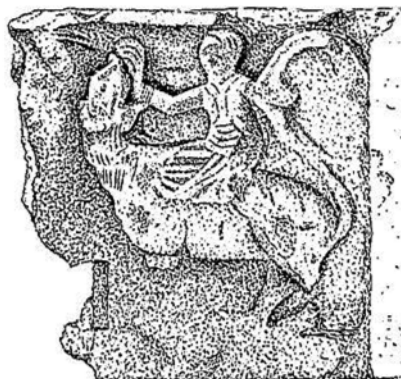
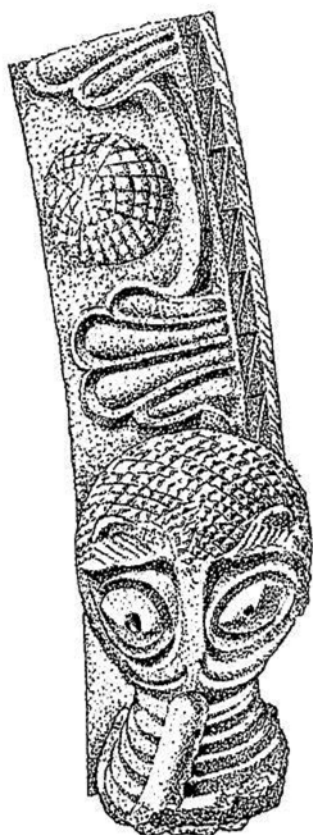
Fig. 1. Twelfth-Century Carvings from the Chapter House (†). (Drawn by A. C. Hart.)

(Above) Remains of capital relating to chapter house entrance, with two representations of Samson rending the lion (*Judges*, XIV). This was a popular subject with twelfth-century sculptors, a well known example being in the tympanum at Stretton Sugwash, Herefordshire, dated 1140-50. It is derived in style from churches in or near the department of Charente Maritime in France.¹

(Below) 'Beak-head' type termination of label of chapter house entrance. It would have been matched by another on the north (left) side of the arch. At present this 'beak-head' from Leeds is believed to be unique in Kent.

states that it is the only known example of such a 'beak-head' in Kent (Fig. 1).

Professor Zarnecki has examined photographs of the chapter house carvings and in his expert opinion they date from *c.* 1160. He makes comparison with the chapter house at Rochester (*c.* 1150–60), but whereas the spurs on the bases there are pointed, those at Leeds are foliated and of greater interest.

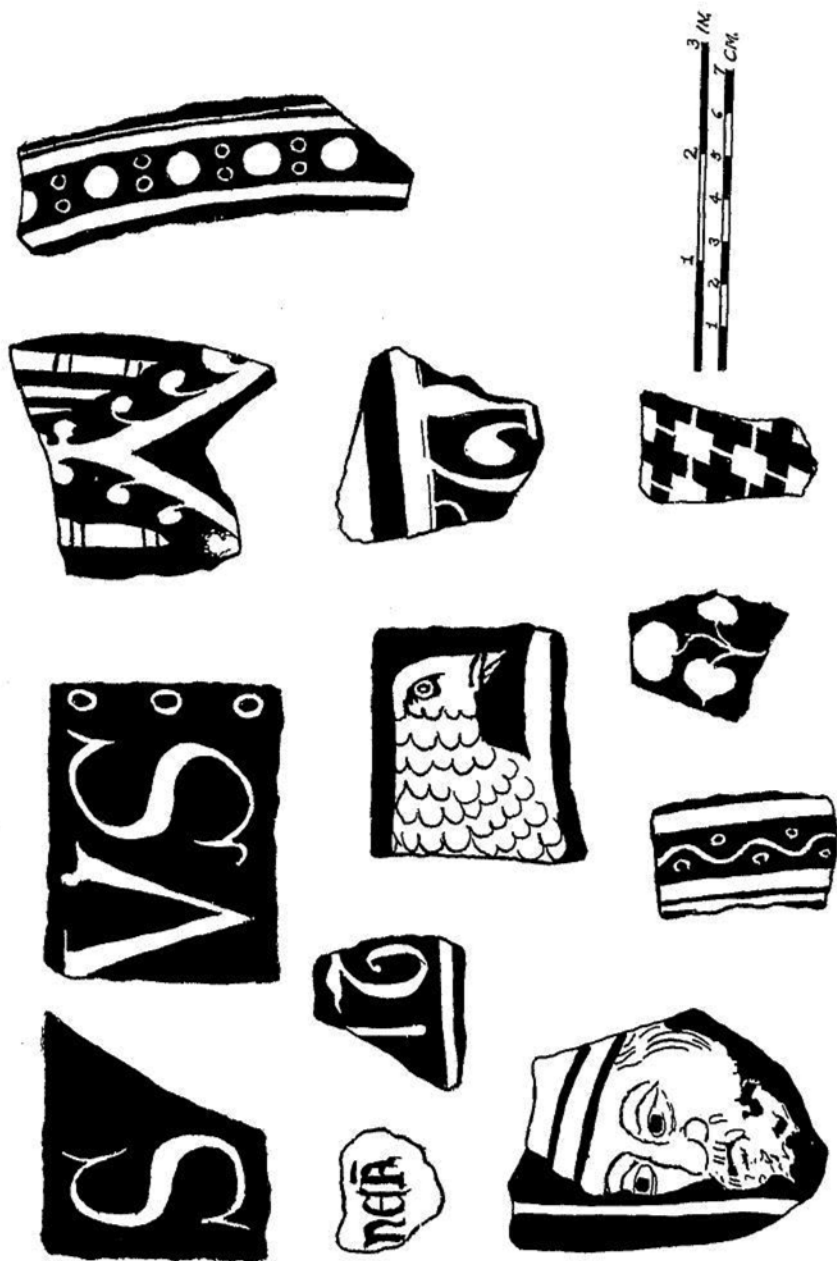
Fig. 7. Fourteenth-Century Window Glass. (Drawn by C. R. Coucher.)

the only ones with significant remains of the original designs. The lombardic letters 'VS' and 'S' are yellow-stained, and though I can find no indication of the stain on any of the other pieces this does not, in view of the generally poor condition of the glass, rule out the possibility that some of them were treated in this way.

Of 157 fragments of glass submitted for examination¹⁶ seven are pot-metal yellow, seven blue, two ruby, and the remainder originally white, many with scanty traces of painting. All are heavily corroded and some laminated, a well-known condition consistent with long burial in the earth. Translucency is almost totally impaired in nearly all the pieces. In a few specimens it is possible to distinguish between corrosion on one side of the glass caused by exposure to the elements while still in the windows and the general deterioration arising from chemical action in the earth. As the glass had presumably been in the windows for about 200 years before the Dissolution this might be expected, but it is an interesting point to note.

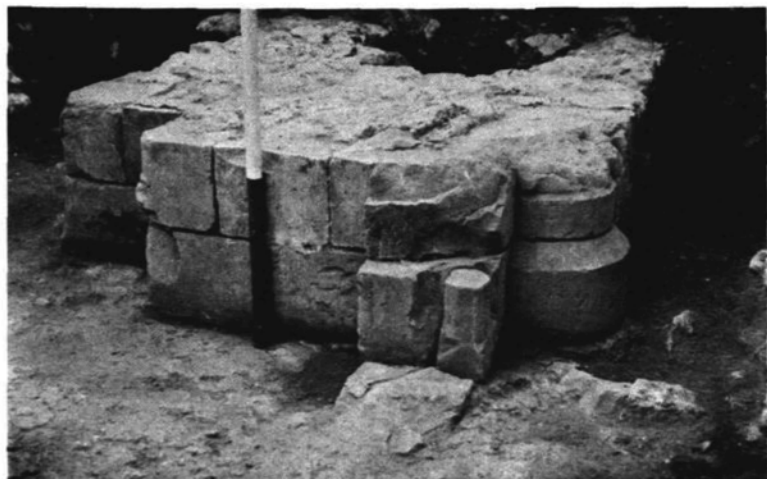
B. West Side of Entrance at North End of Passage between East and South Ranges.

12. West side of the entrance at the north end of the 'dark entry' passage between the south and east ranges (Plate IB).

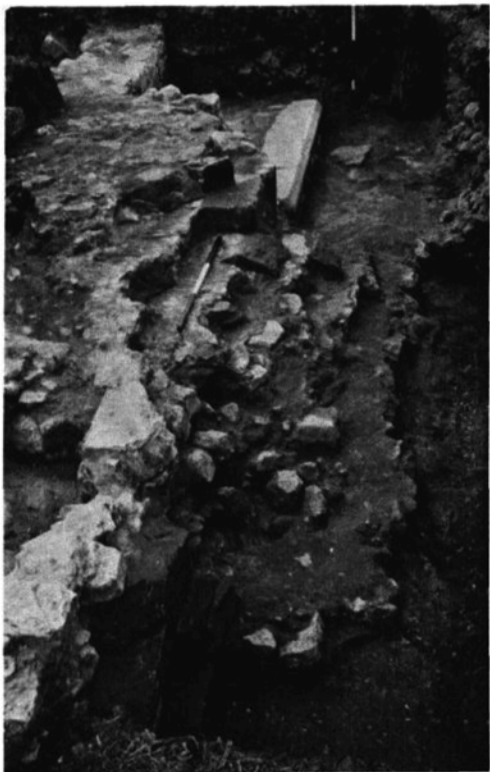
A. Steps of the Refectory, viewed from the East.
Plinth of Laver in Background.

It is probable that the refectory was above ground level in this range, in which case the walls shown on the plan may, in fact, have been those of an undercroft. The entrance from the cloister was towards the west and was approached by a flight of stone steps. These had been robbed leaving only a rubble ramp with impressions of the steps remaining (Plate IIA). The top step, forming the cill of the entrance, was 2 ft. 6 in. above the cloister floor and the ascent is assumed to have continued inside the building, supported on internal walls at this point as indicated on the plan. Both jambs of the entrance could be traced, the opening being 5 ft. 3 in. wide, while the approaching steps were 10 ft. wide and Projected 4 ft. into the cloister.

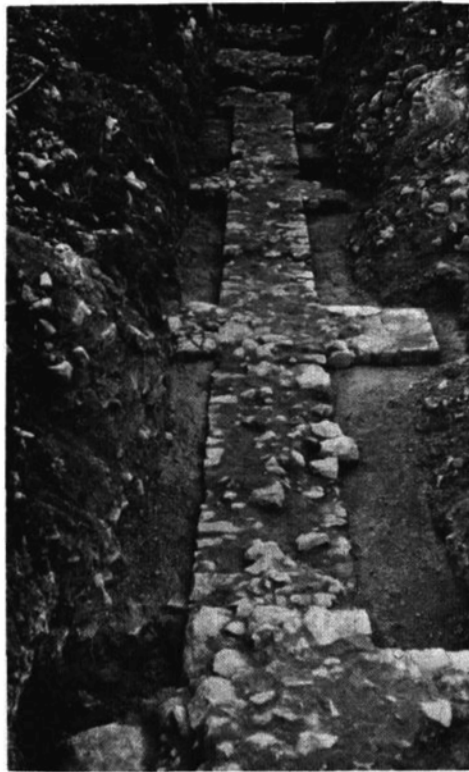
B. West Wall of West Range, viewed from the North.

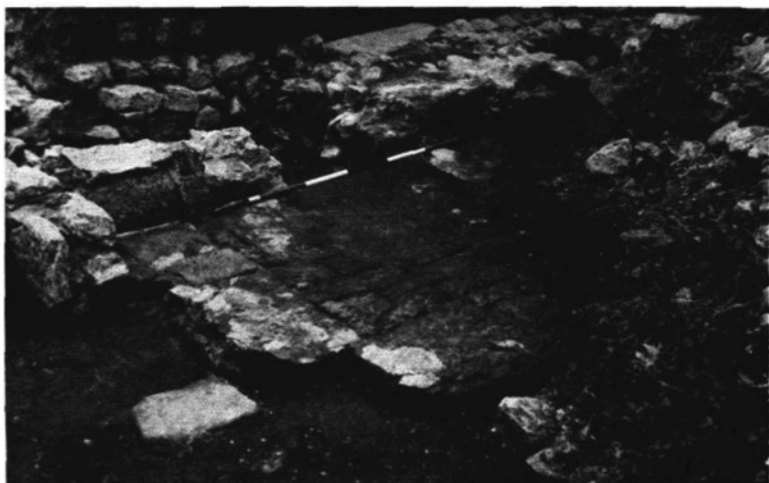
A. East Side of Kitchen with Remains of Fireplace and Hearth.

Disturbance in this locality had confused stratification and rendered interpretation difficult. On the east were indications of a wide fireplace with evidence of repair and renewal extending into the post-Dissolution period (Plate IIIA). Scattered pottery from this area ranged in date from the fourteenth to the eighteenth centuries. A doorway in the north-east corner apparently communicated with the room under the refectory, and at the north end was the lower part of a stone stair, turning to the right, and no doubt originally leading up to the refectory.

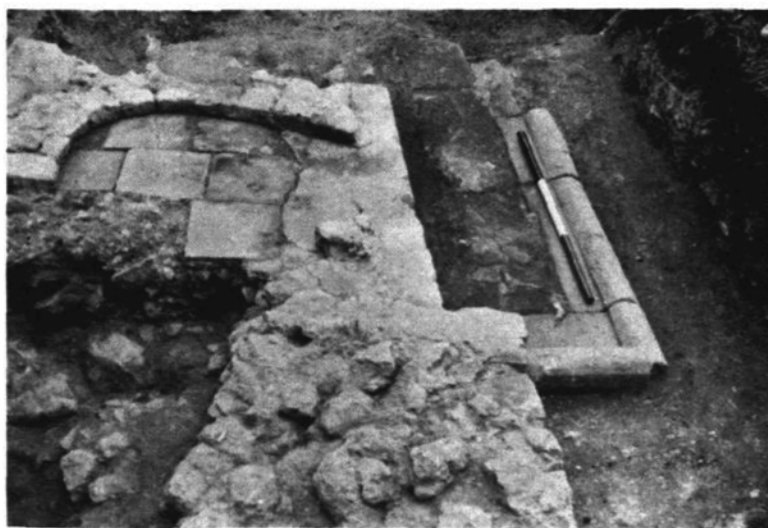
B. Fireplace and Oven in South Wall of South Range.

In the south range, the brick oven inserted in the back of the medieval fireplace is evidence of continued use of this part of the Priory after the Dissolution and, as previously stated, both constructional evidence and associated pottery leads to a similar conclusion regarding the kitchen.

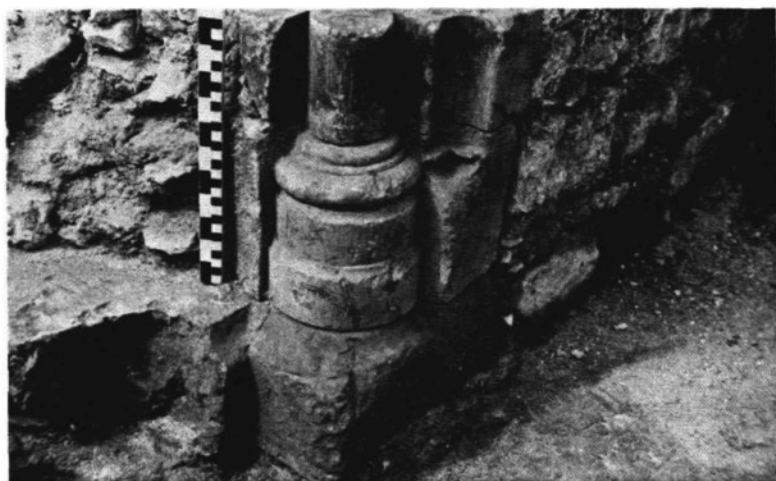
A. Base of North Side of Doorway from West Walk of Cloister into West Range.

Towards the north end of the east wall the well-preserved lower part of a doorway from the cloister remained, the jambs hollow-chamfered with the bases and lower portions of both nook-shafts in position (Plate IVa). Normally, a doorway in this position led into a cross-passage serving as the outer parlour and a communication with the outer court. Occasionally, however, the outer parlour took the form of a large room projecting westwards, e.g., at Selby and Bridlington. At Leeds there was a wing at right-angles to the north end of the west range to fit this arrangement and its south side may have been defined across the interior of the main building by a timber partition, as there was no stone foundation on this alignment. The wing cannot have extended much further than shown on the plan on account of the stream running south – north on the west side of the farm road.

5. Base of jamb shaft of doorway between west walk of cloister and west range (Plate IVA). Fourteenth century.

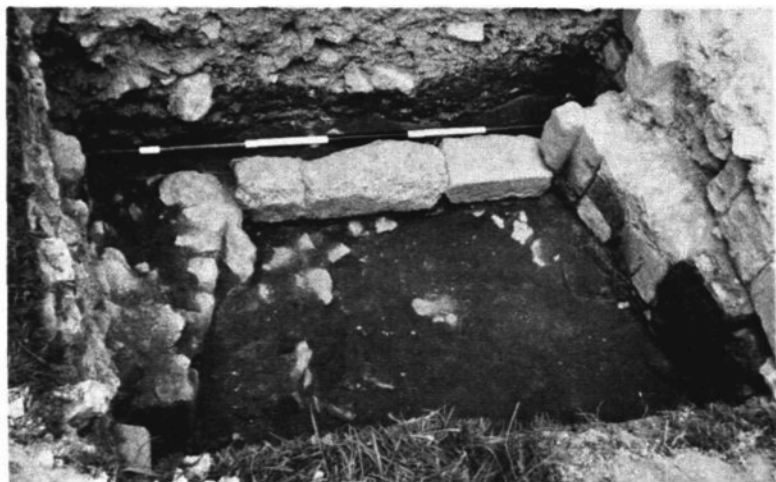
B. Doorway in South Wall of West Range, viewed from the South.

At the east end of the south wall there was another doorway, its outward splays indicating that it is unlikely to have been an external entrance and must have communicated with a building on the west side of the kitchen (Plate IVB).

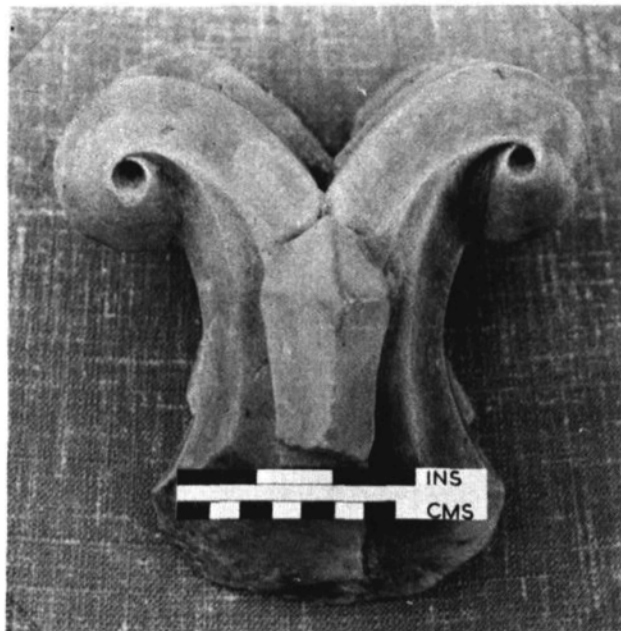
A. Split Cusp from Mural Arcade in North Walk of Cloister.

Plate VIA. Example of 'split cusp' from the mural arcade of the north walk of the cloister.

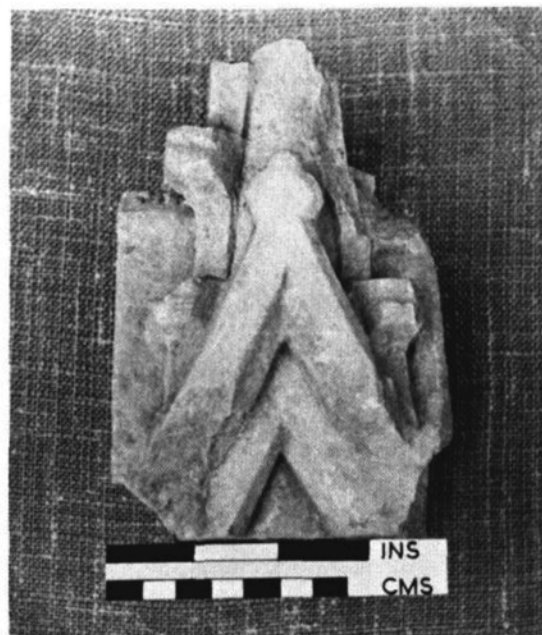
B. Fragment of Pinnacle found in Association with Grave in North Aisle of Nave.

Plate VIB. Part of a pinnacle found in association with grave in the north aisle of the nave. It may have come from a tomb originally covering the grave and bears remains of red paint and gilding.

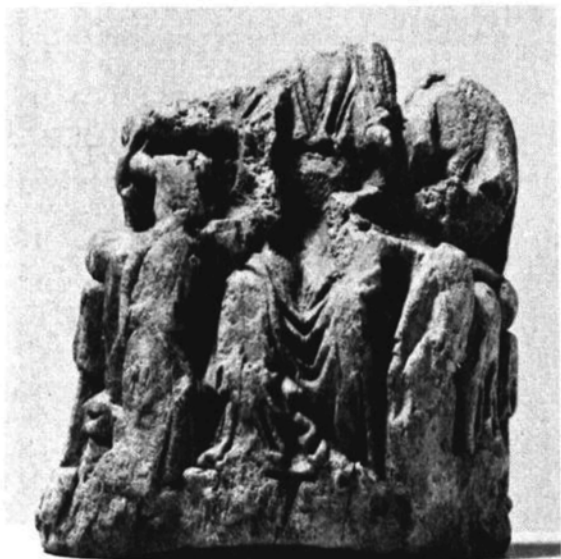
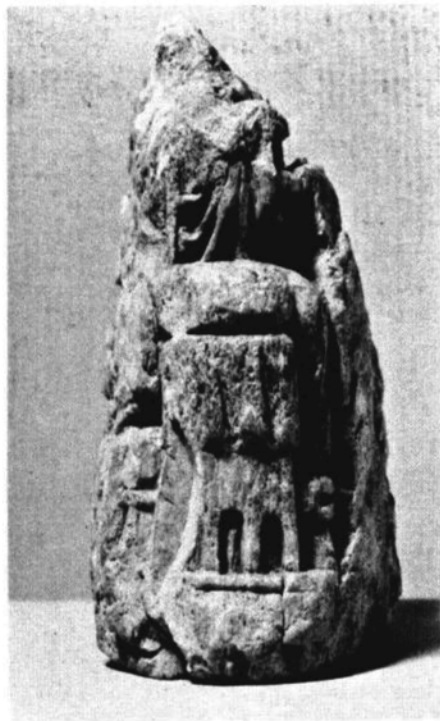
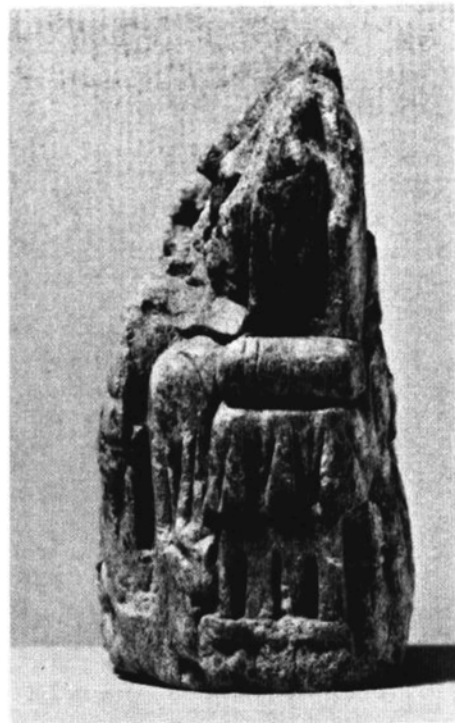
Ivory Carving. Front (left) and Rear (right) Views. Height 2·8 in.

Side Views of Ivory Carving.

This small walrus ivory carving was found about 2 ft. below ground near the south-west corner of the south transept. It is 7.16 cm. in height, 6.35 cm. wide and 3.49 cm. in depth.¹⁷
