# THE TOPOGRAPHY AND BUILDINGS OF HORTON MANOR, NEAR CANTERBURY\*

TIM TATTON-BROWN

#### HORTON MANOR CHAPEL

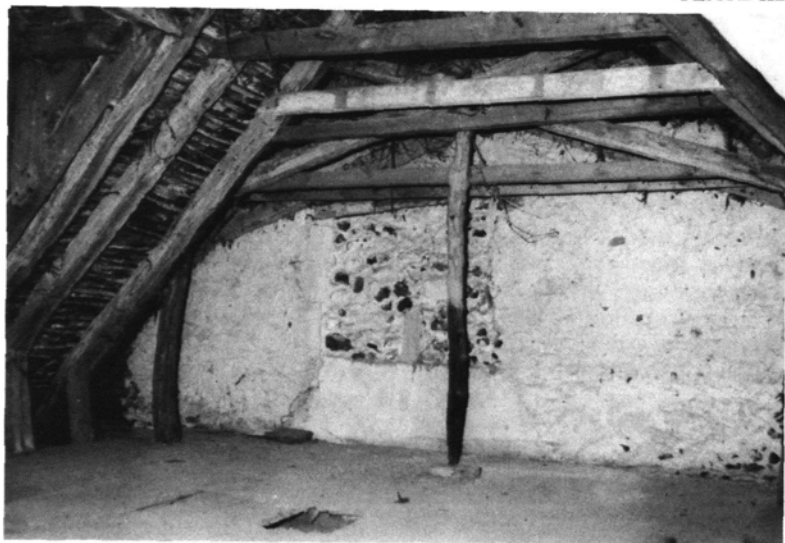
PLATE IIB

Horton Manor Chapel: Chancel Roof, looking South-west.

The chancel roof is a much simpler affair with no tie-beams or purlins. The small collars were lapped onto the eastern sides of the rafters. The junctions between the rafters, ashlar-pieces, and wall-plates were obscured by the inserted floor, but it was possible to see that the inner wall-plates only had a simple chamfer on them. In both roofs several of the rafters are missing, but this has not been

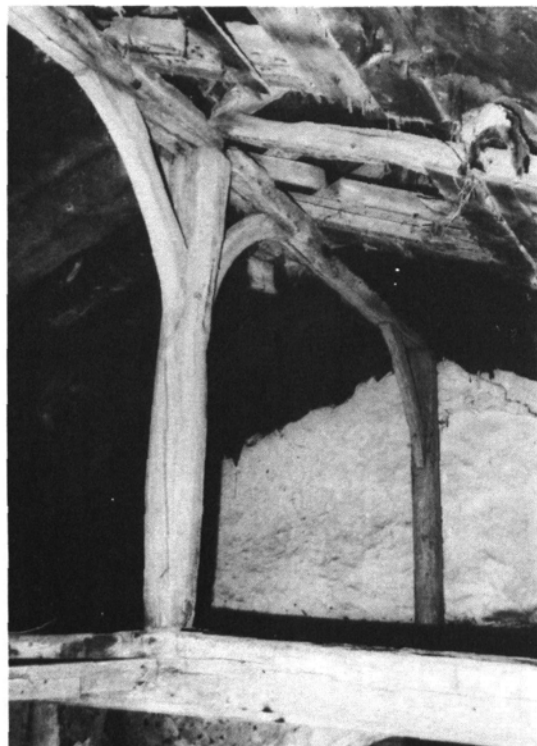
PLATE IIIA

Horton Manor Chapel: Nave Roof, looking North-east  
with Chancel Area below.

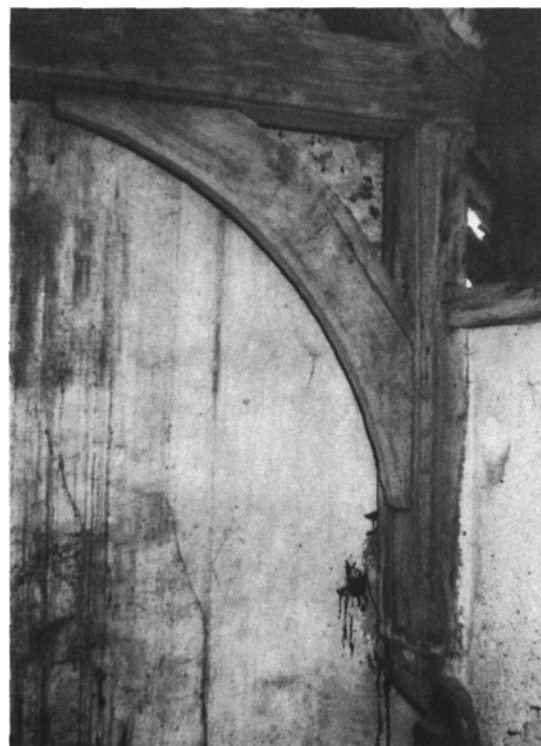
PLATE IIIB

Horton Manor Chapel: Northern Half of western Truss  
in the Nave Roof.

Returning to the nave roof, it can be seen clearly (Figs. 9–11) that the original scissor-braced roof extended beyond and predates the chancel arch. During the rebuilding work of the late fourteenth century the original west gable was demolished, and once the new chancel arch had been inserted a new tie-beam<sup>20</sup> and crown-post were inserted at the east end of the nave. The tie-beam in the centre of the nave may well be an original tie-beam, but if so it had new mouldings cut on its undersides (as did the inner wall-plates) in the late fourteenth century. Once the two eastern crown-posts and the collar-purlin had been inserted, a special truss was framed at the west end to fit in under the final rafters and scissors (Fig. 7). This had a high tie-beam (to clear the new west window) and two wall-posts on corbels. Like the centre crown-post, the new western one was braced both to the scissors and to the collar purlin, which at this point has a simple butt-joint in it. The purlin is in fact only held together by the mortice of the brace with two pegs in it (Figs. 10–11). The new western truss, which also has braces from the wall-posts to the tie-beam, also has a fine series of mouldings on it; the braces even have tiny brooches at the base of the chamfers (Fig. 7). Once this truss had been inserted the western gable and bell turret were rebuilt.<sup>21</sup>

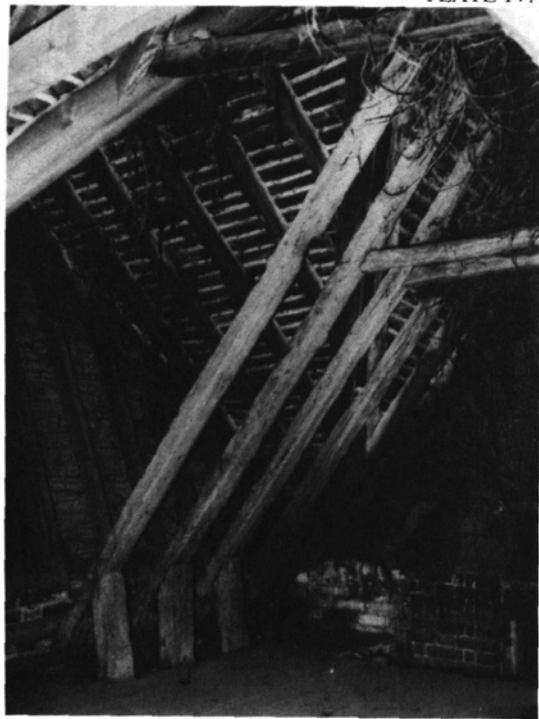
PLATE IVA

Horton Manor Chapel: Chancel Roof, looking North-east.

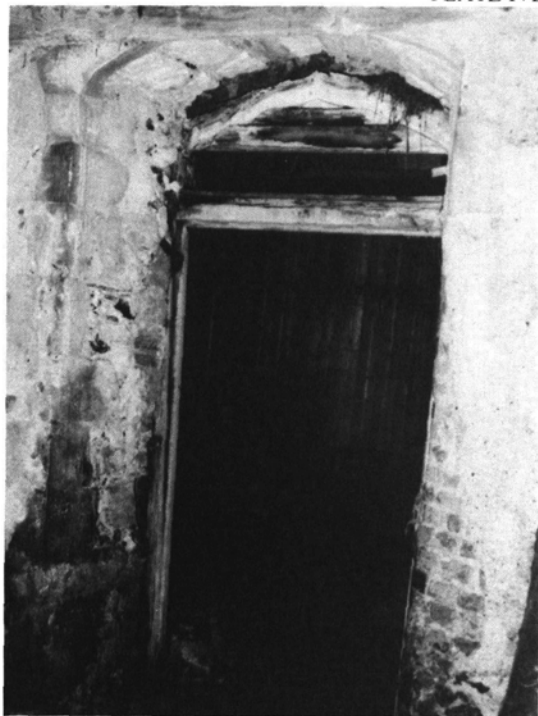
PLATE IVB

Horton Manor Chapel: North Door of the Nave from inside.
