THE RE-EXCAVATION OF THE ROMAN 'VILLA' AT WINGHAM

Part 1

FRANK JENKINS, M.A., Ph.D., F.S.A.

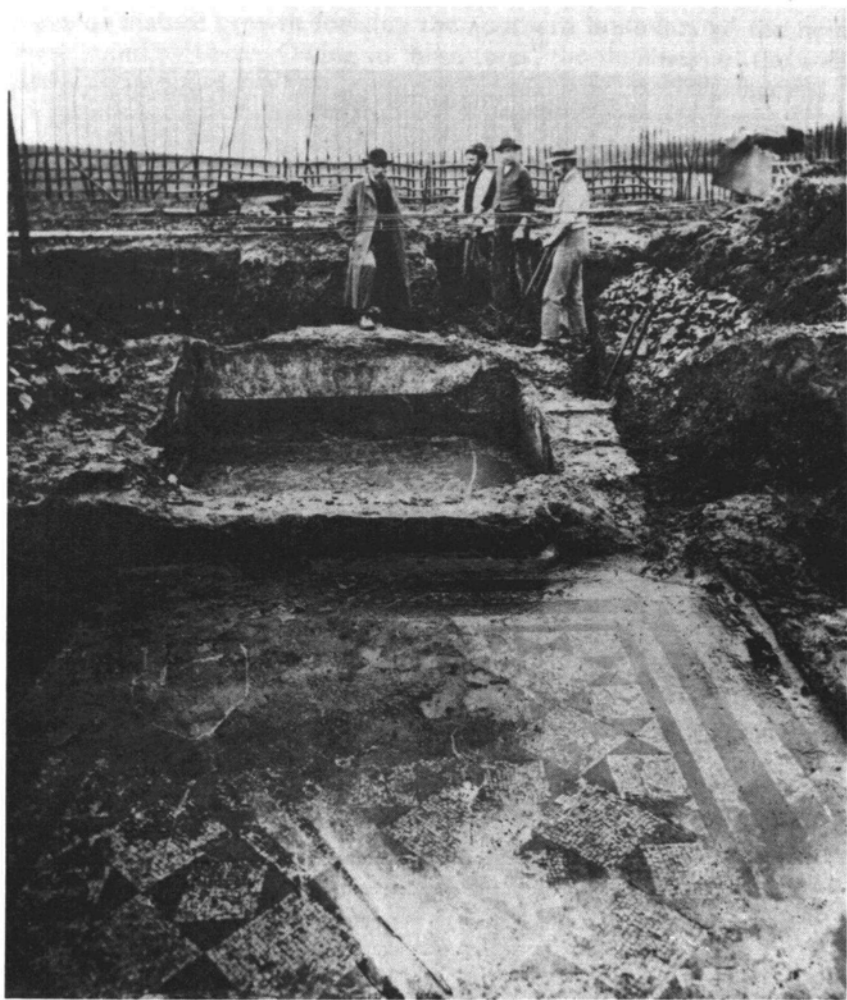
View from the North, showing the sunken cold bath (Dowker's Room no. 1) when first uncovered in 1881.

photograph of the bath was taken before his men dug the trench (Plate I).

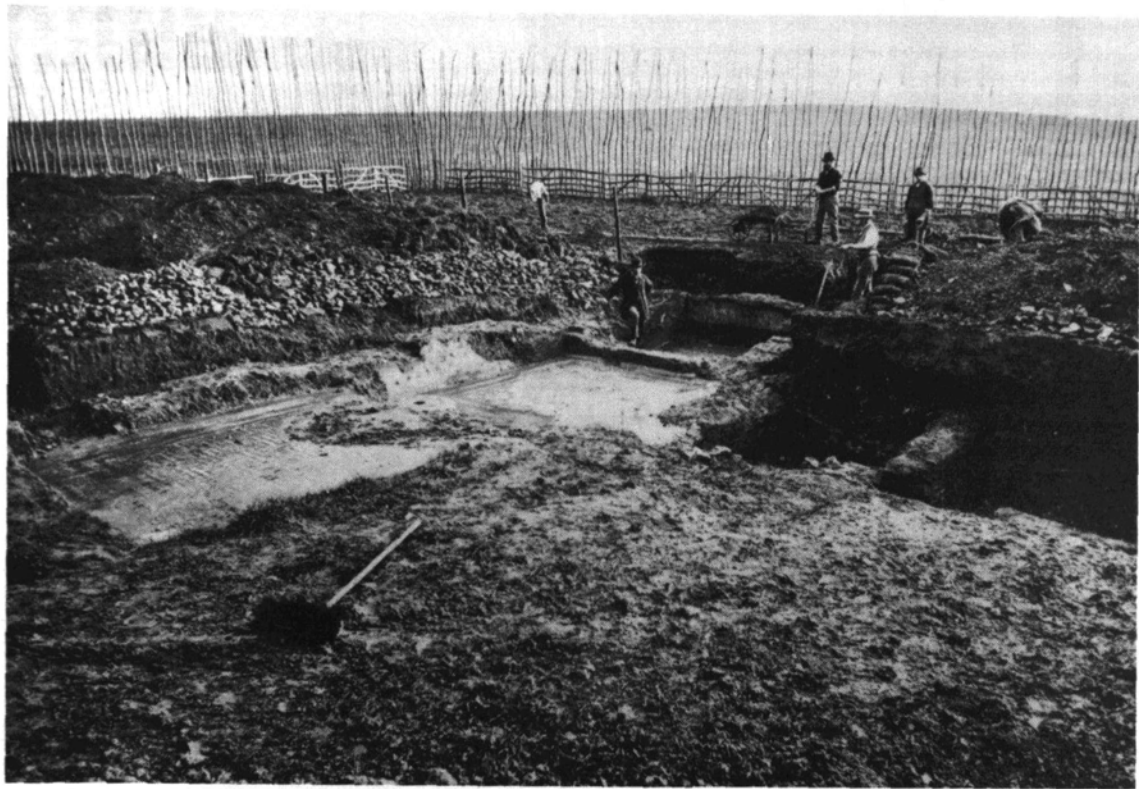
General View of the Remains of the Rooms at the east End of the Bath-house in 1881.
