THE ROMAN FORD AT IDEN GREEN, BENENDEN

CECILY LEBON

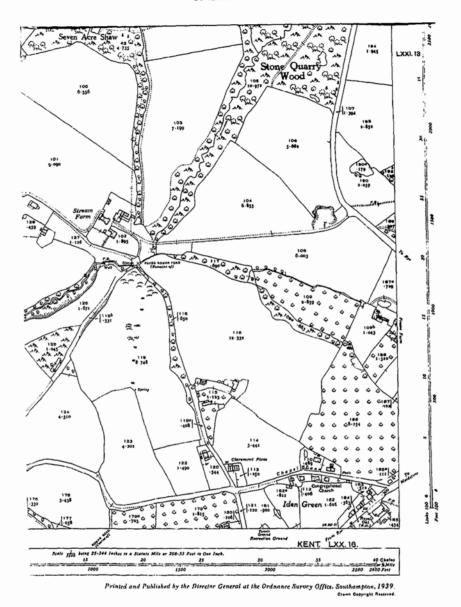
Fig. 1. Location of Ford Site and associated Roads. (O.S. map, 1:2500, 1939. Crown Copyright reserved.)

Following its course from north to south, one can see the ancient road marked by traces of iron slag at intervals in the east bank of a hollow way which runs southwards from Seven Acre Shaw to Stream Farm, with the present-day footpath parallel to it on higher ground at the edge of field 103 (Fig. 1). On plot 102, when barns were recently rebuilt, their foundations and drains went down into burnt earth of undisclosed depth immediately west of the presumed line of the road. Containing hardly any iron slag, the feature may possibly indicate a brick-making site for the building of the early eighteenth-century Stream Farmhouse and for the adaptation of the older, timberframed farmhouse (on Plot 125) which was soon afterwards converted into three labourers' cottages. On the 1769 mapping by Andrews, Dury and Herbert (Fig. 2) the old farmhouse is named Pruiny Hall. It is now again converted into a single dwelling which appears near the western edge of the location map (Fig. 1). The confluence of several potentially useful streams and a network of tracks converging in the vicinity suggest a history of early clearings and the pursuit of economic activities such as stone-quarrying, brick-making and iron-working, besides the agriculture and stockrearing which persist.

In a nodal position, as seen on Fig. 1, a conspicuous feature is the small, roughly pentagonal, enclosure where the excavations were undertaken in close proximity to the boundary stone. The main

In the south-western quarter of Fig. 1, No. 118b is a lane which on the ground looks like an old carriageway, bordered with trees and displaying outcrops of Tunbridge Wells sandstone in its banks and similar, but detached, stones here and there underfoot. Strangely, its stony surface does not reach to the stream side opposite the site enclosure, but it peters out as the lane opens into the marshy strip alongside the south bank. At its other end this lane leads into Coldharbour Lane which crosses the south of the map as a continuation of Chapel Lane.

On the southern margin of Fig. 1 the Ordnance Survey marks 'Roman road (course of)'. This shows conformity with the track adhered to by Margary on a course which takes it for granted that the road did not veer just before the stream crossing, but plunged straight across, continuing due south 'up the spine of the spur', etc. It is strange that he made no comment on the obvious and currently used Field Farm Lane, although elsewhere he looked carefully at possible tracks branching towards harbour sites. He may have relied too much on the impressive photograph by Crawford (Plate I) which he published as Plate XV in his Roman Ways in the Weald. This photograph has been calculated to date to 1935 on the basis of the present age of one of the boys who appear in the scene. Crawford, Margary and subsequent commentators, as far as I know, accepted without question the supposition that the array of massive slabs then protruding at high level along the north bank and recorded in the photograph represented in situ the remains of an original north–south ford, the stream having, since the ford went out of use, cut down its bed to a much lower level. This assumption is questionable on a number of grounds:

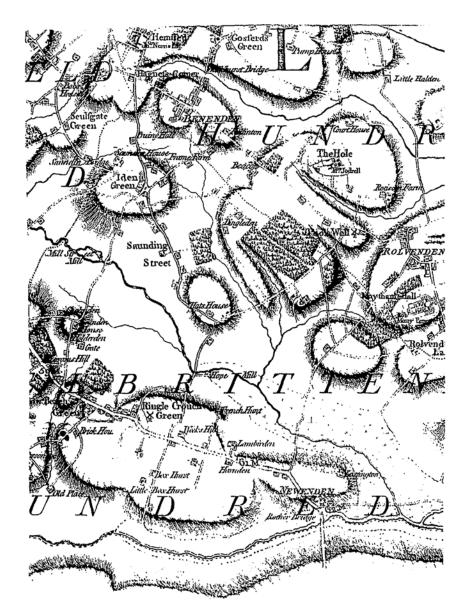
Fig. 2. Andrews, Dury and Herbert Mapping, 2 in. to 1 mile, 1769; from sheets reproduced by H.H. Margary, 1975.

The course south of the ford can hardly have been up a steep spur where no track remains, as claimed by Margary. An old lane to the south-west of the ford seems more likely to be medieval or Tudor, for it shows no similarity of metalling, nor continuity with the Roman levels north of the stream. But the sunken lane to the south-east of the ford vicinity does contain iron nodules and slag similar to that composing the earliest road surface found north of the stream. I now believe that Field Farm Lane dates from Roman times. It was part of a route which passed through Iden Green hamlet and continued via Standen ('Saunding') Street towards a wharf on the Hexden, probably above the site of Hope Mill where the marshes begin (Fig. 2).

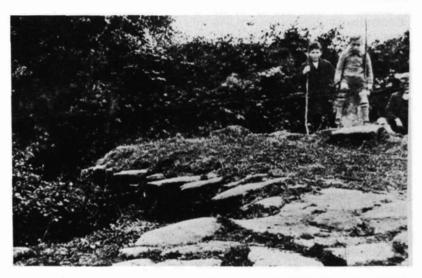
Part of Ford Paving, photographed by Crawford in the 1930s. Reproduced 1984.

- (iii) It is important to consider where the camera was pitched in 1935 and how restricted the view is (Plate I). A longer shot might have revealed where, and in what direction, the ford stones had crossed the stream. As it is, with the forward slabs cut out, the picture leaves uncertain which way this streamside part of the paving was intended to make the passage across. Although not shown in the photograph, it is close to the foreground that the stream makes a big right-hand bend, compelled by the force of a tributary entering opposite and running out of the lower stretch of Field Farm Lane, fed by field drains. Unfortunately, on the projecting bank at this bend, already subject to much erosion by water, a tall alder has been allowed to grow up and its roots have disrupted and dislodged most of the ford stones seen in the right foreground of the photograph.

- (iv) If the row of stones seen in the north bank towards the left side of the photograph were in fact an undisturbed part of

the ancient ford, it is conceivable that they were aligned along the course rather than across it and that the stream has eaten away the side of a causeway below the bend as well as through it further upstream. Alternatively, there may have been originally, or at a subsequent repositioning of these stones, an intention to use the place beside the ford for industrial or domestic purposes requiring hard-standing close to the water; for example, for brick-making, laundering, watering animals and other farm work.

Crawford who first identified the features he found on this site as a Roman ford, seems to have carried out an excavation on the north side of the stream and found a pavement of roughly-squared stone blocks.3 The paved area measured 5.72 m. east to west along the north bank and 3.89 m. from north to south. He exposed a wooden post lying horizontally under the paying and 51 cm. below its top surface. He must, therefore, have taken up some of the stones, but presumably replaced them in back-filling. However, by 1980 most of the paving-stones visible were lying in the stream. It is not unlikely that others had been furtively removed to serve as doorsteps and in gateways. A Benenden resident recalls by name a farmer who carted away at least one load of paving-stones to break up for road- and yard-making. Thus, the array of large slabs had vanished before the 1980-83 excavations. A half-sized slab was lying on the ground beyond the bridge at the entry to Field Farm Lane; and another was observed on the near side at the foot of the alder tree. This latter may be reckoned as the sole survivor in situ of those in the right foreground of Crawford's photograph. One or two smaller, rounder stones are firmly clasped in the roots of the alder.

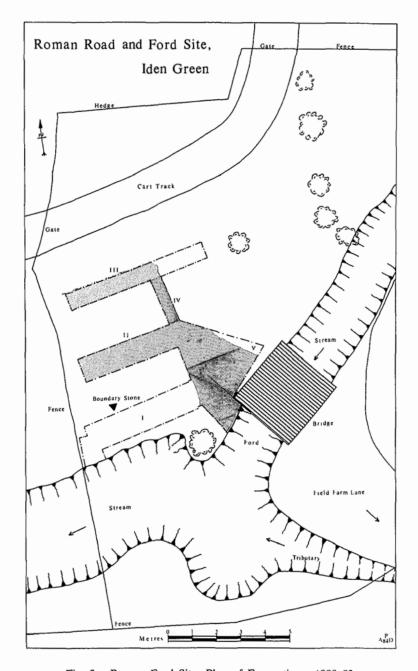
Fig. 3. Roman Ford Site: Plan of Excavations, 1980-83.

At the outset only two parallel trenches, outlined on the plan (Fig. 3) as Areas I and II, were opened. The hard layer in Area I was found, where intact, to be buried only 5–15 cm. It consisted mainly of angular stones, typically 3–6 cm. in dimensions, mixed with pebbles, a little slag, fragments of roofing-tiles, bottle- and sheet-glass, crockery, clay pipes, brass curtain-rings and bits of bicycle: in short, domestic and builders' rubbish, dating to no further back than the eighteenth century.

After the first two seasons, the site was freed from the passage of cattle. It became a priority to open up a wide area near the bridge, Area V on the plan (Fig. 3), in order to see more of the spread of iron ore and slag, and to obtain dating evidence. The layer has been represented on the plan by stippling which does not appear in Area I because there we refrained from digging below the upper metalling, noting that it had already been much cut into.

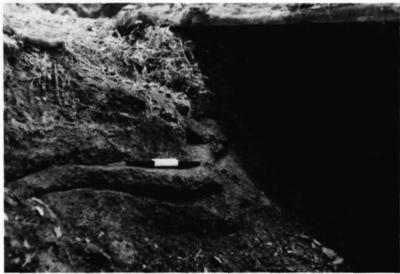
PLATE II

(Photo. N.R. Aldridge)
Roman Hard-core, seen outcropping in Stream Bank.

The evidence has already pointed to an early ford having led into Field Farm Lane. Standing down in the stream and examining the banks carefully (Plate II), one could see an outcropping band of iron, 10–20 cm. thick, running horizontally half-way up the north-west bank from where a modern drain-pipe projected under the bridge to its obliteration among the exposed roots of the alder tree, a distance of about 2.40 m. (unfortunately cut at both ends). The opposite bank showed a corresponding, but thinner, band, both under the wooden
