INTERIM REPORT ON WORK CARRIED OUT IN 1985 BY THE CANTERBURY ARCHAEOLOGICAL TRUST.

1. *St. Martin's Hill*

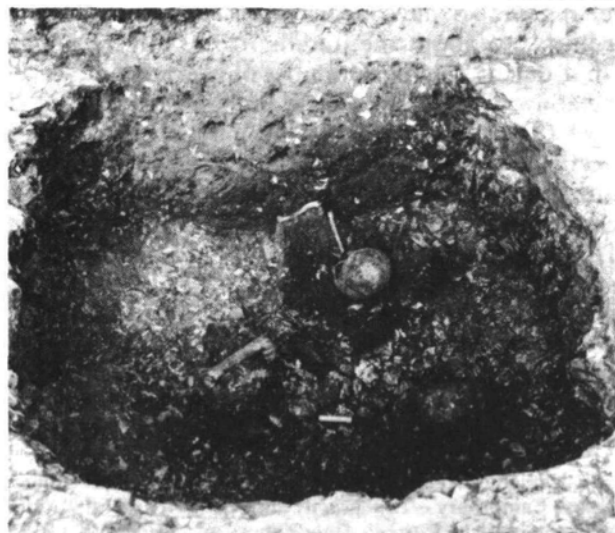
PLATE IB

Crundale Limeworks: possible Iron Age Exposure Burial.

A number of new trenches were opened on the brow of the hill north of last year's site in the area threatened by future quarrying. A late Iron Age ditch, a number of post-holes and a large late Iron Age rubbish pit containing the disarticulated remains of an inhumation burial (Plate IB) were uncovered in these new trenches.

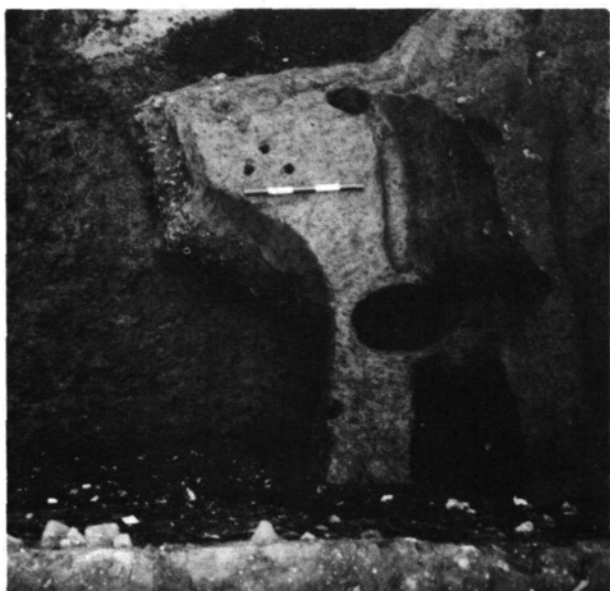
PLATE IIA

41 St. George's Street: Part of an Anglo-Saxon sunken featured Building c. fifth-sixth Century

The earliest structural evidence for Anglo-Saxon occupation on the site consists of part of a sunken-featured building (the first structure of this type to have been located in this part of Canterbury) which contained pottery of fifth- or sixth-century date in its backfill (Plate IIA). Elsewhere on the site were levels containing eighth-century pottery similar to that excavated recently at St. Augustine's¹¹ and St. Martin's Hill.¹² These levels were overlaid by the remains of a late Anglo-Saxon industrial structure, which may have been connected with iron smelting, associated with rubbish pits containing pottery dating to c. 950–975 and a few residual earlier sherds together with a fine seventh-century double-sided bone comb. This industrial structure would, therefore, have been built soon after the new High Street was created across the city from the Westgate to the Newingate in the early tenth century.¹³ The evidence from both this excavation and
