## INTERIM REPORT ON WORK CARRIED OUT IN 1986 BY THE CANTERBURY ARCHAEOLOGICAL TRUST

Thirty-five excavations and watching briefs have taken place since the compilation of the last interim for *Arch. Cant.* This increase in Trust activity is in part a reflection of the rising number of re-development sites in the city and in part the product of attempts by both the Canterbury City Council and the Trust to incorporate archaeological work in all development schemes within the area designated 'of archaeological importance' under the terms laid down in the Ancient Monuments and Archaeological Areas Act (1979).

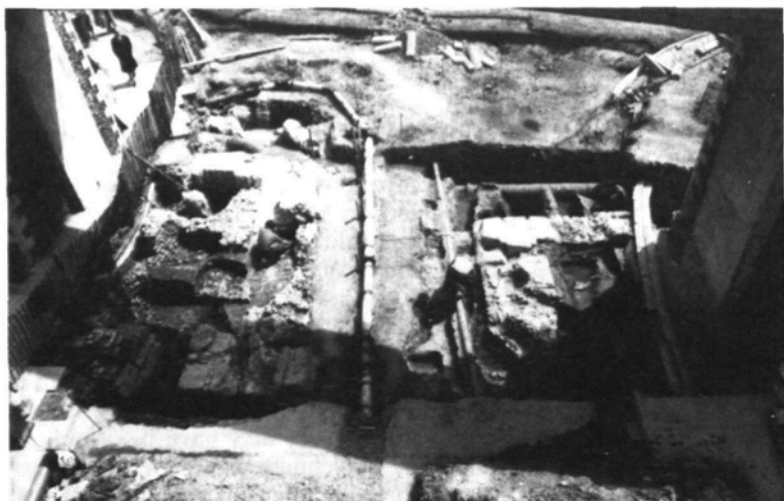
PLATE III

The Ridigate, Canterbury. General View of Excavations from the North-west.  
(Scale: 2 m.)

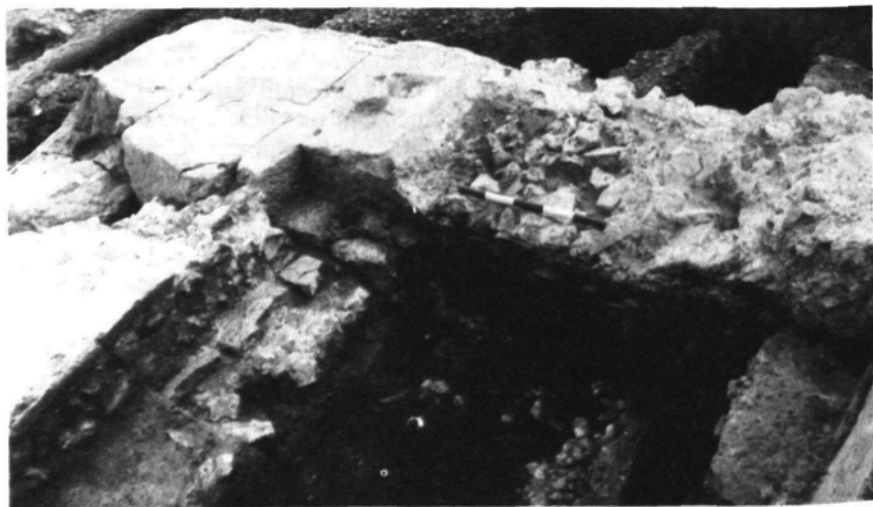
PLATE IV

The Ridigate, Canterbury. Detail of the Entrance of the western Carriage-way  
showing the lead-encased Iron Masonry Clamps, Door Fittings and twelfth-century  
blocking Wall. (Scale: 0.50 m.)

The surviving fabric of the gate was impressive. Above the flint and mortar sub-foundations of the gate was a plinth of massive, chamfered greensand blocks tied together by lead-encased iron clamps. This plinth in turn supported the main walls of flint and mortar, regularly interrupted by string courses of Roman bricks, with quoins of greensand blockwork. The carriage-way arches would have been of Roman brick. The guard-chambers, one on each side of the gate, had rear entrances and were bonded into the fabric of the city wall.

The carriage-way remained blocked until the early Norman period when the church of St. Edmund Ridingate<sup>11</sup> was established in the carriage-way and flanking guard-chamber. It is at this date that a blocking wall (the east wall of the church) may have been built in front of the decayed Roman door. The church was later extended to the west: the west end of the north wall of the church being butted up against the central supporting wall of the Roman gate. Little remained of the church north wall above foundation level, except a few ragstone lumps (possibly re-used from the Roman fabric). This church was united with the St. Mary Bredin parish in 1349, after the Black Death depopulated the area. The church was probably demolished soon after that date.

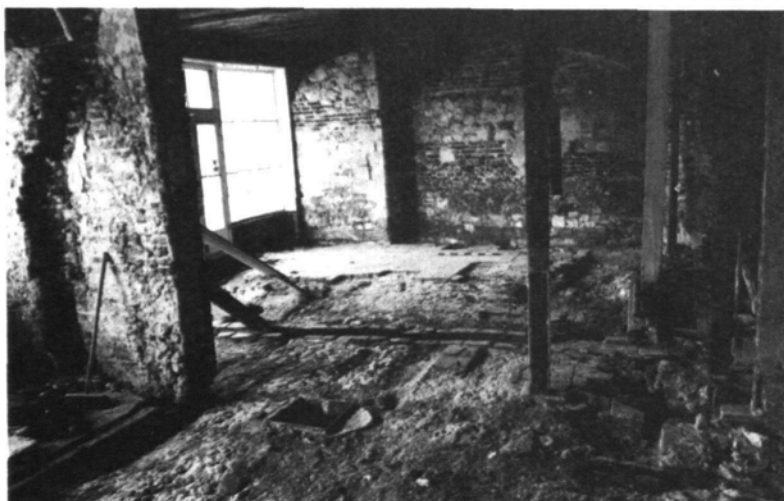
PLATE V

Nos. 35-37 Burgate. General View of surviving Tile-Floor and Drain viewed from the East. (Scale: 1 m.)

The tiled floor in the ground floor area was presumably in existence for some time as many of the tiles were badly worn and in several places the floor had been patched with new tiles and bricks. The wear pattern and areas of patching indicated the position of internal doors and partitions. The existence of these fittings was confirmed by mortices for framed partitions surviving on the underside of the original first floor joists.

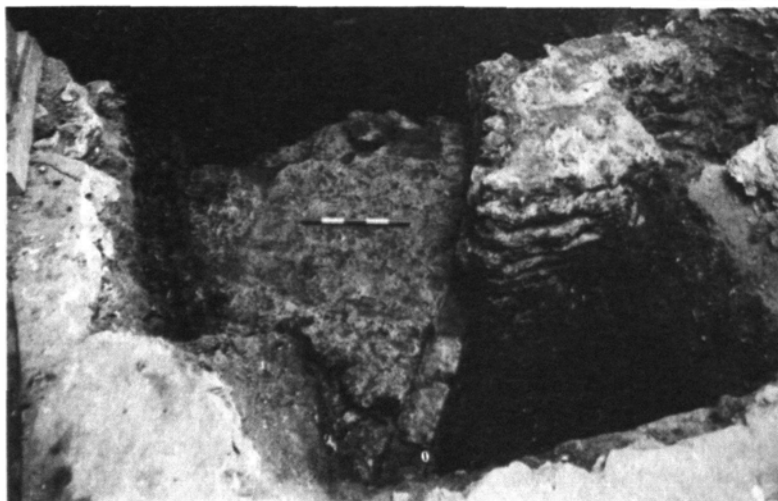
PLATE VI

No. 20 St. Margaret's Street, Canterbury. Apsed Foundation for *caldarium* of the Roman Public Baths. Viewed from the East. (Scale: 0.50 m.)

The wall foundations of the bath-house, including a huge foundation for an apsidal-ended room, continued for a depth of over 3 m. below the floor of the cellar (Plate VI). The foundations were designed to carry substantial loads and must indicate a building of great height. The lower floor of the heated room was bedded on a thick flint and mortar raft which in turn overlay a number of large pits or clay quarries yielding quantities of early Roman pottery.

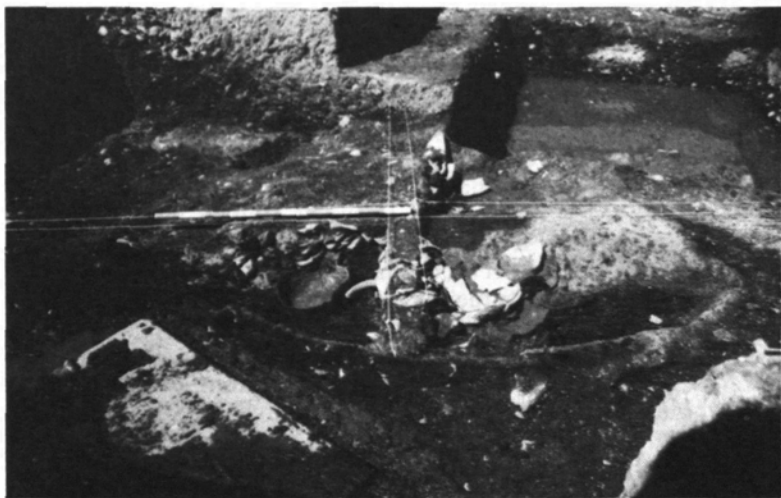
Pound Lane, Canterbury. Mid twelfth-century Pottery Kiln, during Excavation.  
Viewed from the South-east. (Scale: 1m.)

At the present time we have just uncovered the remains of a complete mid-twelfth-century kiln, packed with pottery (Plate VII). The kiln is of unique importance. It is by far the oldest medieval kiln found in Kent and the kiln products are of a type that were hitherto thought to have been made in north France or the Low Countries. It seems likely therefore that the kiln and its contents are products of an immigrant French potter, producing glazed and decorated wares in the city during a period when Canterbury was a thriving cosmopolitan centre, both before and after the murder of Archbishop Thomas Becket in 1170. Examples of this potter's work have been found on a number of Trust-excavated sites, particularly in the Precincts of the Cathedral.<sup>14</sup>

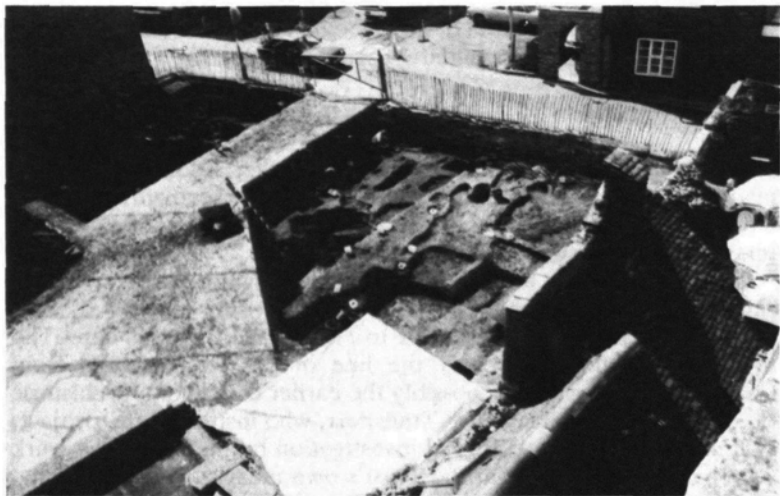
St. John's Lane, Canterbury. General View of the Excavation from the North.

The first few weeks of the excavation have concentrated on the removal of garden deposits associated with Lullingstone House (constructed in the seventeenth century) and the excavation of medieval structures and associated rubbish-pits. The sides of these pits reveal tantalising glimpses of the levels which we will be excavating over the coming months.

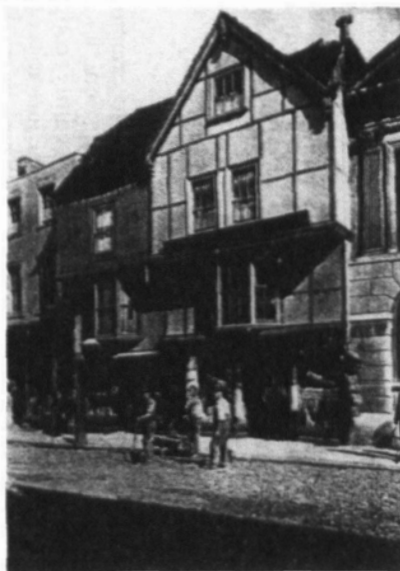
Fig. 9. Nos. 12-13 High Street, Canterbury.

*Restored 1st floor elevation  
showing typical C15th  
framing with inserted C17th  
fenestration.*

Apart from the main framing, which dates from the fifteenth century, no evidence for the original fenestration was uncovered. However, the small seventeenth-century windows, which would have flanked a contemporary bay window, were found to be in good condition. In the nineteenth century the bay window was replaced and the timber-framing concealed.
