# THE WEST FRONT OF ROCHESTER CATHEDRAL: THE INTERIOR DESIGN

J. PHILIP McALEER, F.S.A.

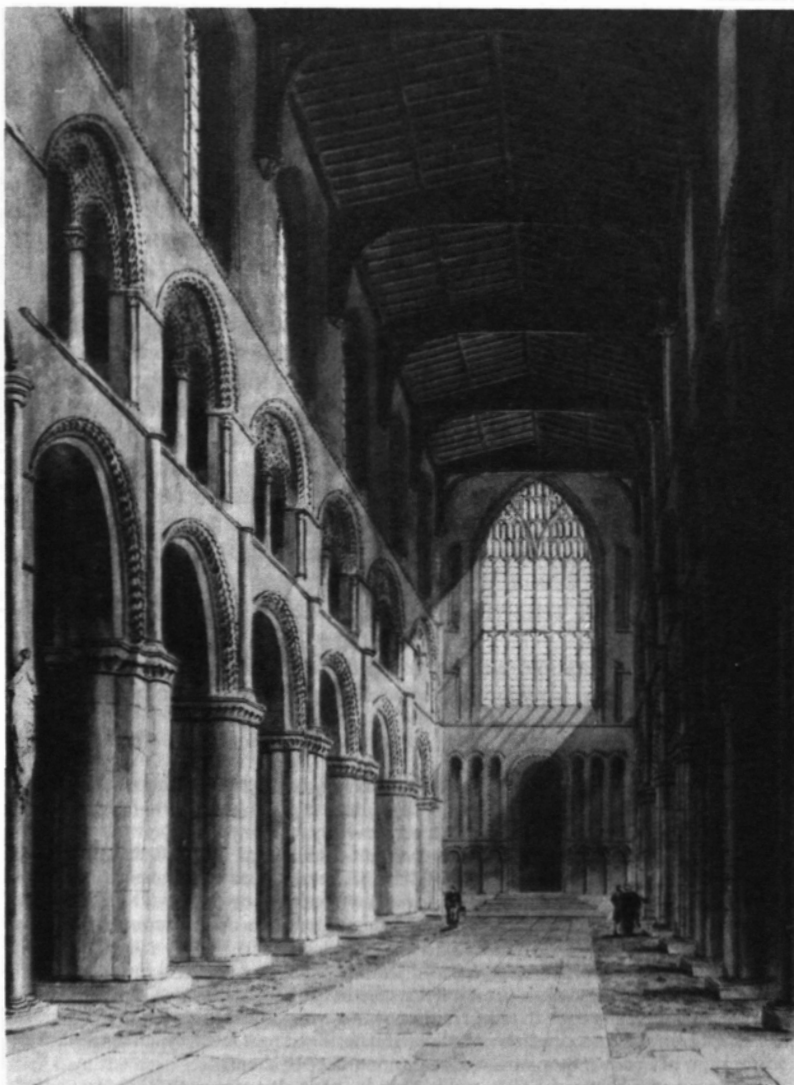
*(Photo. Reproduced by courtesy of the Trustees of the British Museum).*  
John Buckler, *Nave of Rochester Cathedral, looking West*, water-colour, 1805,  
London, British Museum.

#### THE EAST FACE OF THE WEST FRONT (Plate I)

stage of the nave. It is marked by a broad string-course. Below this level, corresponding to the nave arcade in height, is the tall narrow central portal flanked by two tiers of arcading of which the lower tier has shafts and the upper continuously moulded jambs. The lower tier is short, the upper is taller, which reverses the relationship of the corresponding zones on the exterior (Plate II) where a tall blank dado—containing only the small flanking flat-backed niches—is succeeded by a lower zone of arcading, equal to the arch of the portal in height. The string-course at the top of this band of external arcading marks the approximate level of the floor of the internal passage-way.

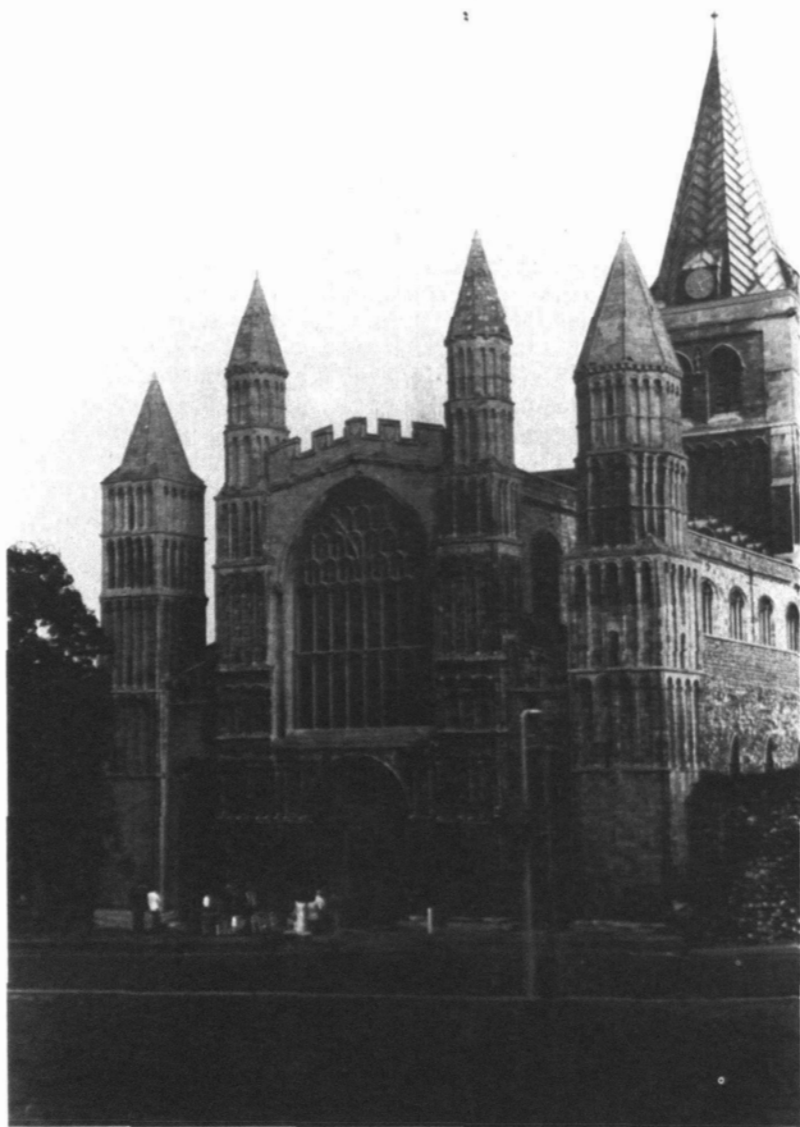
*(Photo.: Author).*  
Rochester Cathedral: Exterior, View of west Front

As the bays of arcading on the exterior (Plate II) are much shorter—it is the zone that has the horizontal lintels and small carved tympana—and begin at a slightly higher level than the interior ones, it is doubtful if there were any windows at this level, unless they simply interrupted the arcading.<sup>16</sup> If the arcading was continuous and

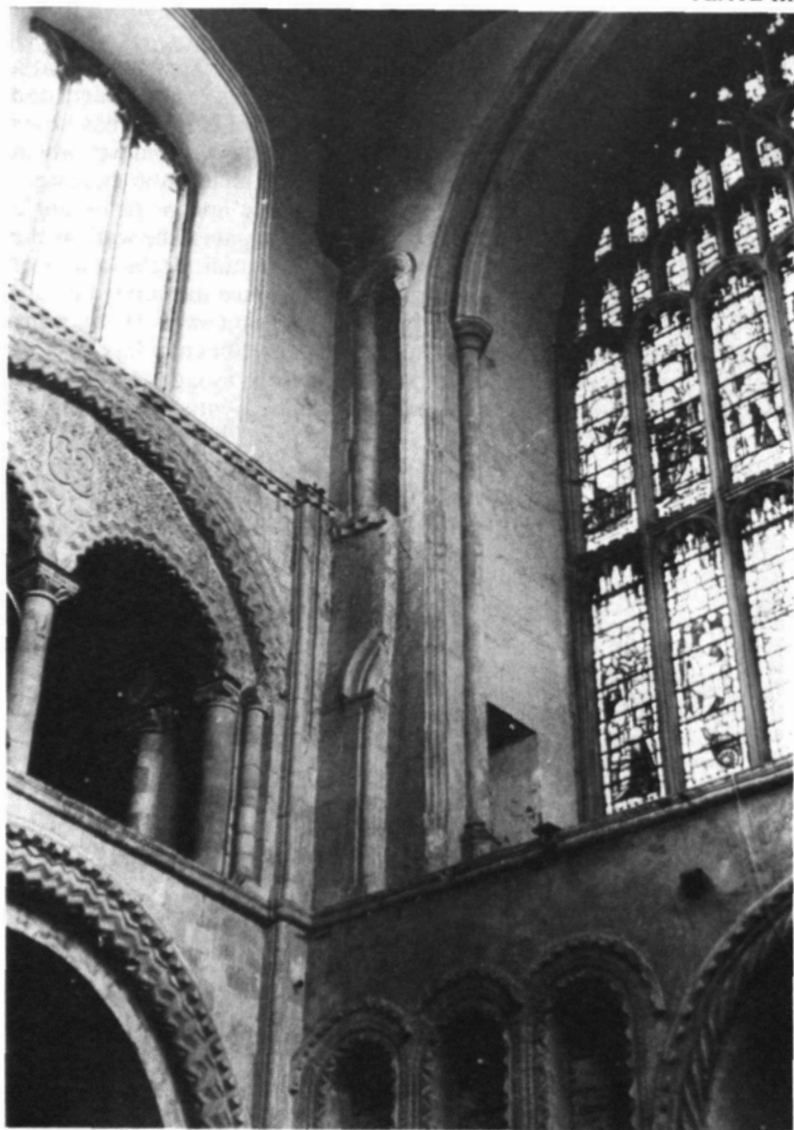
(Photo.: Author).  
Rochester Cathedral: Interior, east Side of west Front, Remains of third and fourth  
Levels of Arcading at the South.

Four bays of sexpartite ribbed vaulting would have fitted the nave very nicely but, admittedly, the alternating 'sets' of three and one ribs would not have related to the single wall shaft that formerly rose to at least clerestory sill level in each bay, nor to the return angle, marked by a thin angle roll, at the junction of the nave arcades and the west wall (Plates III, IV).

Above this level, at either side of the jambs of the interior frame of the west window, are the remains of two tiers of arcades (Plates III, IV). The remains of the string-course between them—in the form of an horizontal zigzag—is a little lower than the string at the top of the second stage forming the clerestory sill, so there was not an exact synchronisation of levels. The third tier is also somewhat taller than the third exterior one and the design of its arcading is completely different. Nor is the third level of arcading equal in height to the arches of the second (gallery) stage of the nave. Indeed, it does not fill the available height of the zone on the west wall; its height is more comparable to the sub-arches than to the superordinate arches of the second stage.

As there was a wall passage at this level and the one above it, one may ask how the arcading was managed? Some kind of vault must have been placed at this lower level in order to support the passage above. As the single surviving shaft (Plates III, IV, V) at the north and south ends is positioned so as to suggest they were originally jamb-shafts, rather than half-shafts engaged to a wall, it may be proposed that there was an open arcade in front of the lower passage. In form, it may have been a continuous colonnade or pairs of openings alternating with a wider pier in order to better sustain vaulting.<sup>15</sup>

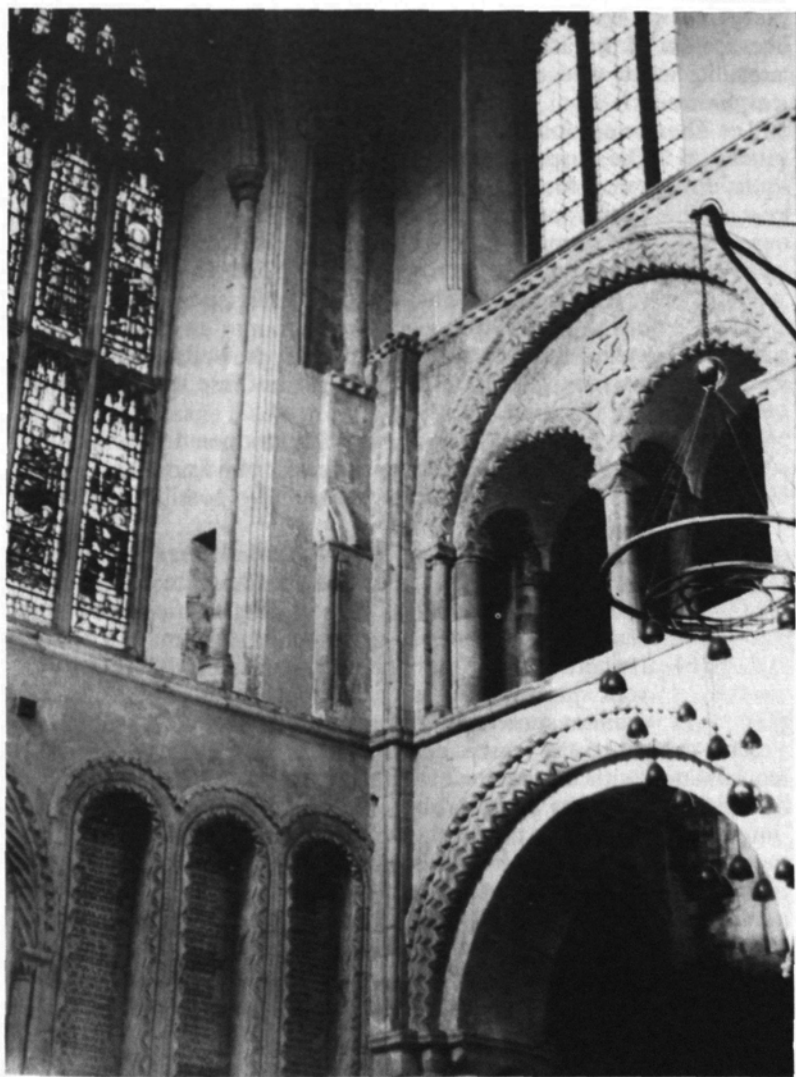
(Photo.: Author).

Rochester Cathedral: Interior, east Side of west Front, Remains of third and fourth Levels of Arcading at the North.

second stage openings. The scale of these openings suggests that either a so-called low or a false gallery was originally intended.<sup>6</sup> In each bay, the gallery opening was designed as a pair of arches with a centre shaft and tympanum, one set towards the nave and one towards the aisles. The passage-way, therefore, passed between the double screen of the openings and continued through the piers between the bays. Behind the openings it is covered by small barrel vaults, placed transversely, with pointed or semicircular arches used in the small section of vaulting between each of them (Plate IV).<sup>7</sup>

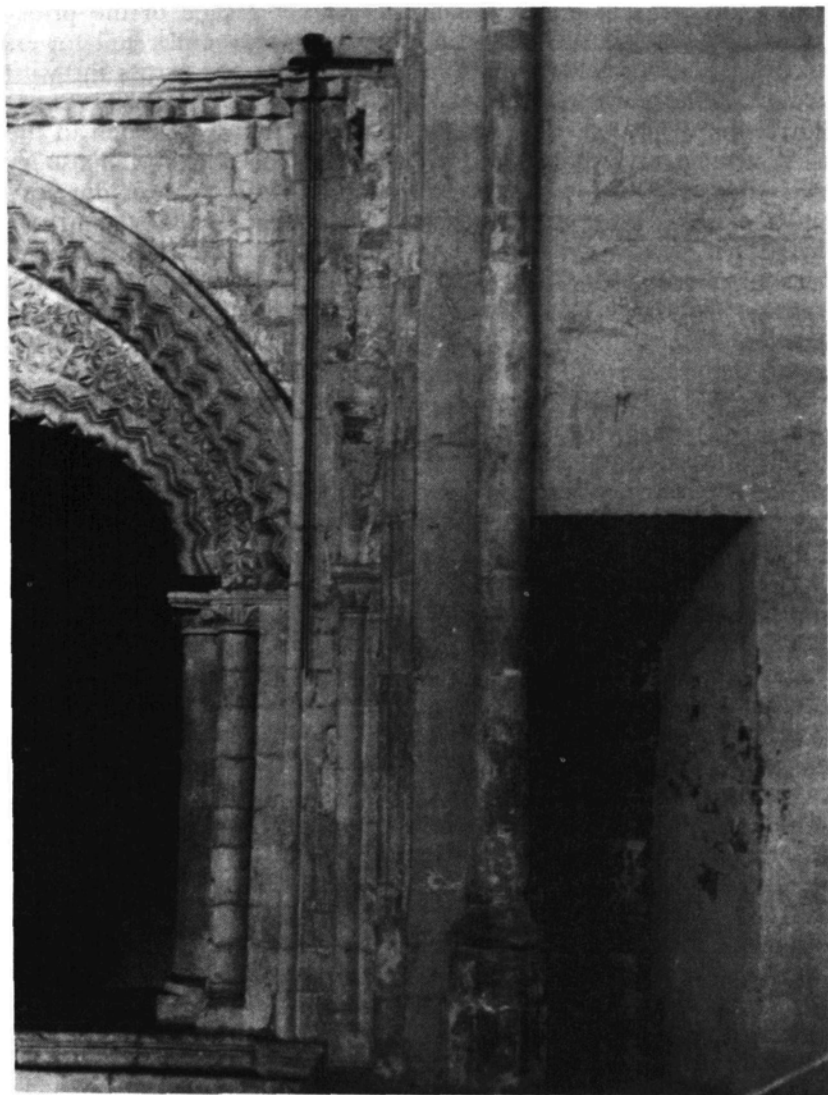
*(Photo.: Author).*

Rochester Cathedral: Interior, east Side of west Front, Remains of third Level of  
Arcading and Wall Passage at the South.
