INTERIM REPORT ON WORK CARRIED OUT IN 1987 BY THE CANTERBURY ARCHAEOLOGICAL TRUST

Thirty large and small excavations have taken place since the compilation of the last interim for *Arch. Cant.* Most of these have been funded by the developer, with additional grant aid coming from English Heritage and the Friends of the Trust. I would like to take this opportunity to thank the officers and members of the K.A.S. for their help during this past year. The support of the Society is extremely important to us and we hope they will continue to assist us, as they have since the Trust was formed twelve years ago, for many years to come. Although the Trust appears to be thriving, we survive only because we receive large measures of local support.

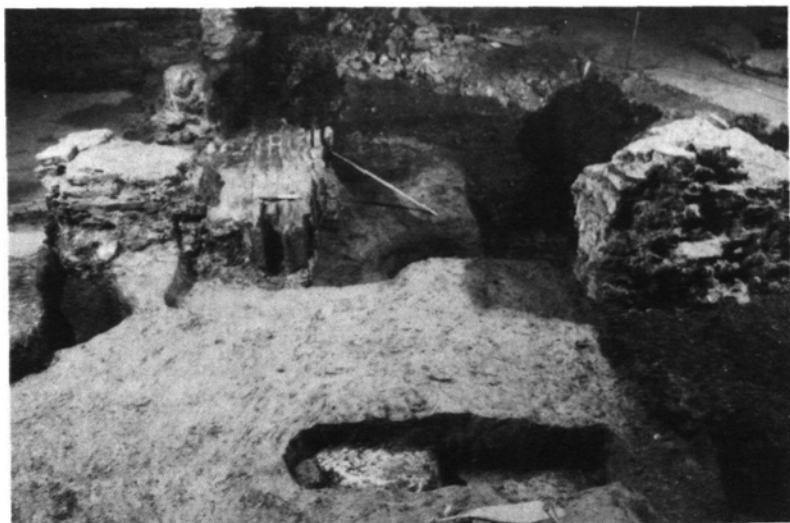
Martin's, no. 20 St Margaret's Street: View of the *Praefurnium* from the south-east, showing remains of the tile-on-edge floor (Scale: 20cm.).

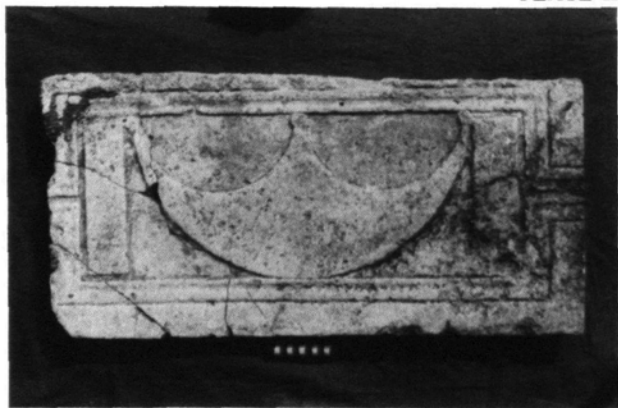
St. Margaret's Church: The *Pelta* re-used in the paved Floor of the Plunge-bath (Scale: 10 cm.).

The second area of interest centred on the stone-paved floor of the cold plunge-bath. During excavation it had been noticed that one of the stones bore a decorative border. This stone proved to be part of a monumental inscription in Sussex marble depicting a form of shield known as a '*pelta*', surrounded by a border. This is a fairly common motif associated with Roman inscriptions, and was probably one of a pair of identical slabs flanking an important inscription, perhaps celebrating the dedication of the baths in the early second century. The slab was re-used in the floor of the plunge-bath when the

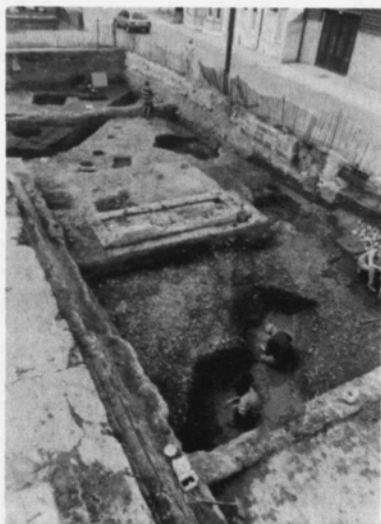
St. Radigund's Street Car Park: General View from the south-east, showing the principal north-west/south-east aligned street with side drains.

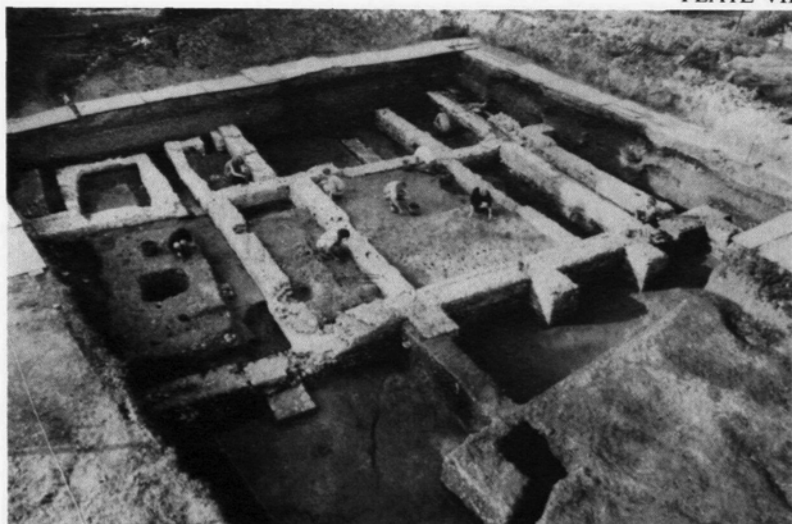
The Tannery Excavation: View of the Roman Building from the south-west.
