EXCAVATIONS AT ECCLES: A PROGRESS REPORT

A.P. DETSICAS, B.A., M.A., D.Litt., F.S.A.

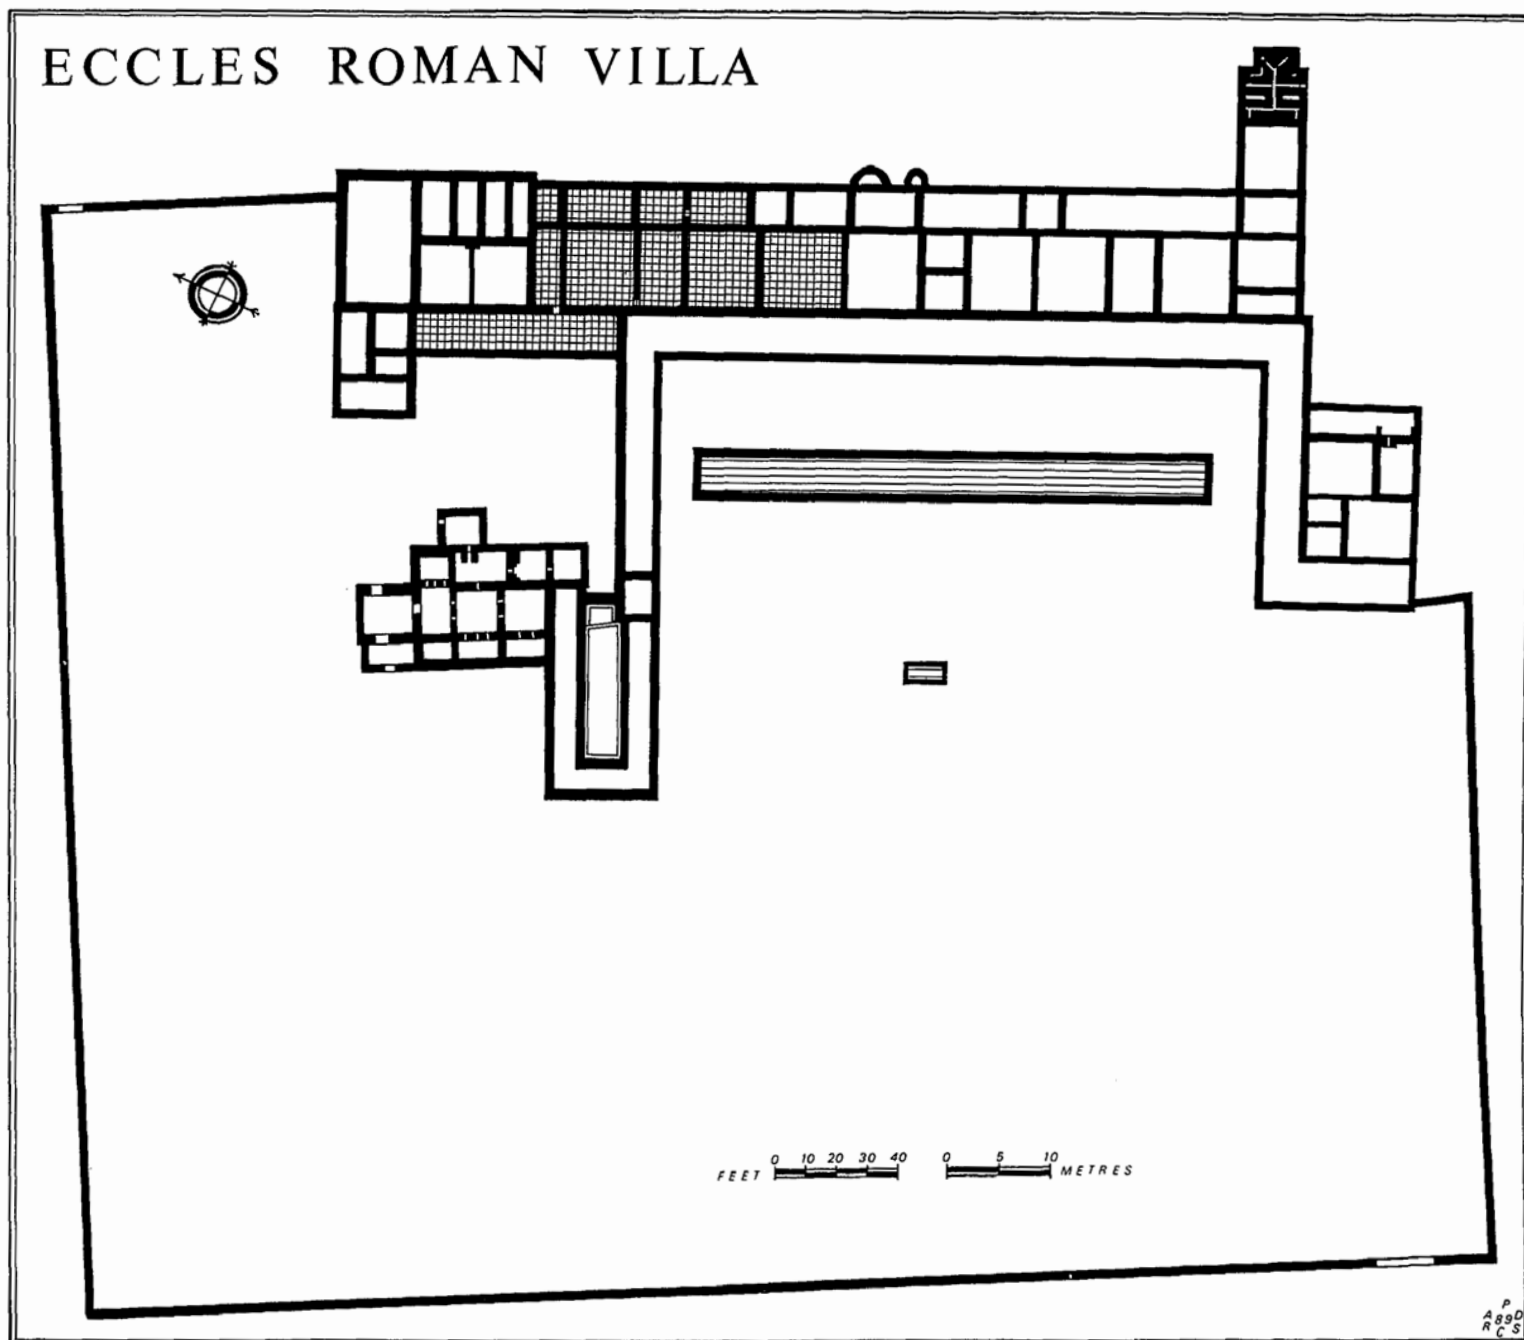
Fig. 2. General plan of the villa, fourth century A.D.

It is now clear that a large ornamental pool was situated in the area fronting the villa's living accommodation and enclosed by its two wings (Fig. 2).

excavation;⁹ its total dimensions were established as 83 × 11 ft. 6 in. (24.90 × 3.45 m.), internally. However, the tentative suggestions as to the purpose of this structure previously put forward¹⁰ must be abandoned. For there is no doubt, as Walthew and Smith have already pointed out,¹¹ that this structure was an ornamental pool at the centre of the house's inner courtyard and further to north-east of the small basin excavated in 1973.¹²

The eastern part of the villa's boundary wall was first cleared in 1972,⁴ further explored in 1975⁵ and in the 1976 final season of excavations⁶ was found to extend to 229 ft. (69.84 m.) beyond the villa's south wing. This perimeter wall then turned at right angles to south-west and, after a short length, ended at a regular face, suggesting a gate-way into the villa compound. In 1976, this entrance appeared blocked by a later wall of different construction and at a rather different alignment. There was no evidence to indicate the dating of this blocking length of wall, which could belong to a structure abutted onto the corner of the boundary wall at a later, possibly post-Roman, date. However, further examination of the site records shows what is clearly a construction trench found in two trenches excavated further to south-west of the boundary wall's southern corner. This construction trench is in direct alignment with the short length of the boundary wall beyond its southern corner, which clearly means that the boundary wall of the villa continued into the area to the south-west of the foot-path (Site S) leading to Rose Cottage and beyond (Fig. 1). Moreover, in 1966⁷ a similar boundary wall was exposed at the northern limit of the area occupied by the dwelling-house, with a gate-way, later blocked, at its northern corner. The alignment of this western boundary wall was not further explored but, if projected to south-west, it would intersect the construction trench on Site S at c. 115 ft. further south-west. Fig. 2 shows the area enclosed by the villa's perimeter wall to south and west of the house as restored by the projection of the excavated lengths of boundary wall.
