RESEARCHES AND DISCOVERIES IN KENT

BROOMHILL CHURCH PROJECT: 1988 SEASON

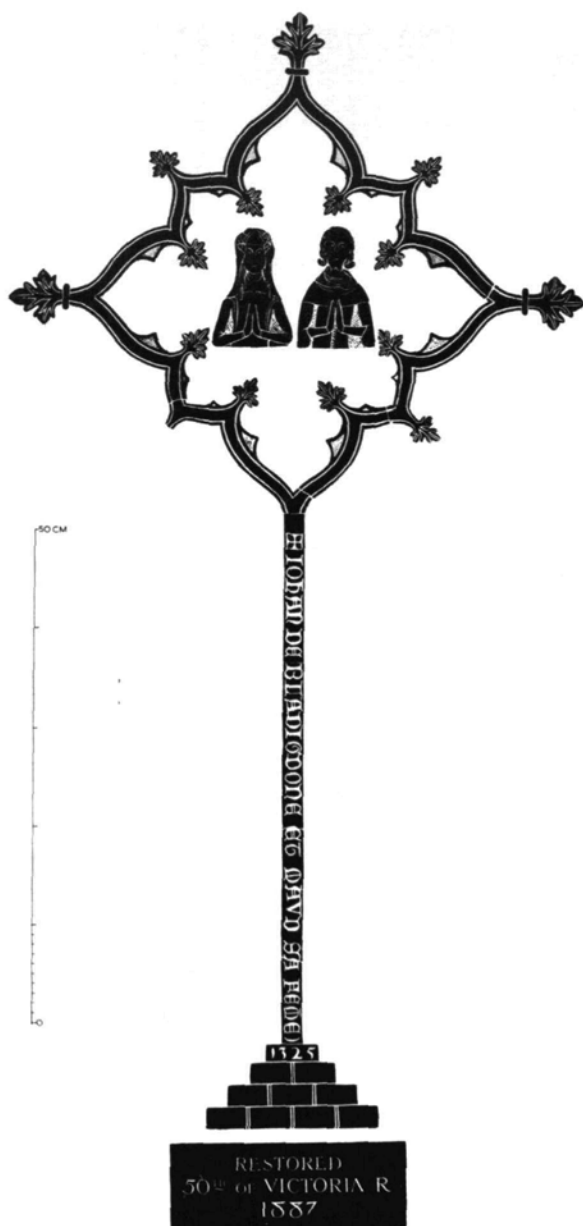
Fig. 1. Brass to John and Maud de Bladigdone, as restored in the nineteenth century.
(*Rubbing by P.J.T., 1956*).

JOHN DE BLADIGDONE AND HIS WIFE MAUD (Fig. 1)

This important early brass has had a chequered history. A drawing made in 1809 by Thomas Fisher (Fig. 2) shows the lower part of the gravestone missing, with the inscription on the shaft of the cross broken off after the letter S of SA. The three foliated terminals were by then lost but the drawing shows the indents formerly containing them, and this, together with recent observation of the very eroded Purbeck gravestone still surviving in the middle of the church, shows the restoration of the brass in 1887 to have been somewhat defective in replacing the terminals on too small a scale. Probably the restorer was guided by Haines' drawing of 1861 (Fig. 3) when much of the brass was detached from the gravestone,² and the conjectural outline

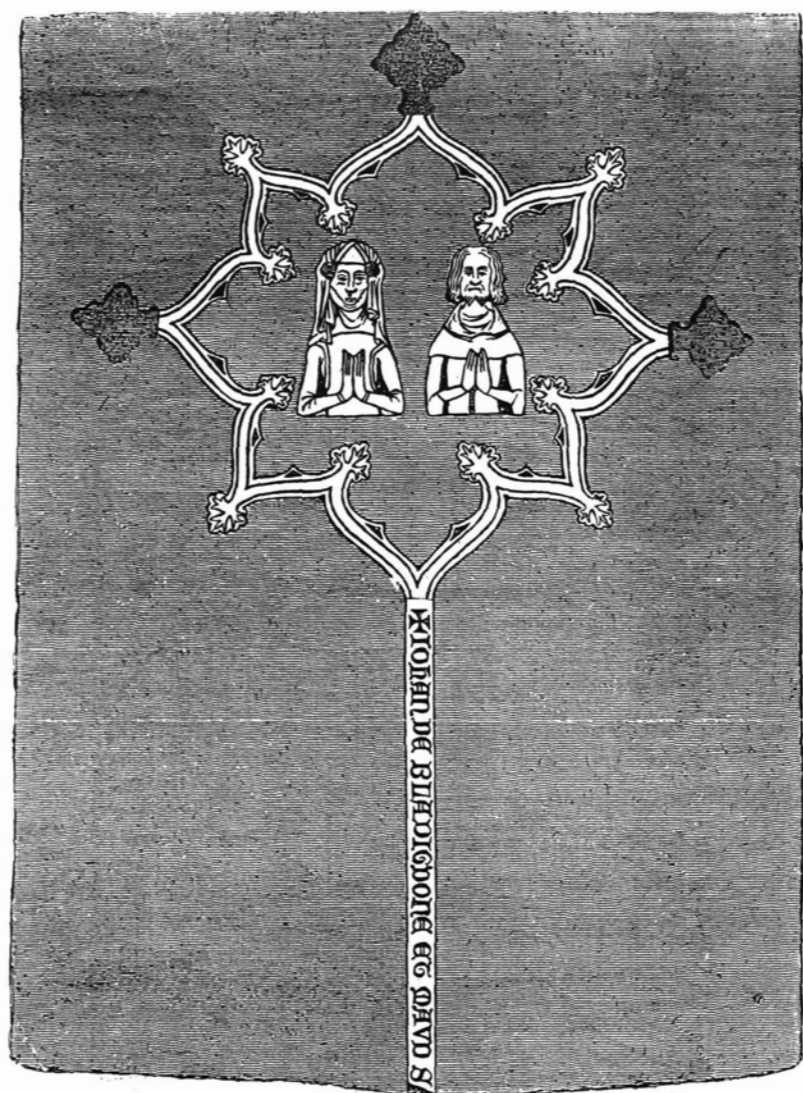
Fig. 2. Etching by Thomas Fisher, 1809, showing parts missing by that year.

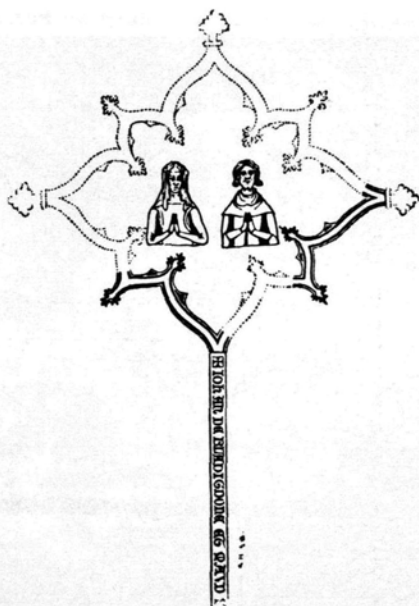
Fig. 3. Illustration in Herbert Haines' *Manual of Monumental Brasses*, 1861. Much of the open cross-head had apparently been detached from the gravestone by that date and the missing parts are shown conjecturally in dotted outline. This, and the date given (c. 1325), probably influenced the restorer in 1887.

was represented by dotted lines. It is known that at one time parts of the brass were loose and kept in a drawer in the vestry.³ Reference by the restorer to the indent could have avoided the error, but the brass was at that time re-set on a new stone. It is now recognised that originally the distance between the lateral terminals of the cross-head was approximately 11 cm. greater than in the present reconstruction, and their form was more angular.

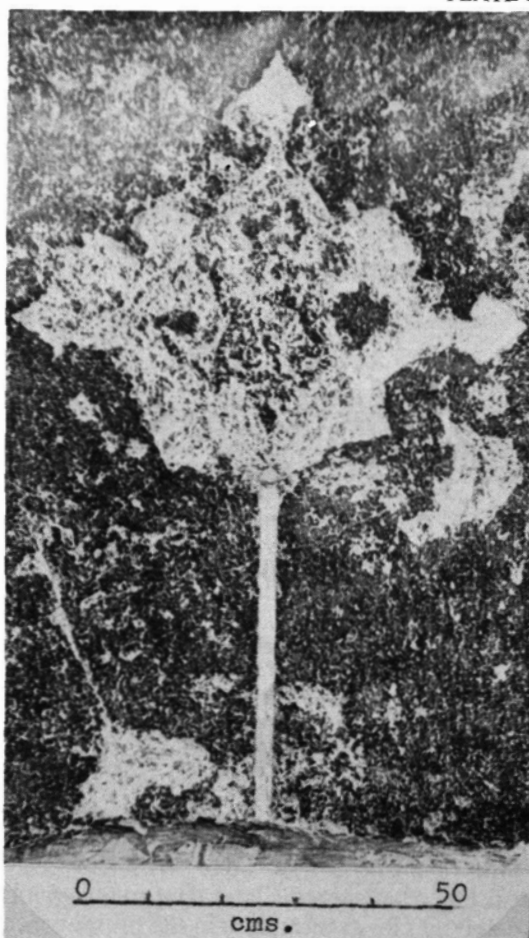
Rubbing of part of the original gravestone showing the indent of the brass in its original form. (*Rubbing by P.J.T., 1956*).

In 1969, the brass was removed from its later stone and mounted on a board for permanent display in the modern church. A rubbing of part of the original gravestone bearing the eroded indent is shown here as Plate I.

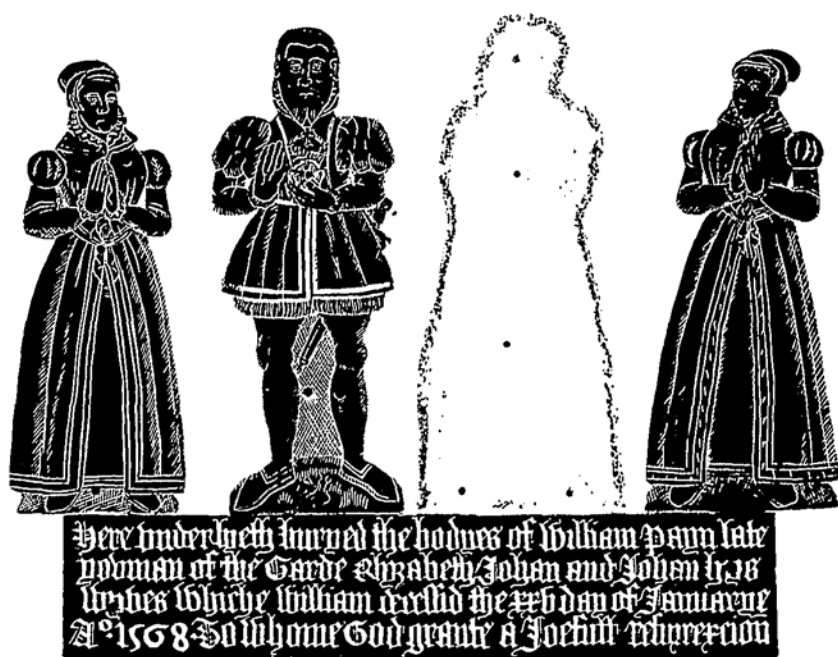
Fig. 4. Brass to William Payn and his three wives, 1568. Rubbing made in 1956 (P.J.T.) before the brass was removed from its slab in 1969.

WILLIAM PAYN, YEOMAN OF THE GUARD, AND HIS THREE WIVES, 1568 (Fig. 4)

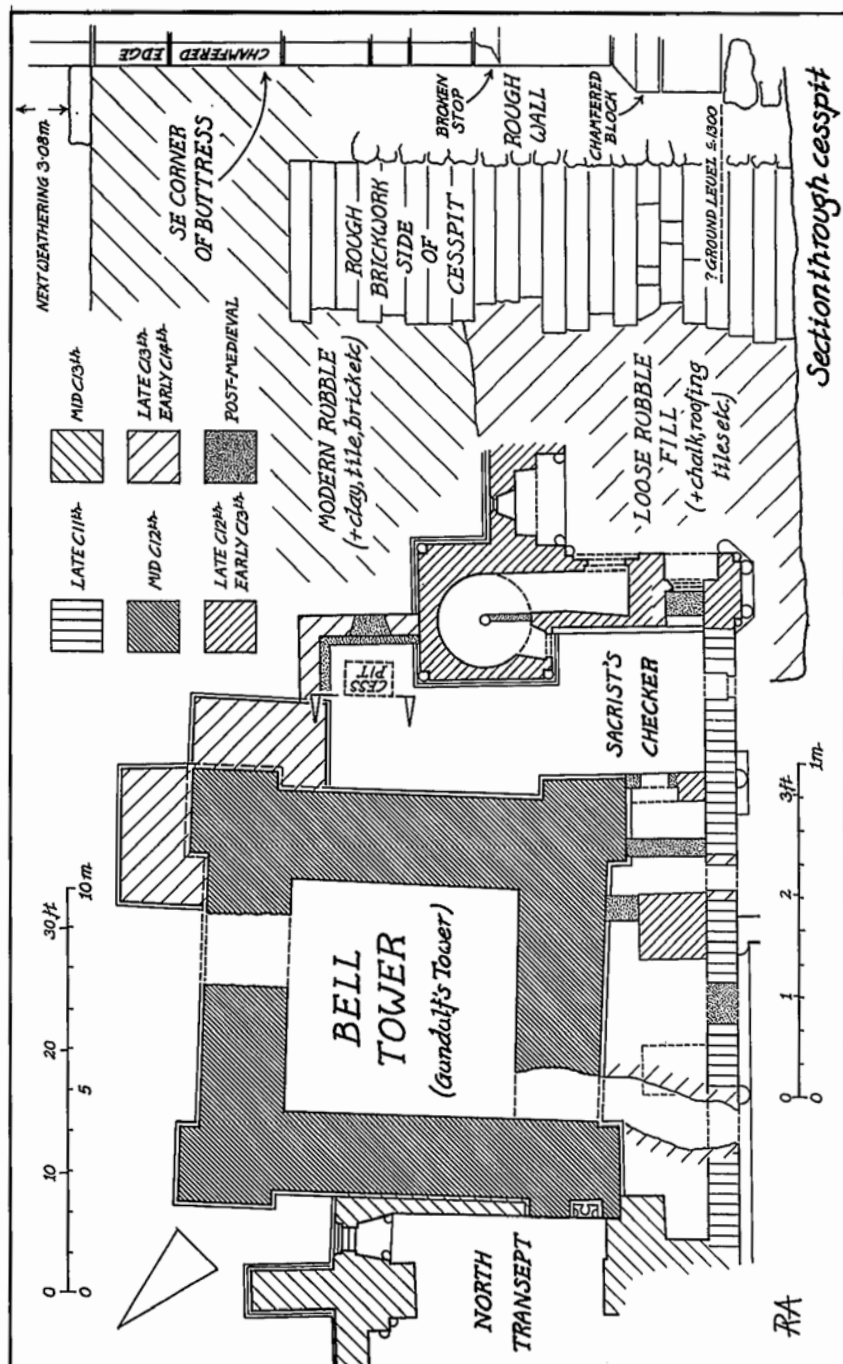
Fig. 1.

The hole made by the workmen was examined by the writer of this note, and a rough plan was made on 28th July. On the following day (a Saturday when no workmen were present), he managed to draw the main section in the hole (Fig. 1); the main feature revealed was a brick and rough stone-lined cess-pit. This had been cut through and destroyed by the workmen on the south-west and north-east (and its contents were completely removed). It must, however, have been a nineteenth-century cess-pit for the forerunner to the recently demo-

lished toilets. At the base of the brickwork (the level to which the workmen had dug) was a harder, more consolidated and leached layer. This contained mortar and Reigate stone fragments and may well be the building level for the eastern arm of the cathedral where much Reigate stone is used.² The eastern arm was probably constructed in the last two decades of the twelfth century, soon after the fire of 1179 (though dated by W.H. St. John Hope to c. 1200–1215.)³ Overlying this harder layer at the bottom of the hole, and behind (and cut through by) the brick lining to the cess-pit was a layer of up to 1 m. in thickness of large, loose broken chalk fragments and tiles. Some of these tiles were apparently pantiles, and the layer perhaps dates to the eighteenth century and may relate to the time when the top half of 'Gundulf's' tower was destroyed.⁴ This act of vandalism seems to have taken place soon after 1781 so that the materials could be used for 'the repair of the church'.⁵ Above the layer of loose chalk and tiles was a more compact layer containing loam and clay as well as smaller fragments of brick, tile, etc. Overlaying this was the bedding level for the concrete.

In the north-west corner of the hole dug by the workmen was the corner of the eastern of the two large buttresses added to the north-east corner of 'Gundulf's' tower. Only the very corner of the buttress had been exposed, but it was possible to trace this right down to its foundation. The south face of this buttress was masked by the angle of the cess-pit wall, while the southern side of the east face of the buttress was covered by the foundations of the brick north wall of the recently demolished toilets. The south-east angle of the buttress to 'Gundulf's' tower was made of large ashlar blocks of a yellow fine-grained sandstone (probably from the Hastings Beds of the lower Cretaceous).⁶ These had a 7 cm. wide vertical chamfer on the angle, and this ended at a rather damaged plain stop half-way down the

section. Below the block with a stop on it was a chamfered block (apparently made of Purbeck marble)⁷ and then one more course of fine masonry before the foundation of rough stones was reached. The foundation level was at least 20 cm. above the hard surface at the base of the hole (mentioned above as being possibly the c. late twelfth-century construction level). It must, therefore, be later than this.
