INTERIM REPORT ON WORK CARRIED OUT IN 1991 BY THE CANTERBURY ARCHAEOLOGICAL TRUST

I. EVALUATIONS

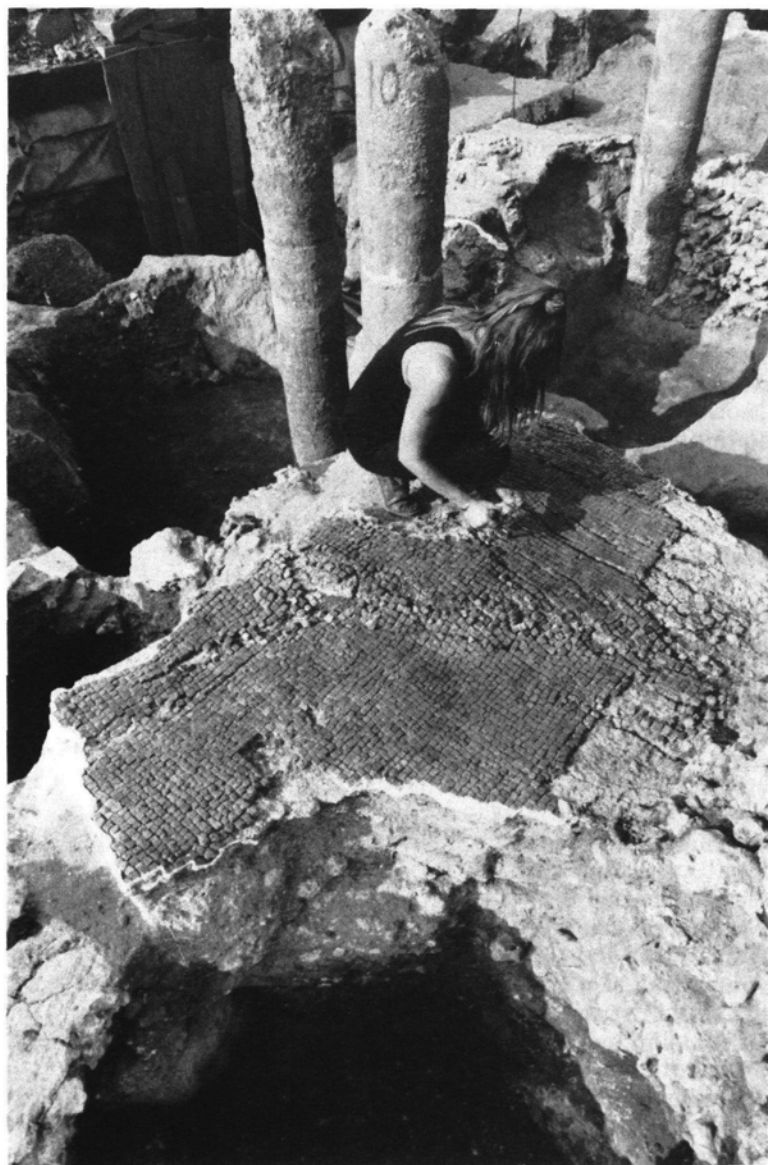
Longmarket, Canterbury: Detail of mosaic panel with geometric patterns. Looking north-east.

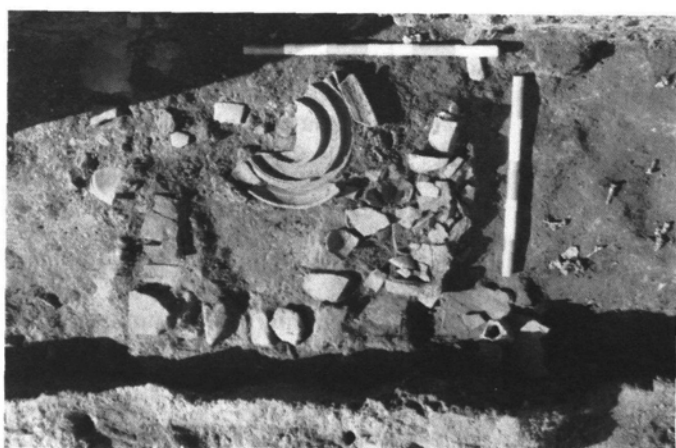
Longmarket, Canterbury: Above: Drawing of unusual Roman vessel from the Longmarket. Fine pink-buff ware. Late second to early third century. Scale: 1:4.
Below: Vessel *in situ* with other pottery on a hearth of burnt Roman kitchen.

The main building and lean-to were destroyed by fire in the late second or early third century. The fire had probably spread from one of the hearths. One hearth yielded a curious circular dish-like vessel which was found still lying where it had been abandoned (Pl. II).²⁰

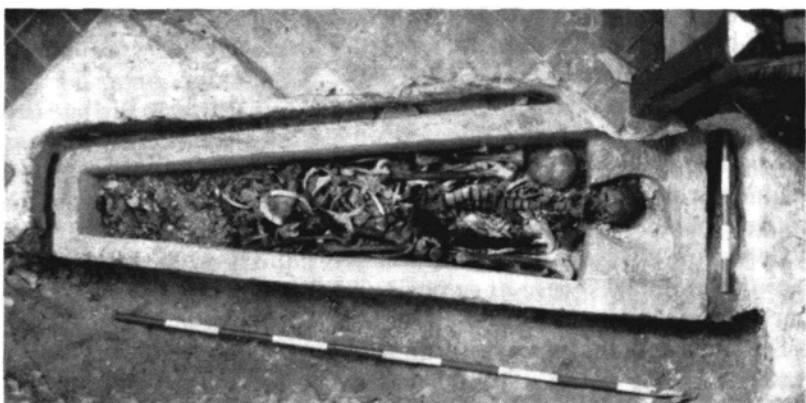
St. Nicholas Church, Thanington: General views of the stone coffin. Scales: 2 m. and 0.25 m.

The constructional details of the coffin and the decoration of the lid suggest that the primary burial may have been of fifteenth-century date. A date for the re-opening of the coffin was not established.
