INTERIM REPORT ON WORK CARRIED OUT IN 1992 BY THE CANTERBURY ARCHAEOLOGICAL TRUST*

I. EXCAVATIONS

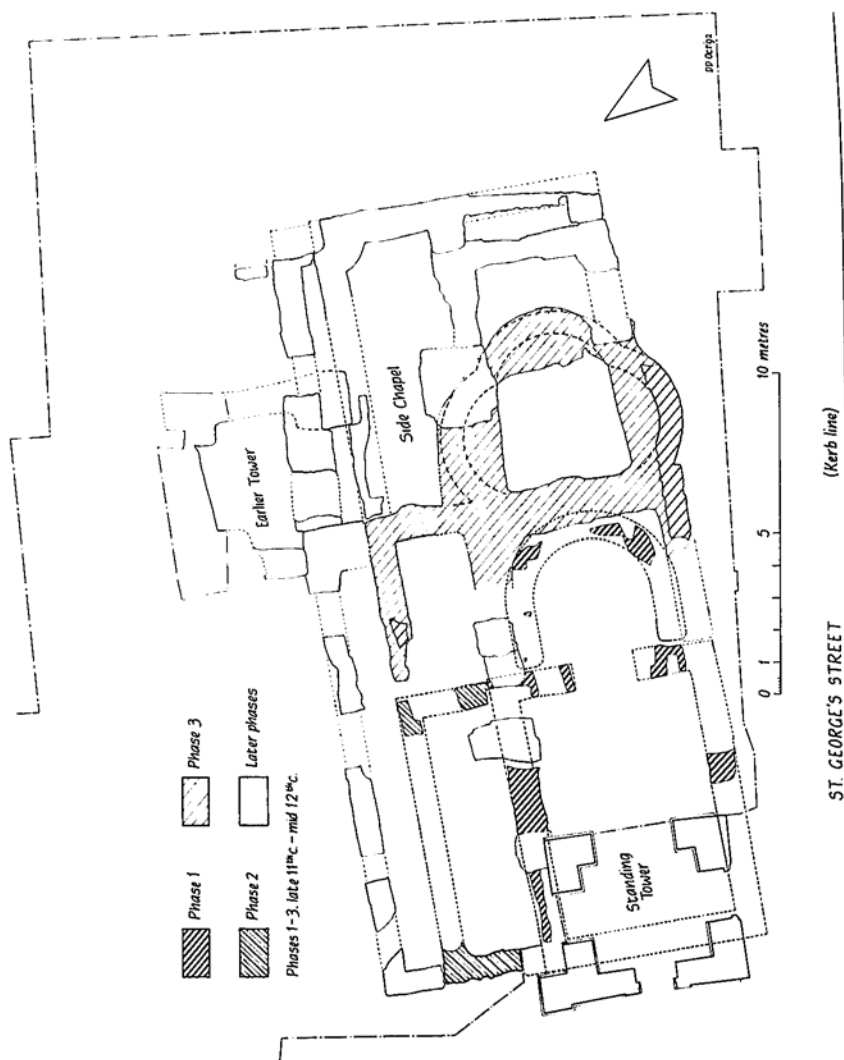
Fig. 1. St. George's Church: Plan.

The St. George's Street trench (Fig. 1)

The earliest feature uncovered was a length of truncated ditch of Iron Age or early Roman date. Above this a flint-and-tile surface was interpreted as a Roman courtyard, and traces of floors possibly associated with a Roman building were observed, mainly in the sides of later features. These were all sealed by a substantial deposit of dark soil. Between these and the first church levels were earth floors and other deposits dated by pottery to 1050–1200/1225, but little associated structural evidence.

The first church on the site was almost certainly of early Norman date. Five phases of building were identified by surviving foundations, the earliest of Anglo-Saxon tradition (Phases I and II); next, the curious 'trefoil' chancel and substantial foundations suggestive of post-Conquest date (Phase III); then, enlargement in the twelfth or thirteenth century (Phases IV–V); and, finally, in the medieval period the demolition of the northern tower and erection of the tower which stands today. Only two certain medieval burials survived Victorian rebuilding within the church, but a number of post-

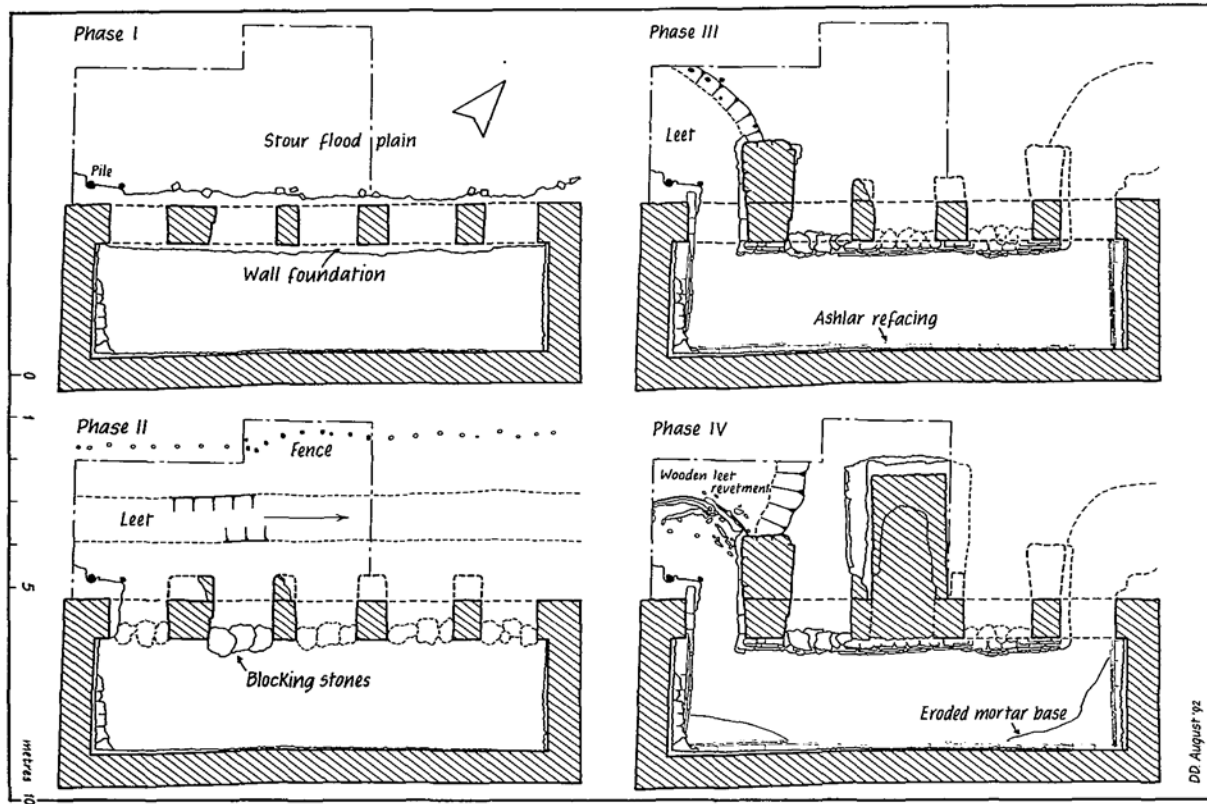
Fig. 2. St. John's Hospital: Plan.

4. St. John's Hospital Reredorter (Fig. 2)

The excavation trench was adjacent to the south-west wall of the standing building. The original south-west wall of the reredorter stood on a trench-built foundation pierced by five arches. The first structural adaptation identified was made to arch 2, probably early in the thirteenth century in an attempt to improve drainage from the cess tank. Shortly after this (perhaps in the later thirteenth or early fourteenth century) the cess tank was completely relined, a new buttress was constructed between arches 1 and 2 (possibly to counteract subsidence) and a new leat was cut. The next modification to the building was the addition of a further more massive buttress which successfully prevented further subsidence. Ceramic material gave the buttress a late medieval date (1375–1500).

Apparently, no formal arrangement was made for the drainage of effluent from the original building, beyond the construction of the five arches within the south-west wall. Drainage must have been achieved by seepage and by intermittent irrigation through river flooding. However, the constantly rising land surface between the reredorter and the river eventually made this form of drainage

ineffective and the first leat to aid drainage was cut sometime before the first structural modification, in the early thirteenth century. Consequent layers of silts, domestic rubbish and river flood debris suggest that these early attempts at drainage were not entirely successful. A new leat was cut around the same time as the construction of the massive buttress (1375–1500), and this seems to have functioned, with several recuts and revetments, until about 1700. The redundant leats appear to have remained an obvious landscape feature until at least the late nineteenth century. Deposits within the cess tank suggest that the reredorter remained in use after this date. The reredorter was eventually connected to the main sewer in the mid nineteenth century; it continued in use until c. 1948.

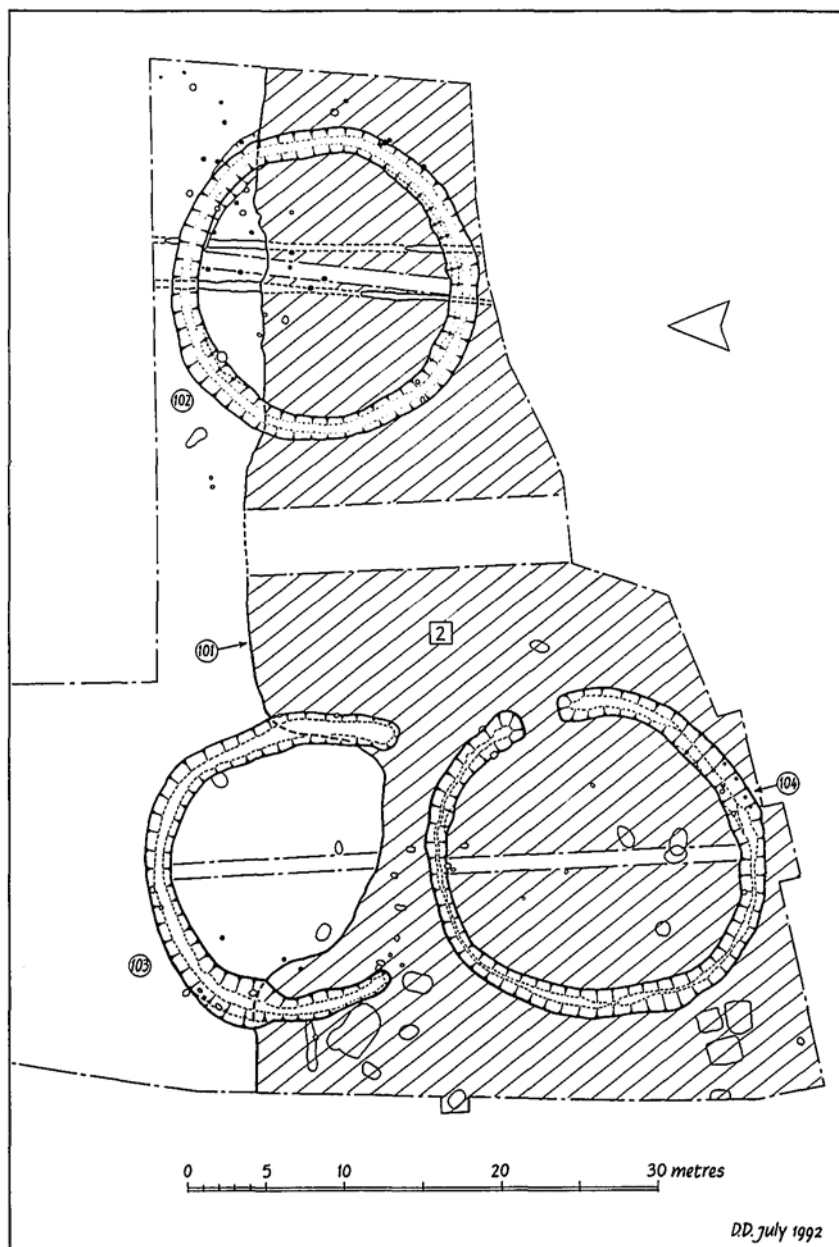
Fig. 3. Folkestone, ring ditches: Plan.

6. Castle Hill, Folkestone (Fig. 3)

Two ring ditches (104 and 102) were identified as possibly of Late Neolithic or Early Bronze Age date, and almost certainly represented burial mounds.

The third ditch (Ring ditch 103) formed a horseshoe-shaped sub-square enclosure. Its spatial relationship with Ditch 104 probably indicated a later date, but it is not yet possible to indicate the precise chronological relationship between this ring ditch and the others. No trace of a burial was located.

A complete absence of mound material made it impossible to determine the form of any of the barrows, but the most common type, the bowl barrow, appears likely, with external banks almost certainly present in the case of barrows 104 and 102.

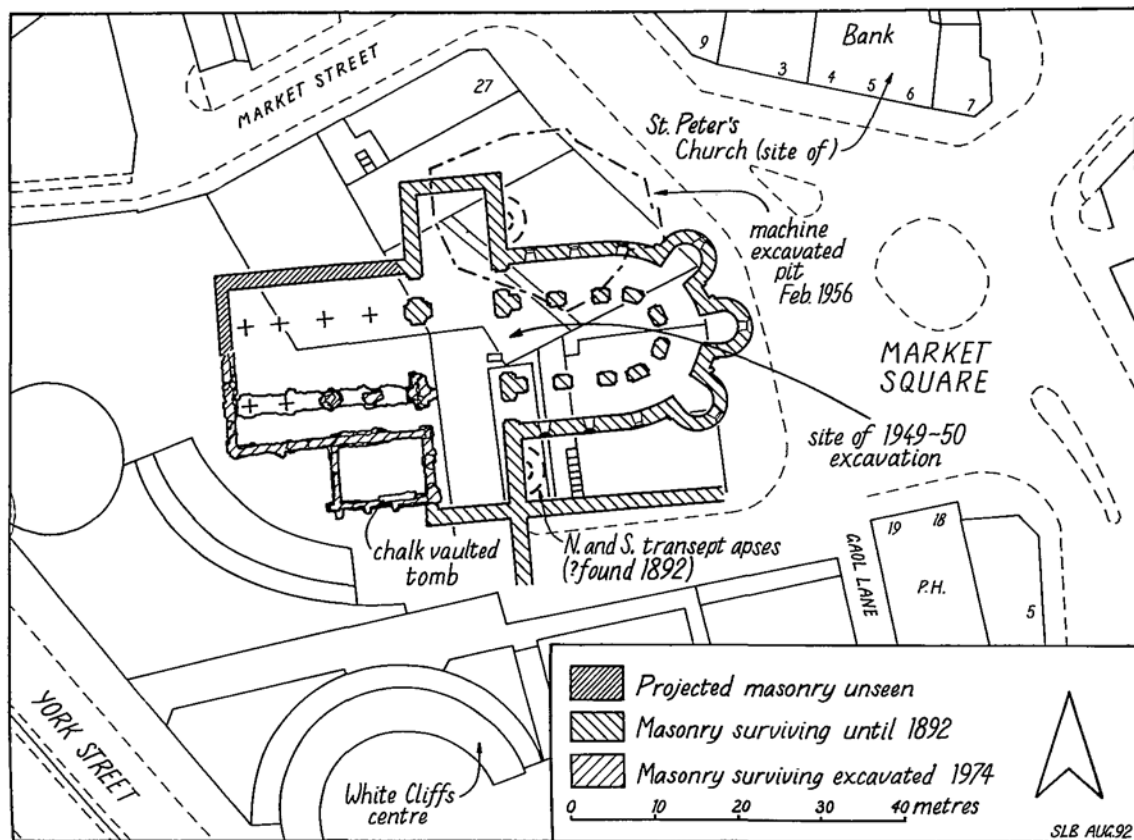
Fig. 4. St. Martin-le-Grand, Dover: Plan.

7. St. Martin-le-Grand, Dover (Fig. 4)

During excavations in 1974¹⁸ in a chapel attached to the south transept of the church of St. Martin-le-Grand in Market Square, Dover, three chalk tombs were uncovered. These, together with substantial remains of the church, were left exposed and are currently

visible north-east of the White Cliffs Experience centre. At the request of English Heritage the Trust was commissioned to make a detailed photographic and drawn record of the surviving remains in preparation for emergency repairs to the fabric of the tombs. The work began in November 1991 and continued intermittently (as access was available) until the spring of 1992. At the beginning of May the poorly preserved remains of a single skeleton were recorded and excavated from one of the tombs. The remains were removed to allow conservation of the tomb to take place and the opportunity was taken to examine the skeleton.¹⁹ The skeleton will be replaced in the tomb once restoration of the tomb is complete.

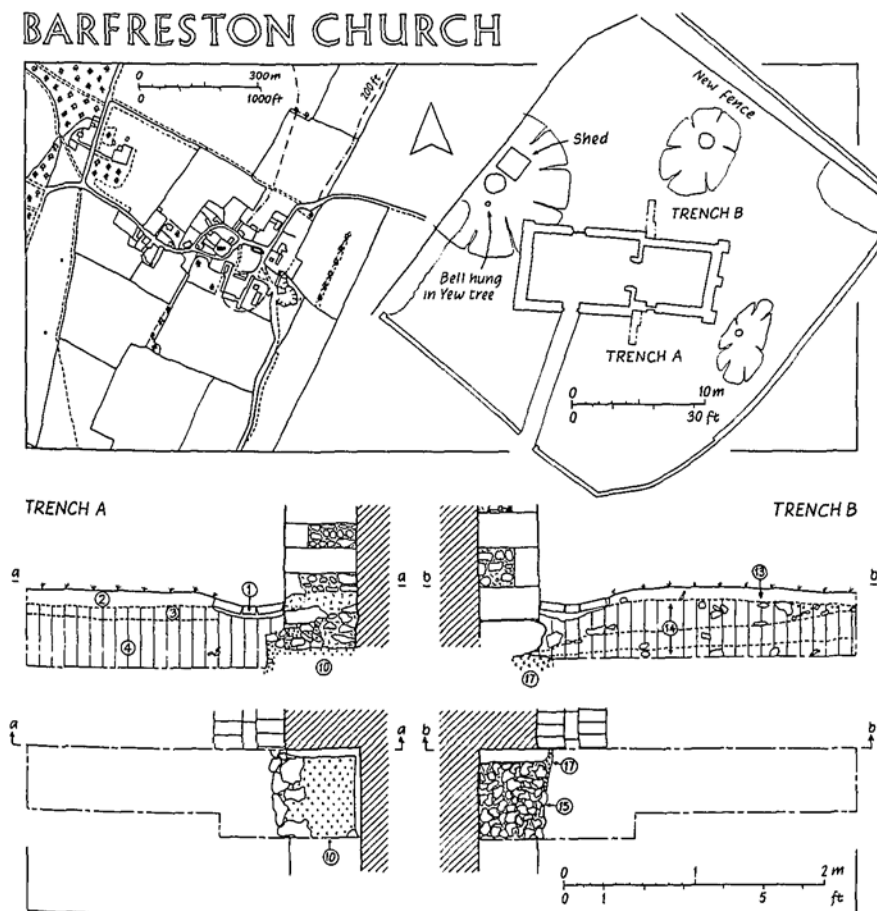
Fig. 5. Barfreston Church: Plan and Sections.

1. Barfreston Church (Fig. 5)

As part of drainage improvement works at Barfreston Church in May 1991, the opportunity was taken to examine and record the early footings of the church. Two small trenches were excavated, one on each side of the church at the junction of nave and chancel. In the southern trench evidence for nineteenth-century restoration work²² was also revealed and a sequence of cemetery deposits was observed, but not excavated. A plan was made of the church and churchyard.

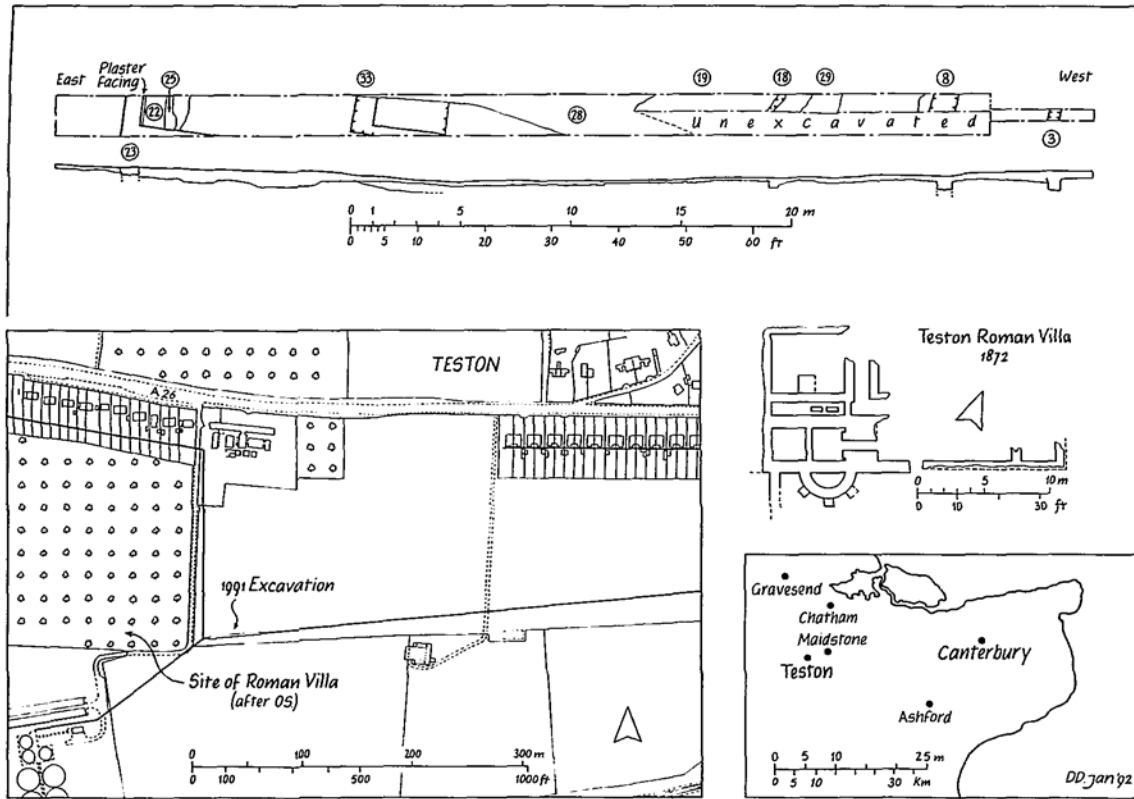
Fig. 6. Teston Roman villa: Plan.

6. Teston Roman Villa, Maidstone (Fig. 6)

Archaeological deposits and features existed over a 40 m. length of proposed pipe run, representing parts of a substantial Roman masonry building. The recovered foundations included parts of a possible corridor or portico with mortar floor, a courtyard and at least one *opus signinum* floor sealed by an undisturbed roof collapse. Although the remains can be interpreted as a single structure, it is more likely that, together with the remains discovered in 1872, they form part of a complex of interlinked ranges for a villa.²⁷ The entire corpus of ceramics recovered during the 1991 investigation spanned the period from the second to the fourth centuries A.D.

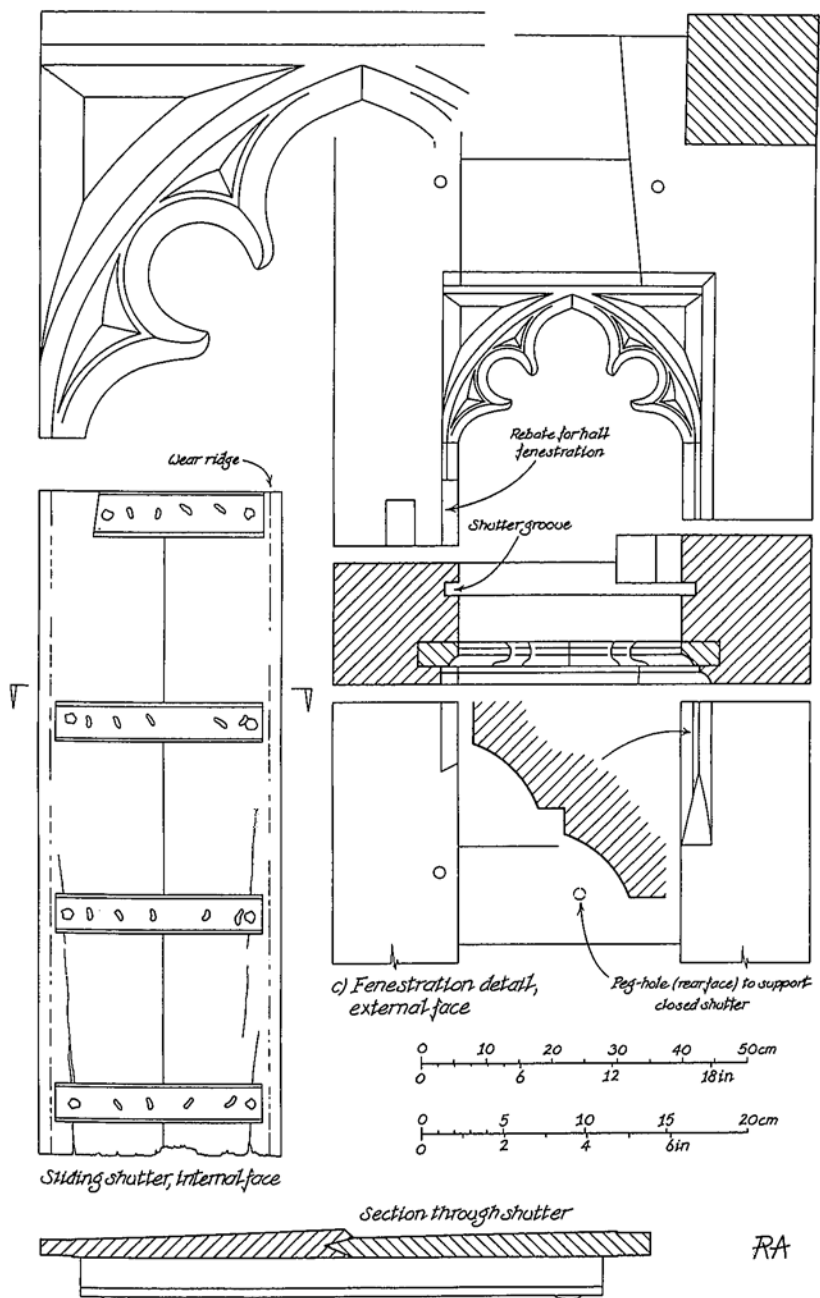
Fig. 7. Nos. 4 and 5 Best Lane, Canterbury: Fenestration and shutter detail.

Although previously thought to have been of two or possibly three phases, the structure appeared to be of one build surviving as a 'half Wealden'.

Very little survives of the hall, though several interesting features remain. A two-storey bay adjoining the hall is relatively well preserved. The stairs were not situated within this jettied bay (as would be expected), but a stair well seems to have been incorporated into the rear of the hall. A framed wall, incorporating a moulded beam and doorway, creates a partition for these stairs approximately 4 ft. wide. This arrangement was later replaced by an inserted stack at the rear of the hall.
