ROCHESTER CATHEDRAL: THE NORTH CHOIR AISLE AND THE SPACE BETWEEN IT AND 'GUNDULF'S' TOWER

J. PHILIP McALEER

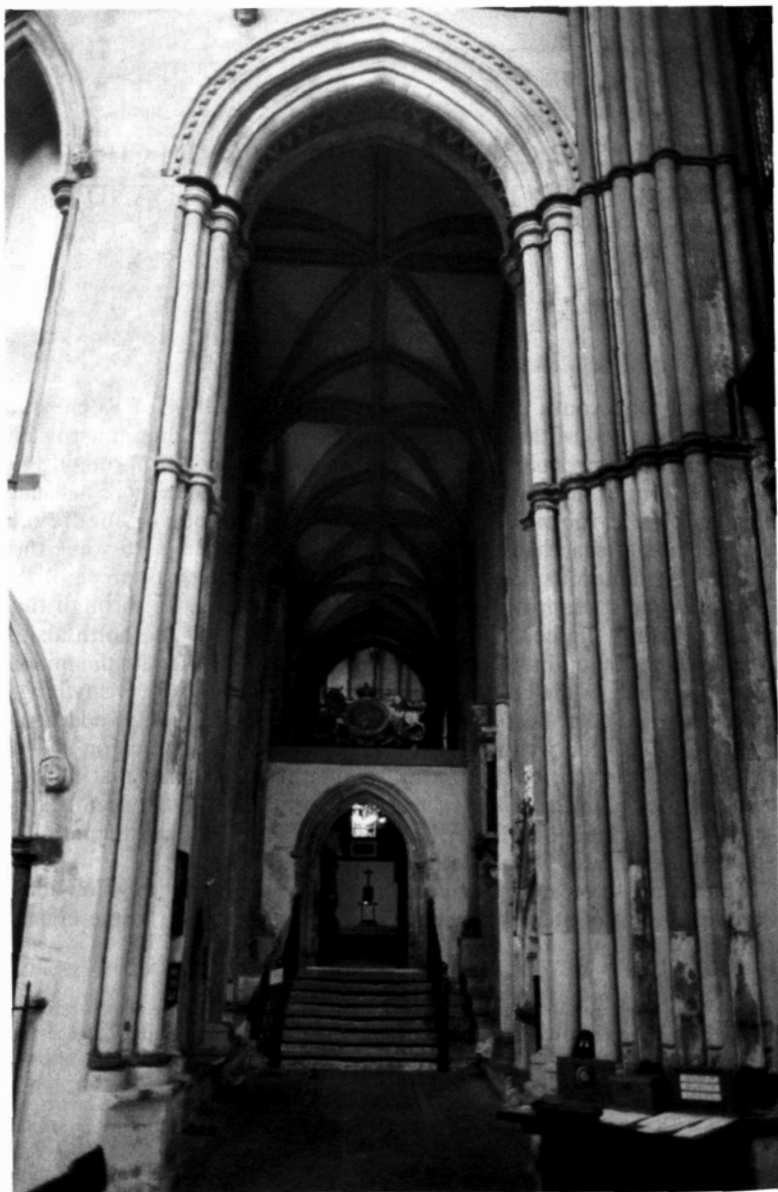
North choir aisle, general view to east (*author*).

The aisle is basically a narrow corridor (Plate IA), its most obvious feature a flight of steps halfway in its length leading up to the higher

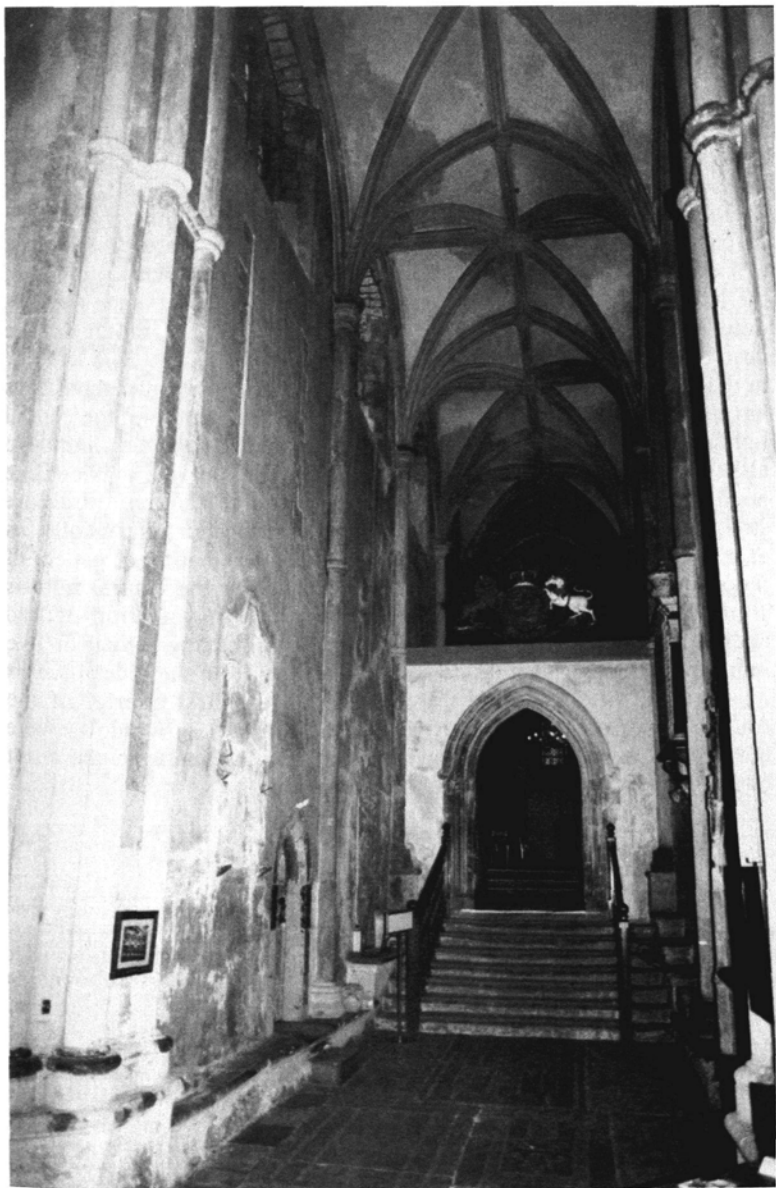
North choir aisle, north wall (*author*).

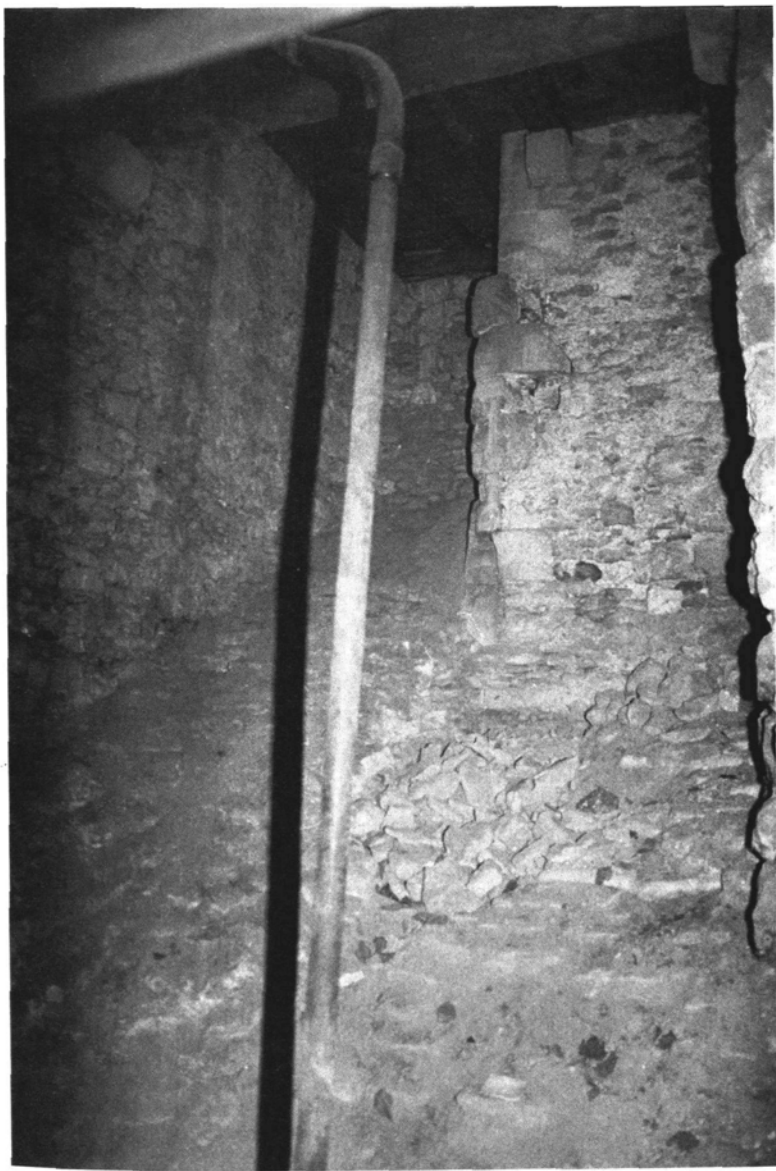
Space between north choir aisle wall and north tower as it now exists (facing west) (cf. *Arch. Journ.*, lxxxvi [1929], Pl. II) (*author*).

the two levels of the aisle.⁹ This debris slopes up higher at the west end of the space, rising against the east wall of the major transept's north arm (Plates IVA, B).¹⁰ This side of the wall, and its earlier history, have been briefly written about by W.H. St. J. Hope, and more extensively examined by F.H. Fairweather.¹¹

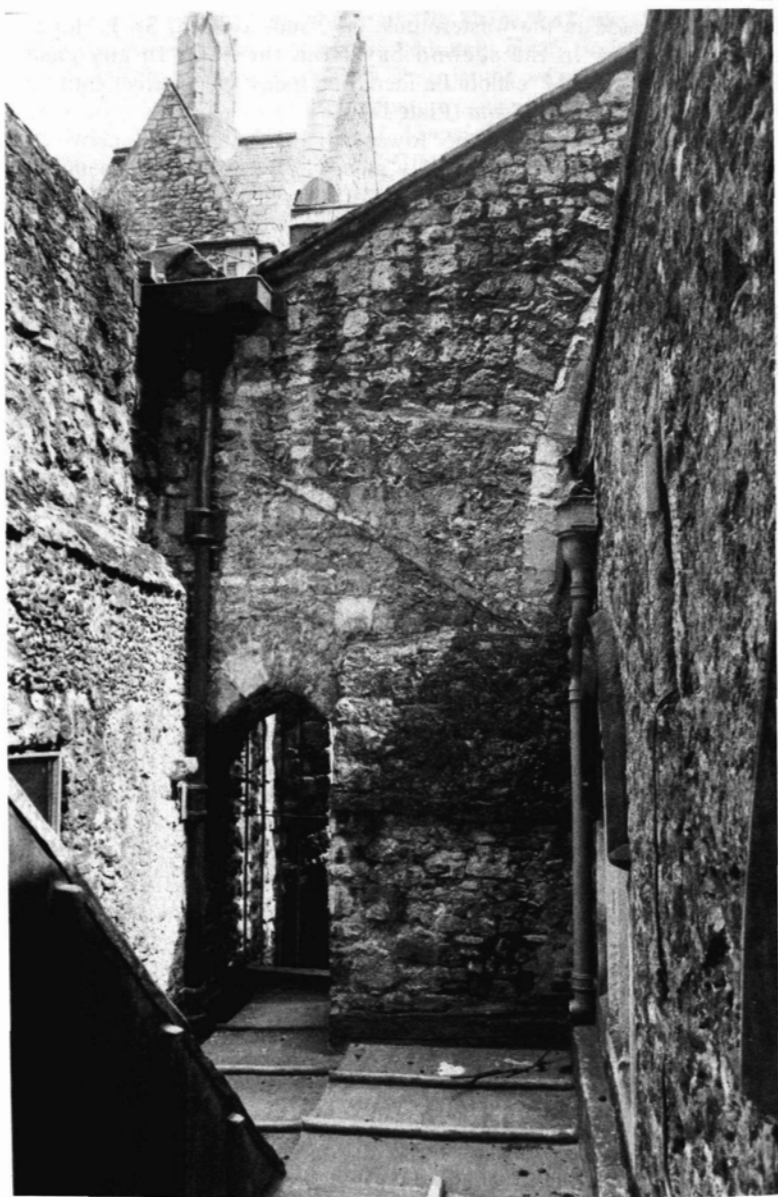
Space between tower and north aisle wall at clerestory level, facing east (*author*).

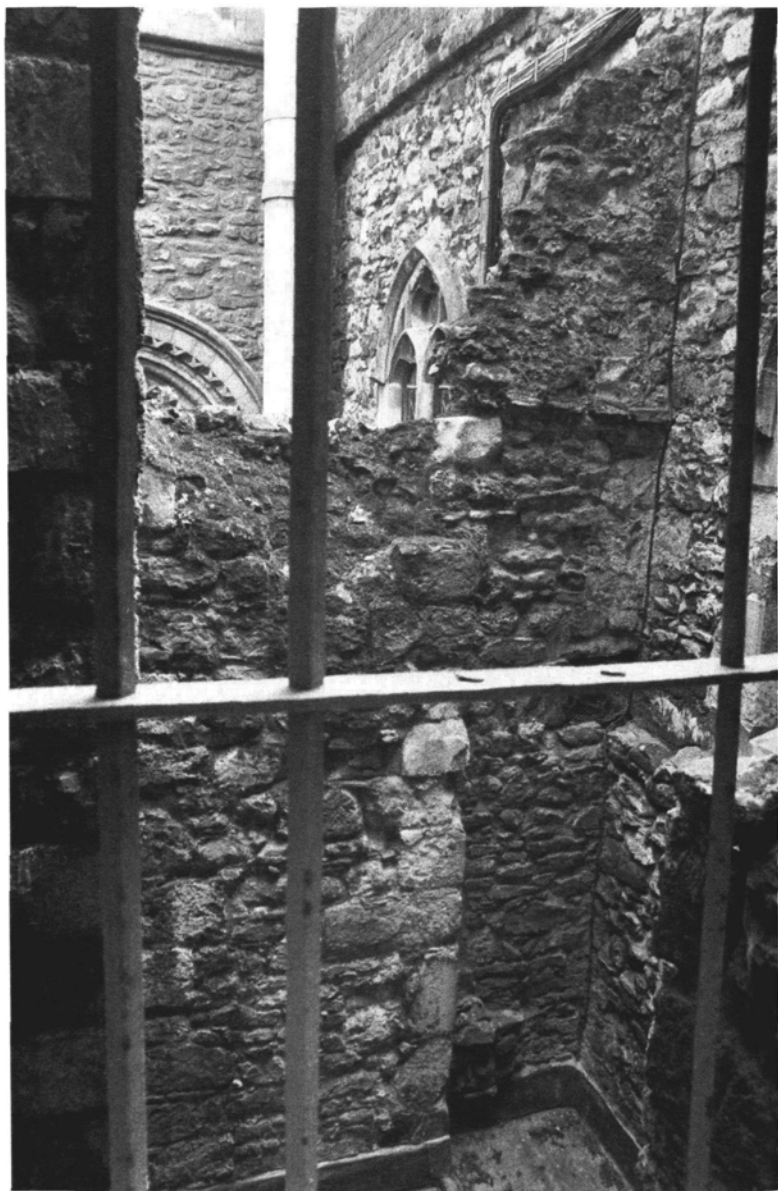
Buttress and screen wall between tower and north aisle wall, viewed from west (*author*).

At the same time the wall was refaced, for it appears to course in with the facing, a thin wall was erected between the aisle wall and a large pier buttress, which had been earlier erected against the south face of the south-east angle buttress of Gundulf's Tower (Plate VIIA),²⁹ thus effectively creating a narrow space between the tower and aisle separate from the larger courtyard-like area between the north side of the tower and the west wall of the minor transept's north arm.
