ST MARY'S ABBEY, WEST MALLING

ALAN WARD

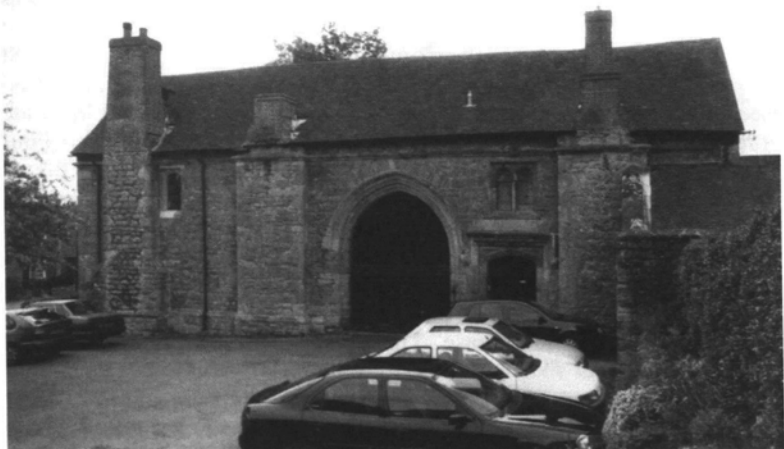
PLATE II

The Gatehouse looking east. Note the difference in the coursing of the stonework of the northern chimney-stack from those to the south and how the upper string-course extends to the south of the modern garden wall.

The ragstone of the northern chimney-stack is not bonded to the main wall and in addition can be seen to be coursed less neatly (Plate II). That it represents a further structural phase than the other stacks is shown not only by the difference in stonework but also by the fact that the upper string course does not go around the stack and that the lower, whilst present at the front, is absent on each side. The latter suggests that there was not enough of the chamfered stone (now being reused) to go all the way around when rebuilding took place. Further support for this chimney-stack being a later addition is provided by the fact that it partially blocks the view from the northern window at first floor level. If of the same phase one or other of these features would have been sighted in a different position. Repairs to this window suggest that the northern half was destroyed on insertion of the chimney. If (as seems probable) of two lights, rather than the one now visible, it would have formed a twin with that above the door.¹¹

range was situated along the line of the modern garden wall and pedestrian gate giving entry into the precinct. However, the 1823 print shows that the string-courses were (unsurprisingly) in existence by that date. Plate II shows that the upper string-course extends to the south of the present garden wall. On internal examination of the building a small length of the lower string-course was also found to the south of this line. A decorative feature such as this would not be covered by a structure, nor indeed would the ashlar wall face. The earlier range must therefore have been situated further to the south and its northern wall was probably in line with the brick gable forming the present south end of the gatehouse. The demolition of this range would have occurred some time in the mid or late nineteenth century. No doubt detailed documentary research would give a more exact date. The brick gable, outhouse and garden wall were all presumably constructed soon after this demolition.

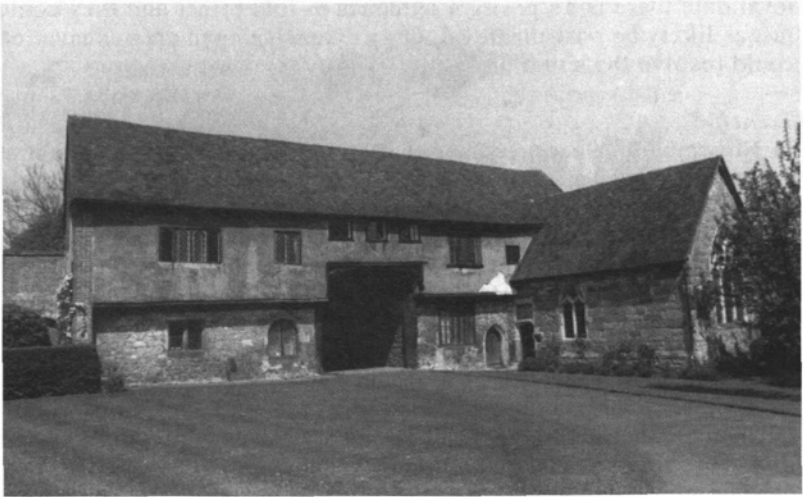
The rear of the Gatehouse looking west with the chapel of St Thomas of Canterbury on the north.

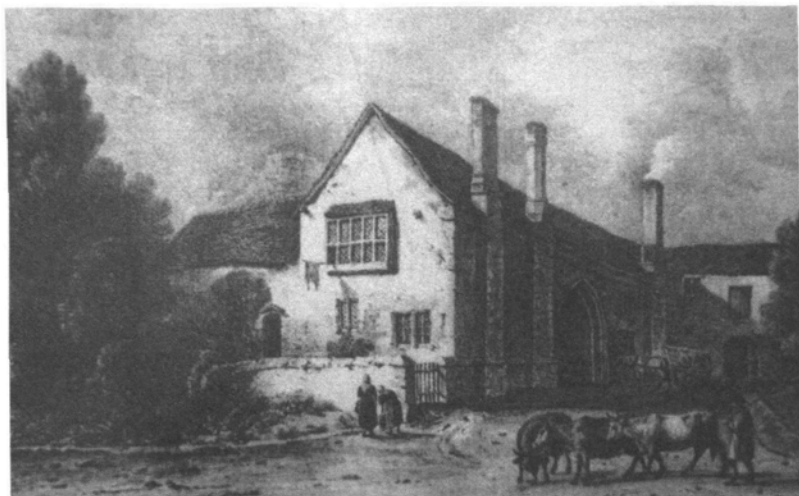
Print dated to 1823. Note the Romanesque arch of the south range and the door still in use in the north wall of the former chapel.

It must be emphasised that no positive physical evidence was seen for the *conjectured* earliest phase. The presence of this phase is based first upon the fact that it seems highly unlikely that there were no buildings in the area before construction of the fourteenth-century chapel. A print of 1823 shows a building forming a range extending to the west of the gatehouse (**Plate IV**). This building has a large door with a round-headed arch that suggests a date prior to c.1200.² The east wall of this structure almost certainly aligned with the west wall of the still standing gatehouse. Secondly an early structural phase is

above (Plate IV). The stripping of plaster within the chapel revealed the inside of this blocked door. A further blocked window is visible internally and has been cut by one of later date. The westernmost surviving window in the north wall is a relatively modern feature.

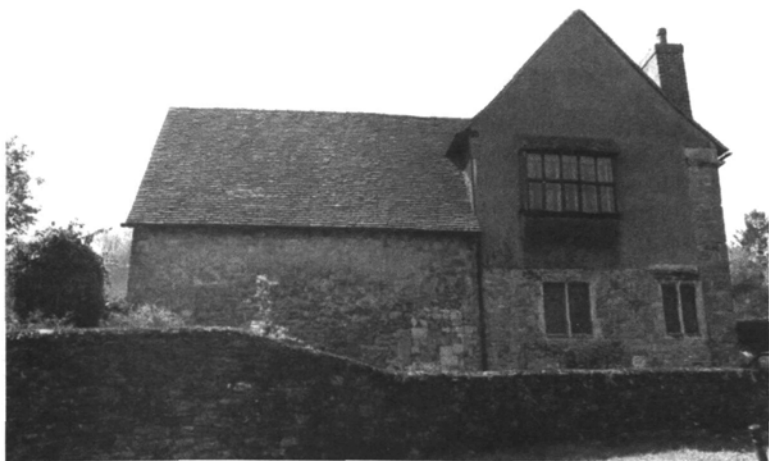
North wall of the chapel showing the blocked door.

Externally the eastern 3.50m of the north wall of the chapel remains unaltered, but thereafter the wall is a 'hotchpotch' of alterations and rebuilding (**Plate V**). A blocked north doorway has cut an earlier blocked window. So called 'salt and pepper' mortar bonds the stone blocking of this door. This grey coloured mortar probably derives its hue from the large quantity of ash within its matrix, charcoal flecks are also prominent. This mortar with its distinctive colour and texture has been dated to about 1750 and carries on into the nineteenth century. In this period the structure was apparently used as a meeting house and later as a carpenter's shop and accommodation.⁶ The door was still in use in 1823 when it was shown on the print mentioned

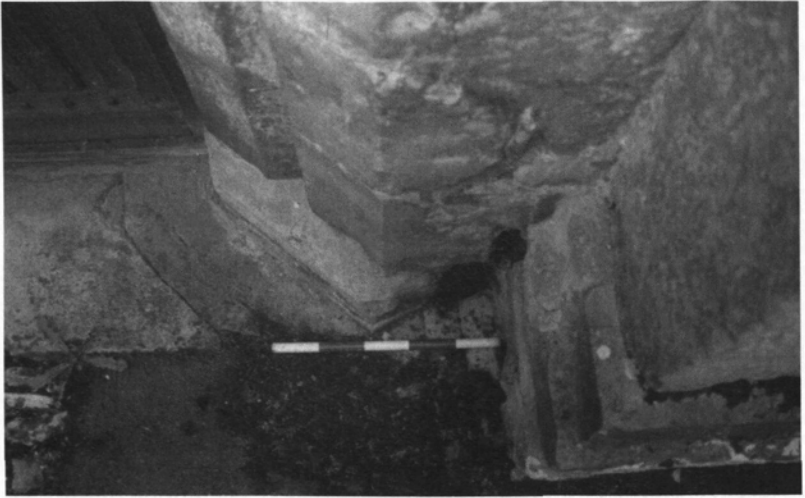
Damage to the south jamb of the door, almost certainly due to the insertion of the southern chimney.

block at ground level; the ragstone of the stacks and wall face is of different colours; there is a definite cut through the base of the door-jamb. For the latter no other discernible reason for the damage other than the chimney-stack being inserted can be observed or deduced. Indeed the position of the damage (at present ground level and below) makes it extremely difficult to create such damage other than by the insertion of the stack. If the stack and wall are contemporary it is also difficult to believe that damage would occur only to the jamb, the stack would have been damaged as well. To ignore such observations and the most obvious consequent deductions would be the height of archaeological folly. Whether the lapse in time between construction of gatehouse and construction of the stacks is very great is a different point entirely. The time lapse may only be a matter of months, weeks or even days. The overall neatness of the string-courses in relation to the stacks and wall face would suggest the time period is very short, but to give emphasis to this afterthought the chimneys are shown in Fig. 5 as a sub-phase.

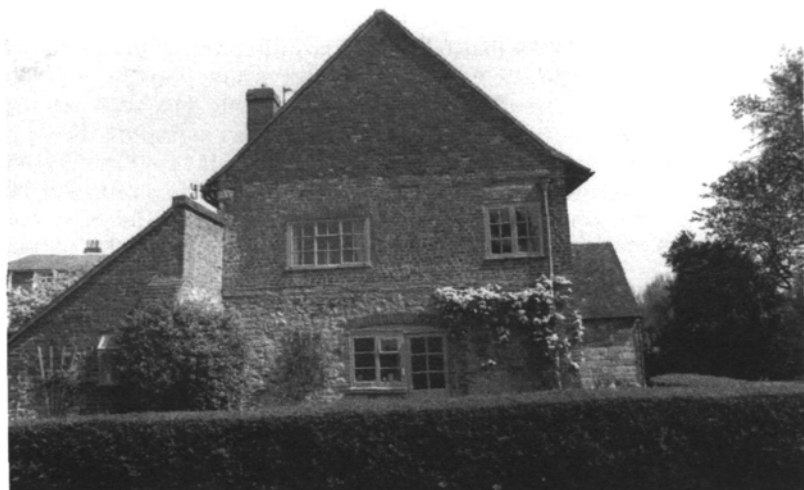
The south wall of the Gatehouse looking north. Note how the stonework of the ground floor curves over the brickwork of the window; there is no sign of the latter being inserted into an earlier wall.

Although the lower storey of the south wall is made from stone it can be seen that it is of one phase with the brick surround of the window. The stone work curves over the shallow arch showing no sign of insertion (**Plate VII**). There is also a butt joint between this wall and the rear wall of the gatehouse showing that they are not contemporary. Both of these factors, along with the evidence stated above, show that the original wall line was not in this position. As a wall could not have existed to the north (i.e. within the building) it must have been to the south. The existence of another room, or rooms, to the south of the standing gatehouse is assured and its suggested approximate position is shown on Fig. 3.
