WESTENHANGER CASTLE - A REVISED INTERPRETATION

DAVID AND BARBARA MARTIN

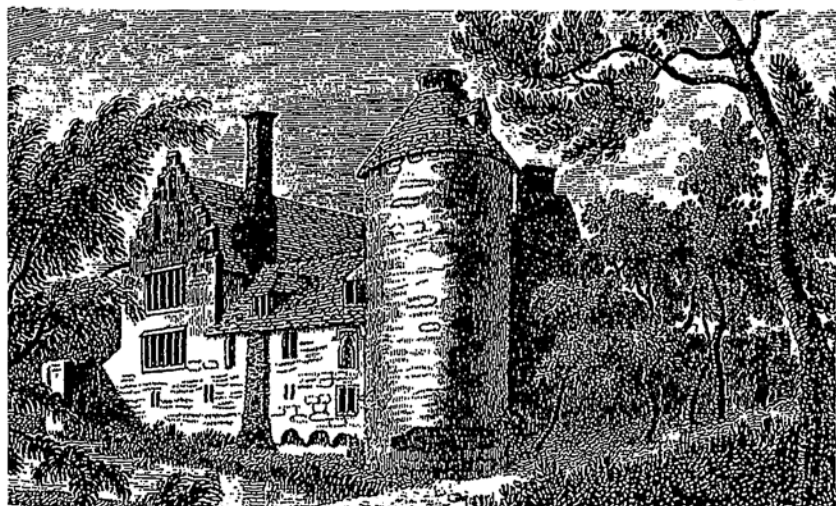
PLATE II

Detail from an engraving showing the house and north-eastern tower viewed from the north-east. Engraving by Godfrey Sculp dated 6 December 1777; published 25 August 1784 by S. Hooper

show detail in this area, but there are extant drawings made before the third storey was removed (see Plate II). By combining the standing remains and the documentary sources it is possible to gain an impression of the crosswing. From what remains it seems safe to conclude that the crosswing was entirely rebuilt during phase 3. The south wall was again rebuilt in the eighteenth century when this wall became the front façade of the new sized-down house, at which date the western end of the range was completely destroyed.

The early illustrations (the best an engraving by Godfrey Sculp dated 6 December 1773 - see Plate II) make it clear that the six-light stone window in the east wall was replicated on the storey above and that this second-floor chamber was also heated. Above was a steeply-pitched crow-stepped gable incorporating two tiers of single-light openings with arched heads, two on the lower tier and one in the apex.

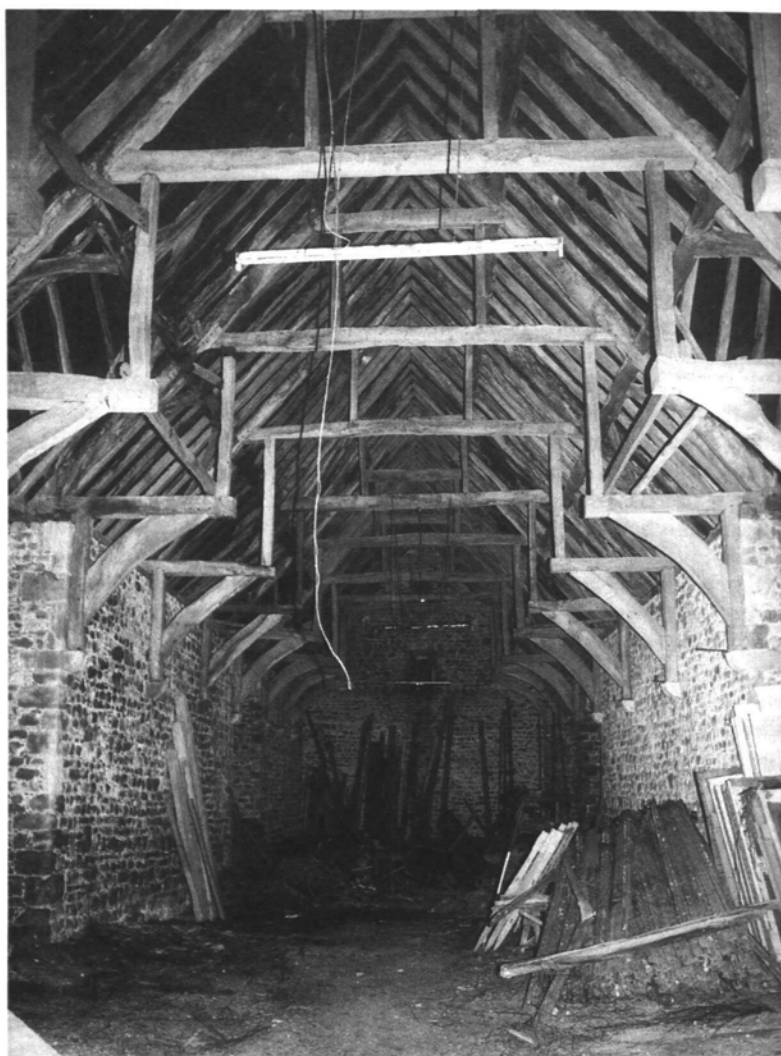
Interior of barn looking north
