THE FOURTEENTH-CENTURY MERCHANT SHIP FROM SANDWICH: A STUDY IN MEDIEVAL MARITIME ARCHAEOLOGY

GUSTAV MILNE

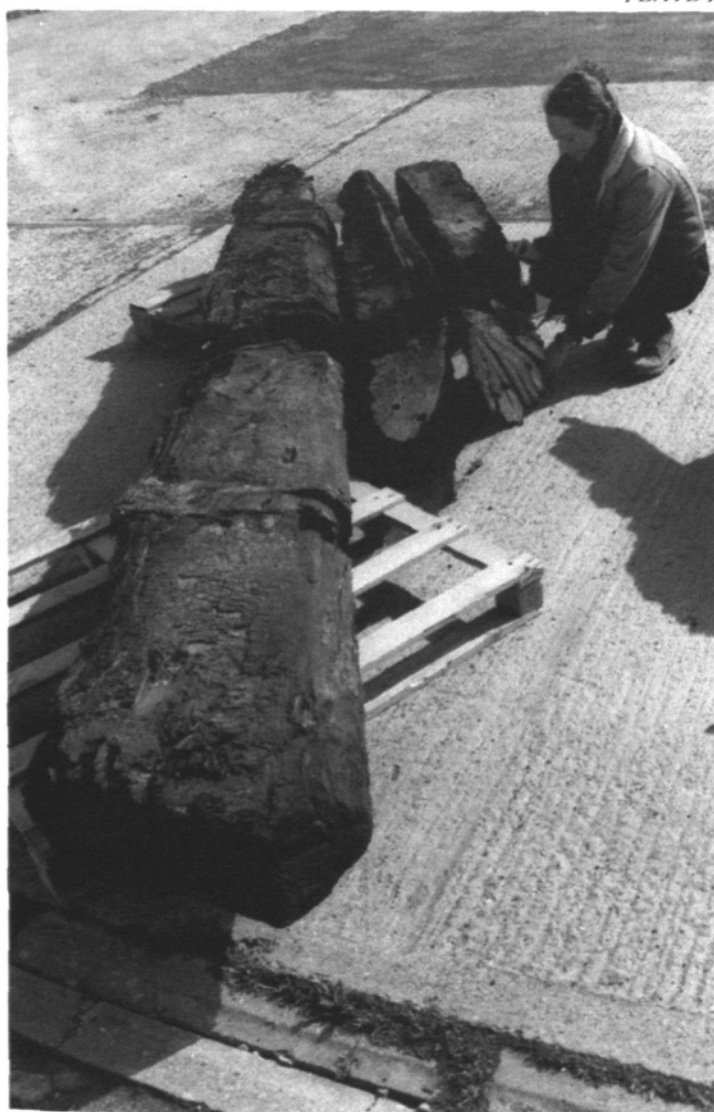
Medieval Sandwich Ship: showing rudder and sternpost being recorded in 1999 (photo S. Miller)

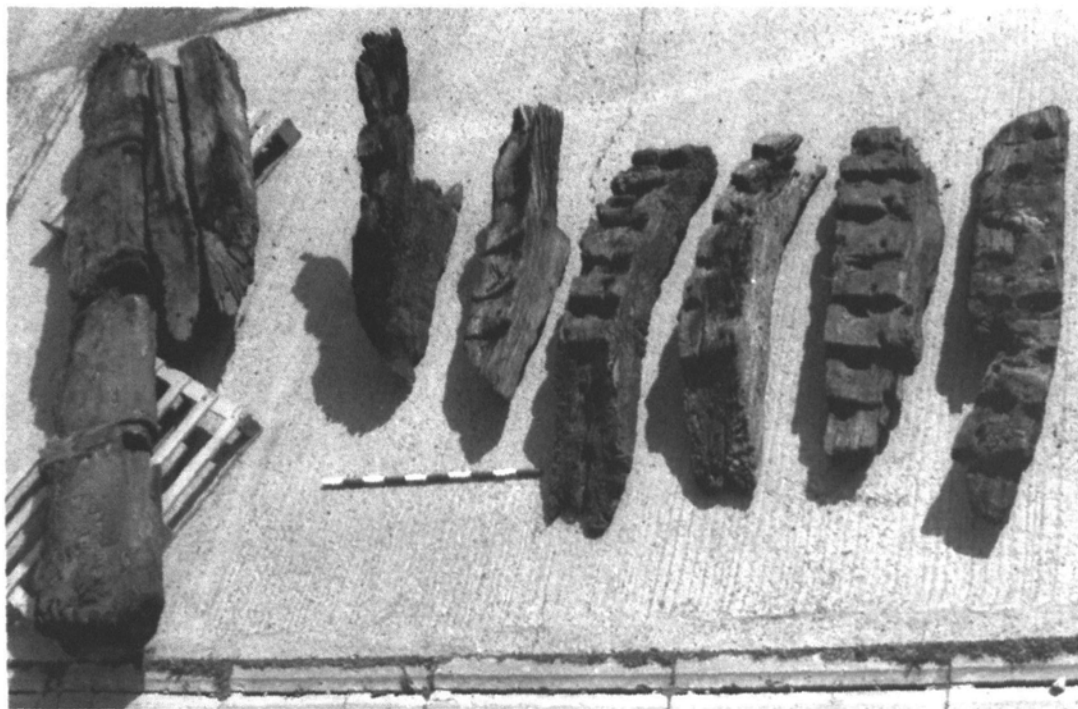
Medieval Sandwich Ship: recorded in 1999, showing rudder, stern post, floor timber and futtocks set out in what may have been their general positions within the ship structure (photo S. Miller)

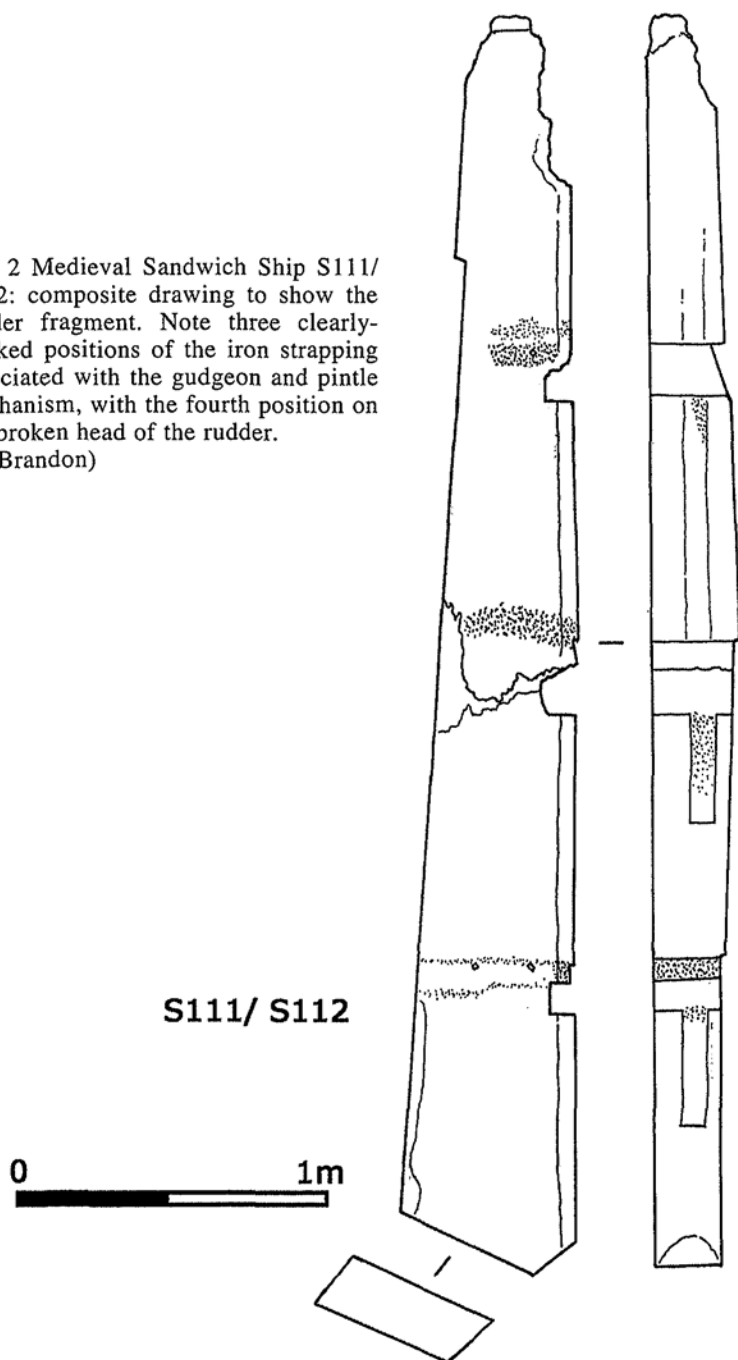
Rudder (Fig. 2)

Fig. 2 Medieval Sandwich Ship S111/
S112: composite drawing to show the
rudder fragment. Note three clearly-
marked positions of the iron strapping
associated with the gudgeon and pintle
mechanism, with the fourth position on
the broken head of the rudder.
(K. Brandon)

The most impressive piece is the rudder [S111 & S112], the first of the ship timbers to be pulled from the trench in 1973. Apart from damage to its aftermost edge and the loss of its topmost section, it was extremely well preserved. It is in two pieces that when fitted together represent the forward part of a rudder with a length of 13ft 5in. (4.1m) from the iron-shod sole. According to Dr Jon Hather, the rudder had been converted from a halved log taken from a tree with complacent rings and low branches: in other words, two broadly identical rudders could have been fashioned from the same log.

Some 0.36m above the rudder base there were two nail holes, 6mm square which contained a hard black substance. Set 0.46m above that was an articulated iron pintle and gudgeon (the pivot mechanism that allowed the rudder to turn) although this subsequently became detached (Fig. 3). Rebates set into the spine of the rudder housed the pintles to ensure that the rudder could not be unshipped by accident. Indeed, the depth of the rebates implies that the strapwork would have been added to the rudder as it was being hung.

The scars and housings for three more such fastenings were recorded, the second set being 0.96m from the first, where a transverse break occurs; the third 1.05m from the second, and the last is clearly defined but in the fragmented head 0.95m above the third. It is not known if the higher iron straps were removed for recycling in antiquity, although it is certainly a possibility, with just the lowest ironwork surviving through its inaccessibility below the contemporary water level.

The form of the rudder is of crucial importance to any evaluation of the parent vessel. Assuming that the spacing of the straps was consistently set at *c.*1m intervals, for example, it is possible to suggest that the complete rudder was some 5m in length, a figure that relates directly of the size and draught of the ship. Again, the angle of the base of the rudder clearly shows that the raked sternpost would have risen at an angle of between *c.*110 and 117° to the keel.

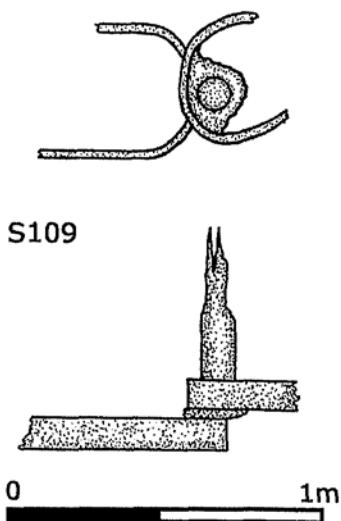
Fig. 3 Medieval Sandwich Ship S109: iron gudgeon and pintle fragment, now detached, but originally found attached to the bottom of the rudder. (K. Brandon)

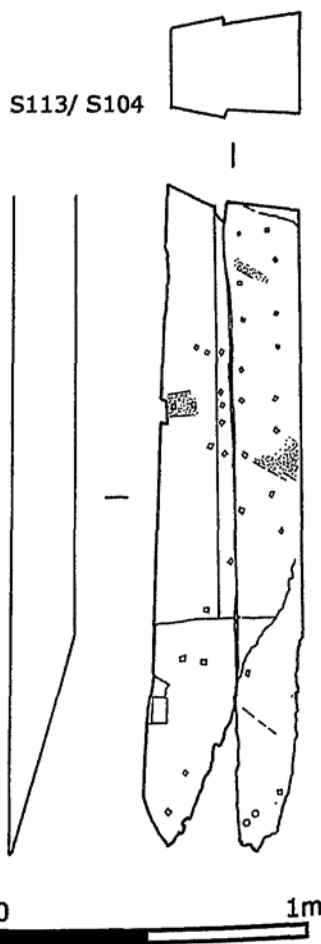
Sternpost (Fig. 4)

Fig. 4 Medieval Sandwich Ship: S104/113: stern post fragment, head broken off, with scarf joint at foot to accept additional timber and rebate in edge to take ends of clinker-laid hull planking (note associated nails and scars from rising lines of plank strakes). (K. Brandon)

The 7ft 3in. (2.21m) length of the sternpost was recovered in two separate pieces split in half down the rebate line [S113]. It would seem that this substantial fragment represents the truncated upper section of the stern post which would have been scarfed to a similar-sized timber that would in turn have articulated with the keel. On the after face of the surviving element were two marks incised for the acceptance of the gudgeons; these were 1.05m apart, the same distance that separ-

ated the second and third strap marks on the rudder (see above). Its lower end was cut for a flat scarf 0.8m long which had been fixed with eight spikes 125mm long by 15mm square in two rows, one driven from each side of the scarf, and a treenail running through the centre.

The stern post had been in good condition and two plank fragments remained firmly in place on the post until removed for safety. These fragments were 3.10m from the baseline of the rudder and consisted of a plank overlap. The lower plank was set at an angle of 9.5° to the centreline of the vessel, the upper was set at 12° to the centreline. This gives a vessel of very fine exit at a considerable height above the keel.

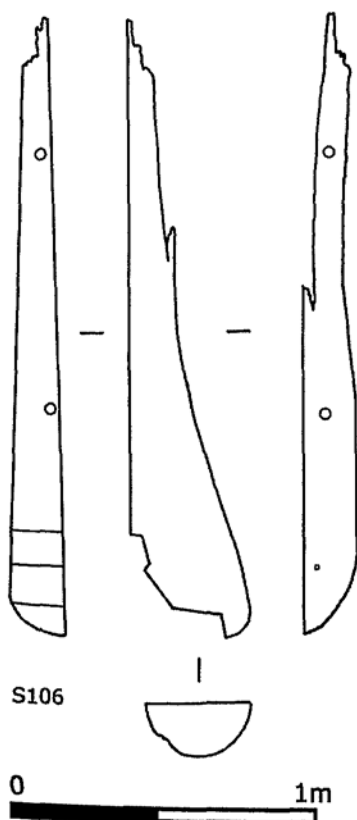
Fig. 5 Medieval Sandwich Ship: S106 timber, perhaps derived from junction of keel and stern post, with head broken although rebates on foot in tact. (K. Brandon)

had clearly articulated in antiquity, providing a significant insight into the structure of the vessel (see e. g. Fig. 12), and it is possible that the otherwise disarticulated fragment [S106: Fig. 5] may also be associated with the stern assembly.

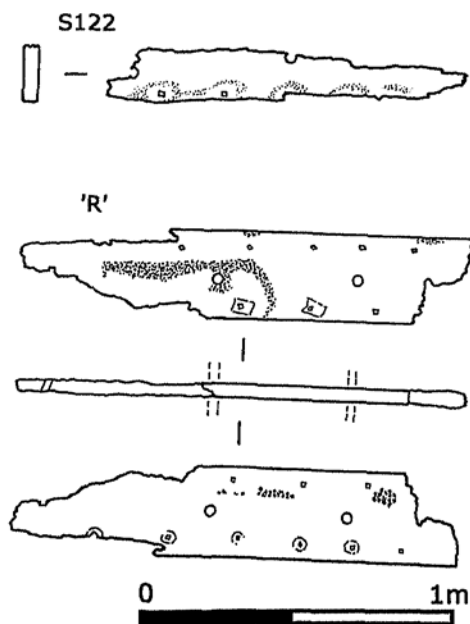
Planks (Fig. 6)

Fig. 6 Medieval Sandwich Ship: plank fragments (K. Brandon).

(a) 'R' a re-drawing of a fragment recorded at Deal Maritime Museum to show marks of circular nail heads (outboard) and diamond-shaped roves (inboard) impressed into the wood; close spacing of the clenched-nail holes used to join the runs of planking; three widely-spaced treenail holes representing the spacing of the framing of the ship. (b) S122: last surviving plank fragment, both ends and both edges badly damaged (i.e. obviously not full width), recorded in 1999.

Twenty-five fragments were recorded in 1973. According to Varrel, the planking appeared to have been riven and was approximately 0.30m wide and some 40-60mm thick. These general measurements are confirmed by Honey, who recorded that the plank fragments varied in length from 0.23-1.98m (9in. to 6ft 6in.), and in width from 0.08-0.31m (3¼in. to 1ft). However, only two of these pieces retained their original full width, which was 0.29m and 0.305m (11½in. and 1ft respectively).

The maximum plank *thickness* measured on the Sandwich Ship was recorded across the middle of the planks, since each one had been dubbed off on its inner upper face to lie flush on the frame, on its inner lower face so that it would lie fairly on the strake below, and also on its outer lower face. The cross-section of each plank therefore assumed a diamond shape, losing about a third of its thickness between the middle and the edges. The planks were originally of radial cross-section. Taking all twenty-five fragments into consideration, the maximum *thickness* was calculated as 75mm (3in.) and the minimum 50mm (2in.). Honey considered those figures less than might be expected for a ship of that size but McGrail has suggested that 'large ships' were built in the medieval period with planking of only 30mm in thickness (McGrail 1993, 11).

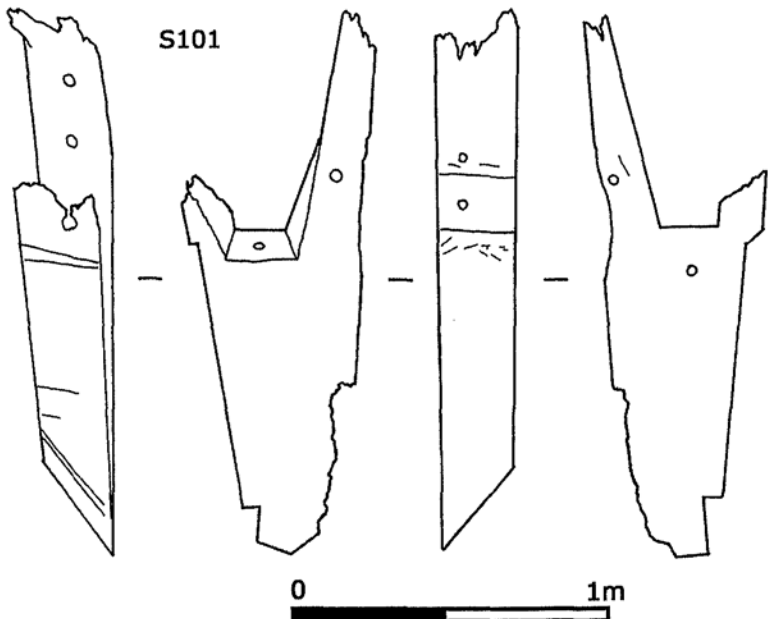
Fig. 7 Medieval Sandwich Ship S101: four faces of a natural Y-shaped floor-frame from the stern of the vessel. Although badly damaged the general form can be readily appreciated. Note the well-preserved angle on the foot of the floor, suggesting that it sat on a rising raked member, and not on the keel.
(K. Brandon)

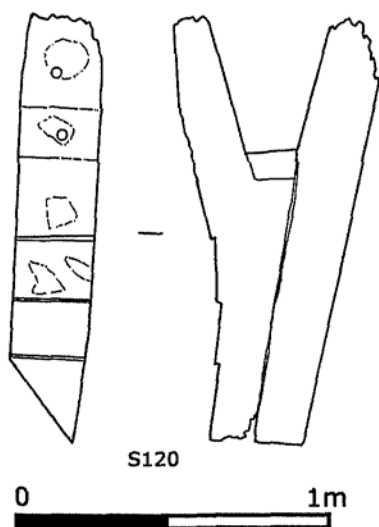
Fig. 8 Medieval Sandwich Ship S120: two faces of a damaged but naturally-shaped floor-frame from the stern of the vessel, showing in particular the lands or joggles representing the runs of hull planking. Note this member also has a well-preserved angle on the foot of the floor: see Fig. 7. (K. Brandon)

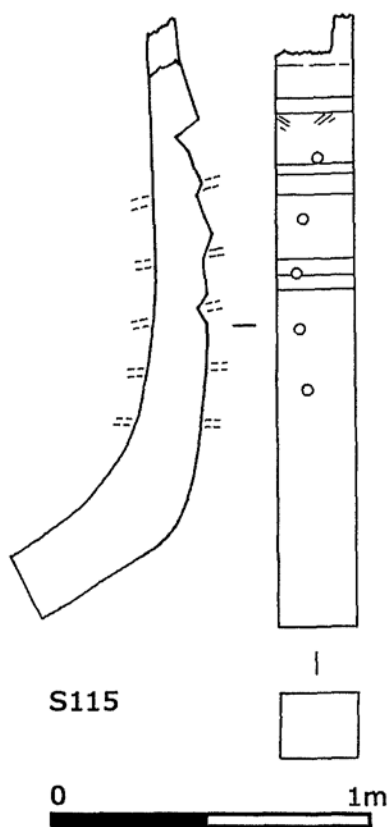
Fig. 9 Medieval Sandwich Ship S115: framing element, both ends damaged, but showing pronounced joggles for overlapping clinker planking over only the upper level of the timber. (K. Brandon)

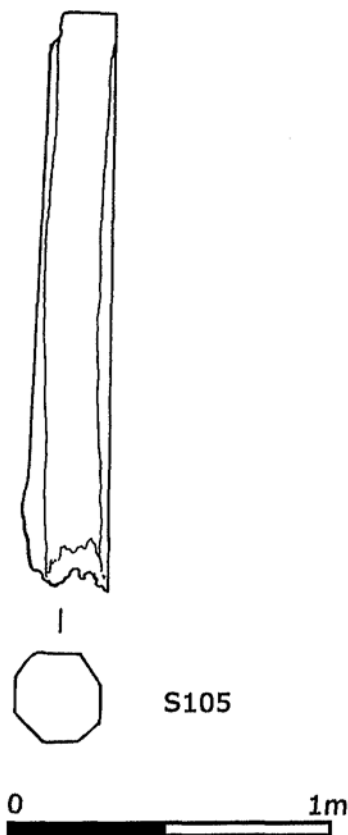
*Pillars (Fig. 11)*

Fig. 11 Medieval Sandwich Ship S105: damaged fragment of an octagonally-shaped pillar, presumably to support a deck beam. (K. Brandon)

There were several pieces representing three broadly octagonal pillars c.6ft (1.83m) long and between 8¾ in. (0.22m) and 11½ in.

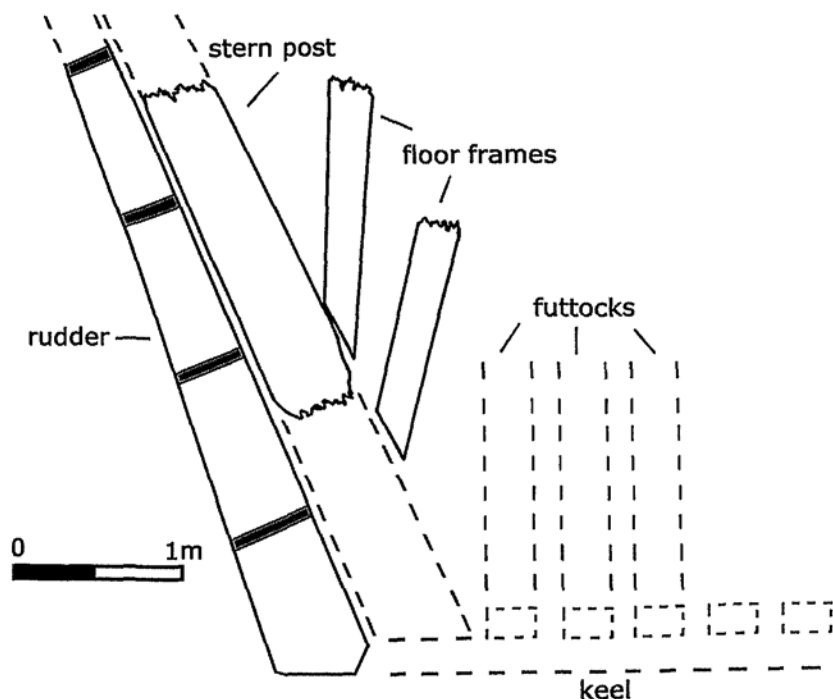
Fig. 12 Medieval Sandwich Ship: schematic illustration to show possible disposition of some of the timber in the stern assembly of the parent vessel. (J. Stripe)

of the stern assembly of the parent vessel survived (Fig. 12), while the albeit rather rushed recording of the site in 1980 confirmed that what was probably the port side of a large vessel was also still upstanding. The *diversity* of vessel parts recovered (not just hull planking but futtocks, stern post and a rudder) also strongly implies that at least one vessel had been disturbed *in situ*, while the uniformly-generous scantling shared by all those timber elements is not inconsistent with the interpretation of one large parent vessel.

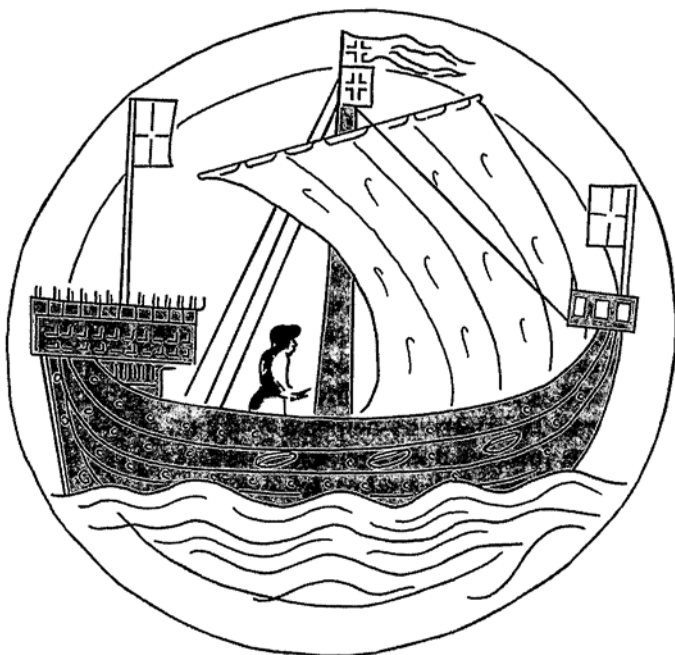
Fig. 13 Interpretative illustration of the general form of the late medieval merchantmen depicted on the Town Seal of Rye, its shape constrained by the circular format of the seal itself. (J. Stripe)

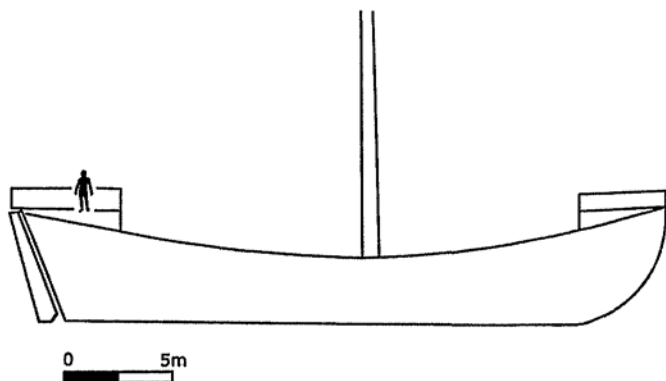
Fig. 14 Interpretative illustration (to scale) to show a suggested outline of the general form of the late medieval merchantmen represented by the timbers found at Sandwich, 1973. This may be compared with Fig 13. (J. Stripe)

Taking all that analysis as a body, and comparing it with broadly contemporary manuscript illuminations has allowed Dr Flatman (2003) to make suggestions as to the general form and profile of such a vessel. His detailed study concludes that, despite depicting a carvel-built vessel, a useful comparison is the ship shown in Bod. Lib. MS Douce 353, f. 31 (see e.g. Bill *et al.*, 1997; Rose 2002, pl. 1). This illustration shows a large vessel with a single mainmast with furled square sail, a strong median rudder, end-castles that have been partially merged into the hull, and nascent masts fore- and aft. He has also argued that the Sandwich ship bears comparison with other forms of medieval iconography, particularly the series of thirteenth-fifteenth-century English town seals discussed by Ewe (1972) for example. These include one from Sandwich itself (*ibid.* 81, 186) that dates to the thirteenth century, but the one from Rye, dating from 1400 offers the best overall match so far with the Sandwich ship according to Flatman (see **Fig. 13**). The vessel in the latter example has a particularly strong, clinker-built hull with sharp ends, and a high, tapered median rudder ending well above deck (Flatman 2003).
