THE ROMAN VILLA AT MINSTER-IN-THANET. PART 3: THE CORRIDOR HOUSE, BUILDING 4

KEITH PARFITT

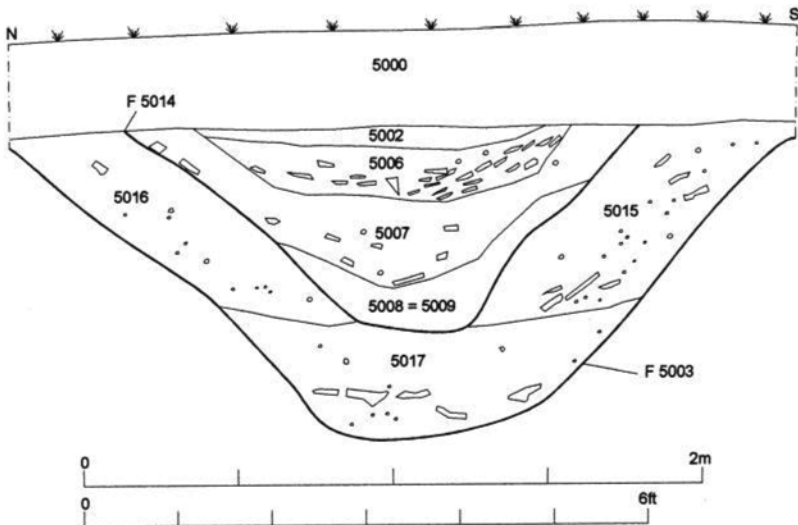
Fig. 3 Section across boundary ditch [F. 5003] and its re-cut [F. 5014].

All trace of the northern part of the new eastern corridor wall had been destroyed by ploughing but a section of deeper foundation survived where it had been necessary for the builders to dig into the soft back-filling of the earlier boundary ditch [F. 5003], see above. The 0.50m wide foundation here (5022) had been built free-standing in a wide construction trench and consisted of roughly coursed, large (re-used) flint cobbles set in dark brown gritty loam, with traces of cream-yellow mortar bonding in the upper course. As elsewhere, this foundation had been extensively robbed but sufficient remained to suggest that it had originally been cut some 0.55m deep into the ditch fill, of which the lowest 0.25m of stonework remained. A few sherds of second-century pottery had become incorporated into the fabric of the foundation. Immediately to the east, the line of the original boundary ditch [F. 5003] was maintained and re-cut as F. 5014, with its repositioned terminal placed just outside the Phase 3 corridor wall, about 2.40m east of the original terminal (Figs 2 and 3).

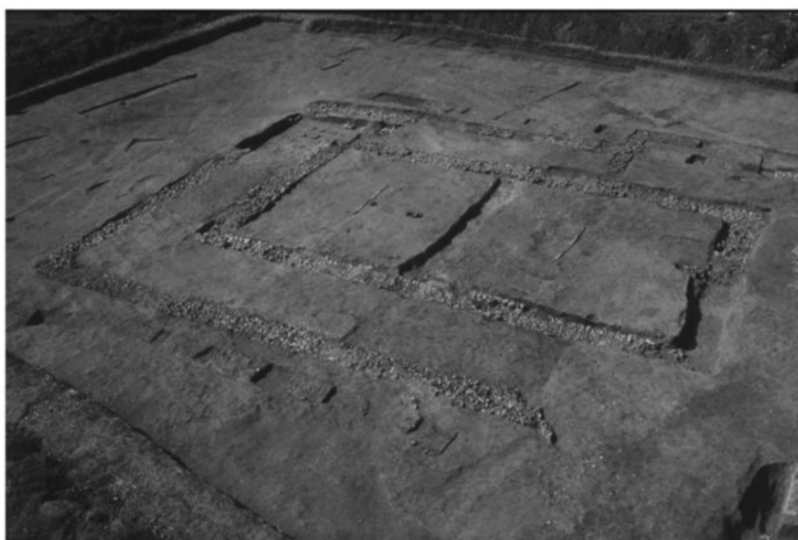
High level view of Building 4

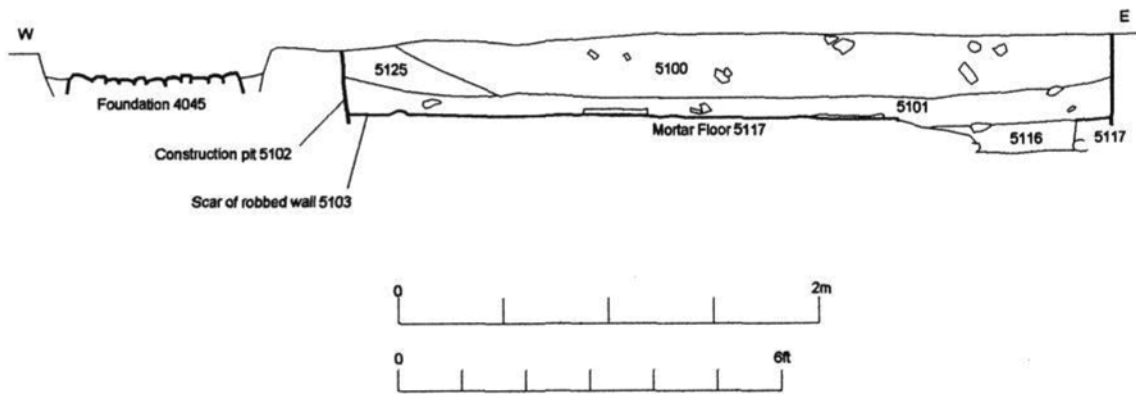
Fig. 5 Section across hypocausted room.

Eventually, the heated room was abandoned and the structure was systematically robbed down to basement level (Fig. 5). There can be no doubt that this occurred sometime during the Roman period as large amounts of domestic rubbish, including some 1,700 sherds of pottery, were subsequently dumped into the basement. The date of the pottery spans the period *c.* 100-250. This could indicate that the material had been dumped over a considerable period of time (Lyne 2002) but more probably it reflects the fact that old midden material had been deliberately brought in from elsewhere. What is less clear is the exact time of the robbing in relation to the overall structural history of the building. The walls of the Phase 1a corridor had clearly been removed at the start of Phase 3 to allow the enlargement of the corridor (see below). Thus, the removal of the hypocausted room might also have occurred at this time; however, since no new heated room was provided as a replacement, this might appear as a retrograde step; so perhaps the existing hypocausted structure was incorporated into the later corridor, albeit rather awkwardly.
