THE ROMAN VILLA AT MINSTER-IN-THANET. PART 5: THE MAIN HOUSE, BUILDING 1

KEITH PARFITT, DAVE PERKINS, EMMA BOAST AND GERALD MOODY

This is the fifth paper detailing results of the Society's excavations, undertaken jointly with the Trust for Thanet Archaeology and the Thanet Archaeological Society, at the Roman villa site on Abbey Farm, Minster-in-Thanet (NGR TR 3135 6463, centred). The report describes the main villa house, designated Building 1. This was the first structure to be investigated, under the direction of Dave Perkins, between 1996 and 1999 (Perkins 1996; 1999; **Plates I-III**). Although the work extended over four seasons in all, most of the building was excavated during 1996 and 1997. It was the largest structure examined and detailed analysis and definition of the building sequence recorded, on what was in the early years, a new and unfamiliar site has required considerable study and thought, hence some delay in reporting.

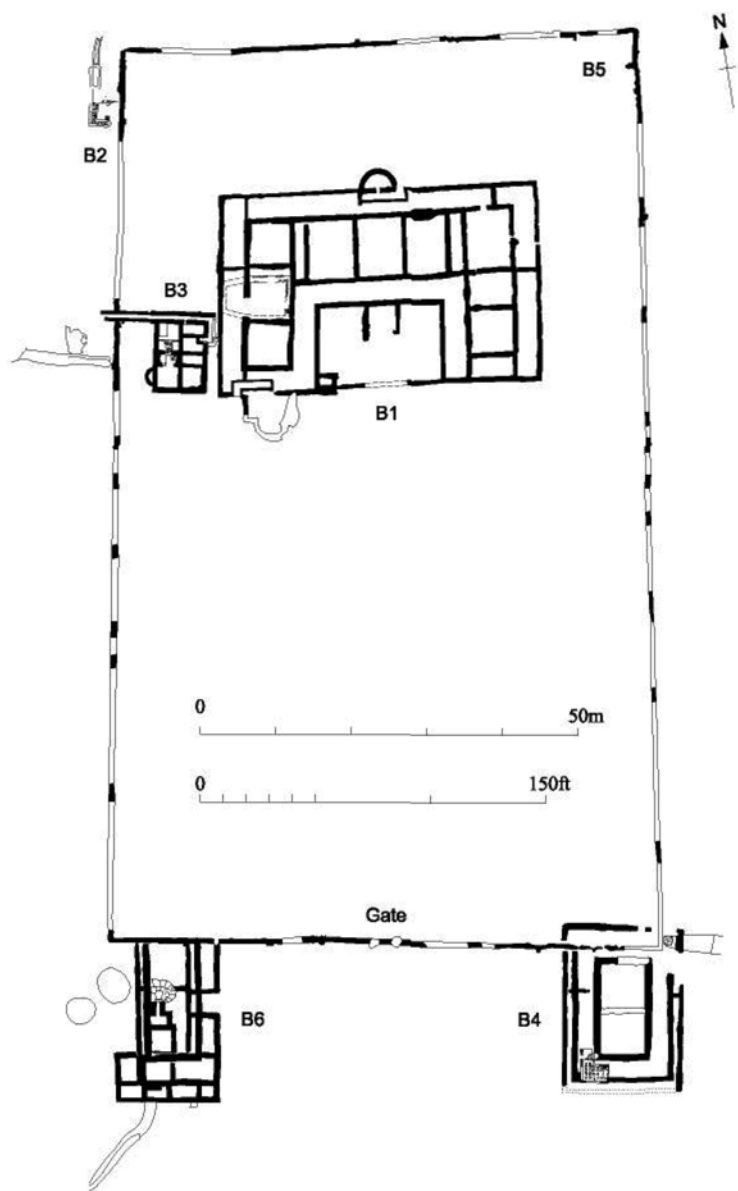
Fig. 1 General plan of the villa complex showing the position of the main house (Building 1) in relation to other buildings and structures.

Building 1 was the principal dwelling of the villa complex and consisted of a 'winged-corridor' house of well-known Romano-British type. It stood on a gentle slope at an elevation of 16-17m OD and was constructed on an east-west axis, facing downhill to the south. This arrangement would have provided its residents with panoramic views across the nearby Wantsum Channel, with the Kentish mainland beyond (Perkins 2004, figs 1 and 2). Immediately to the west of Building 1, set neatly in line with the end of its west wing, was a detached bath-house (Building 3). This has been described previously (Parfitt in Perkins 2004). The two buildings occupied prime position within the upper part of a large walled compound (**Figs 1 and 2**). Other substantial buildings lay outside the south wall of this enclosure (Fig. 1, Buildings 4 and 6; Parfitt 2006; 2007).

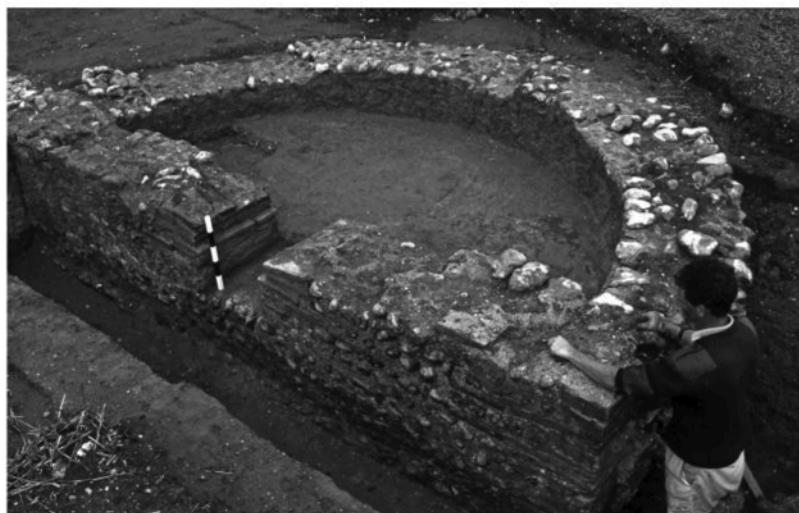
Rooms 10 and 11, looking north-west

A detached, hypocausted apsidal room (Room 10) was located on the far side of the outer corridor, centrally positioned to the north of Room 9 (Plate IV). The associated stoking-chamber (Room 11) was somewhat curiously placed on the south, within the corridor. The exact purpose of Room 10 occasioned much discussion and speculation during the course of the excavation and continues to be enigmatic.

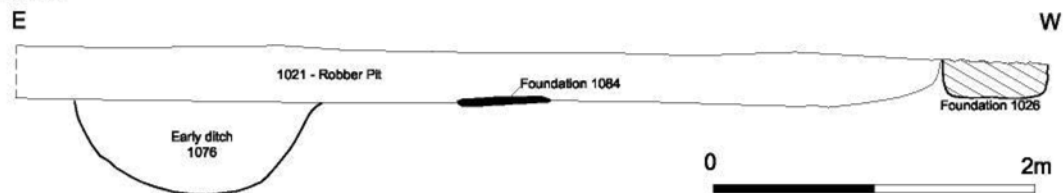
Fig. 5 a and b) Sections across Room 17; c) Section across Room 15b.

After it had been robbed of its re-usable materials, the basemented area of Room 15b was back-filled with soil, building rubble and some domestic rubbish (Fig. 5, 1021). The significant quantities of broken tile and painted plaster recovered from this deposit are presumably derived from the demolished room above. The pottery, animal bone and marine shell must represent dumped domestic rubbish. A total of 225 sherds of pottery, including five samian fragments, were recovered. The latest pieces within this assemblage date to the early third century.

The floor of Room 17 was set somewhat below contemporary ground-level (at least 0.35m deep) to give a shallow basement (Fig. 5, a, b). Indeed, this basement may have been created by extending the original hypocaust stoking-chamber associated with the adjacent Room 15b,

A thick deposit of black ashy loam and carbon accumulated over the floor around these two structures (Fig. 5, *a, b*, 1007). This material must largely represent rake-out from regular firings of the furnace structure and working on the raised hearth. The layer was up to 0.35m thick and produced a considerable number of nails and other iron fragments, which is perhaps consistent with black-smithing activity in this room. Additional finds from this extensive deposit included a coin, a bone needle, a copper-alloy pin, pottery, tile fragments, over 30 pieces of window glass, animal

The room eventually went out of use and the basemented area was infilled with soil, tile, flint and white mortar rubble (Fig. 5, *a*, *b*, 1022). This final levelling deposit also included some painted plaster and 25 pieces of window glass, together with quantities of domestic rubbish in the form of pottery, vessel glass, animal bone and marine shell. Nearly 350 sherds of
