TWO 'NEW' TOWN GATES, ROMAN BUILDINGS AND AN ANGLO-SAXON SANCTUARY AT ST MILDRED'S TANNERY, CANTERBURY

SIMON PRATT

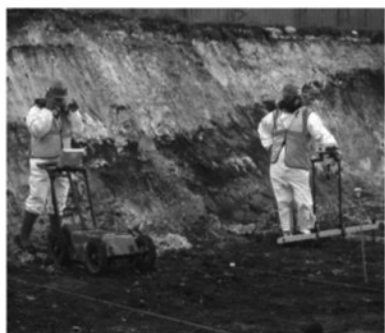
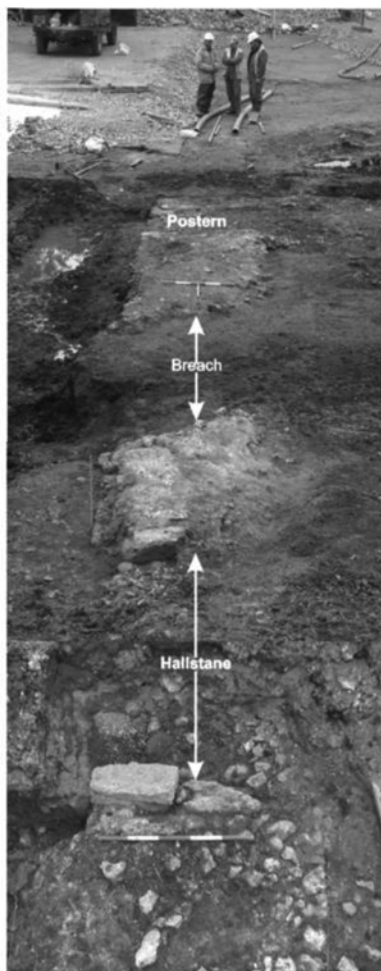
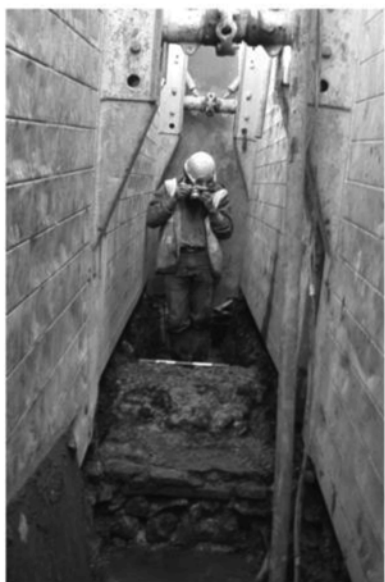
Fig. 3 St Mildred's Tannery, Canterbury: (a) Using GPR (left) and resistivity to search for towers, etc. after the removal of the tanning waste; (b) Composite photograph looking north along the town wall in the area of the two gateways (1 m scales across the wall, 0.5 m scale along it); (c) ?Aisled building, exterior view of main north-western wall (0.5 m scale).

Near the river, short stretches of Roman walls were exposed in three trenches. These marked three sides of a large structure first identified in 1991, then assumed to represent an entire building rather than a single chamber (Pratt 1992; CAT 1992, 374-5). The north-western (Fig. 3c) and south-eastern side walls were both about 0.895m (3 p.M.) thick and had external offsets, probably just below floor level, about 0.30m (1 p.M.) wide. The north-eastern end wall was about 1.04m thick (3.5 p.M.?), at least along its central stretch. The walls and footings were of mortared flint with string courses of lydion tile laid in double thicknesses. On all three sides, the uppermost surviving string course had been covered in trampled earth which had not been fully cleaned off before the next course of flints was laid. This echoes a line of hobnailed boot prints along the surviving crest of the outer wall of the building found in 1987 (to this day, new ground beams are used as convenient walkways across a muddy or uneven site, though subsequent cleaning is usually more thorough). What may have been the robber trench for the fourth side had been seen in 2001, but this was only 0.65m wide and was more probably for a separate or subsidiary structure. Within the main walls, two massive upright timber piles were found, each roughly 0.5m square and of unknown length. A hole in the final surface gravel overlapping the western pile suggested they supported timber posts measuring about 0.30m (1 p.M.) square. As this pile projected above the sewer formation level its top was sliced off and sent for dendrochronological analysis. Unfortunately, though from an oak, it came from the upper part of the trunk and was too heavily knotted and fast-growing to date. It seems likely that such pieces were deliberately selected for piles, which needed no sophisticated carpentry, smoother-grained wood being retained for use above ground. A ?beam

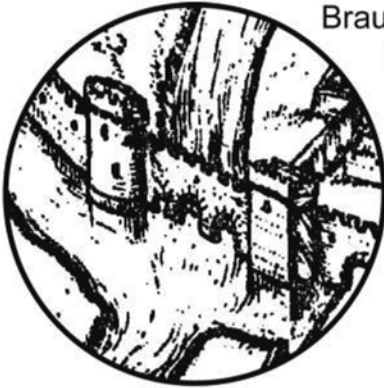
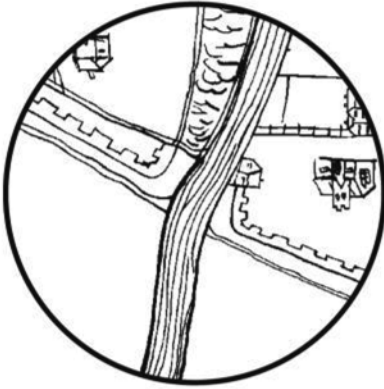
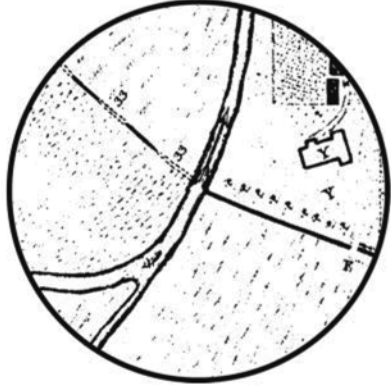
Fig. 5 St Mildred's Tannery, Canterbury: early representations of the city wall in relation to the river

Late sixteenth-century bird's-eye views of Canterbury by William Smith and by Braun and Hogenburg contain no useful detail for the Tannery area – only the nucleus of the former friary is shown whilst a certainly anachronistic watergate crosses the Stour (Fig. 5). Speed's 1605-1610 survey of Canterbury and its derivatives are little better, though perhaps showing a rather confused representation of the two re-entrant walls by the river. These are far clearer in a map of c.1640, held in the cathedral archives (CCA Map 123). A breach in the town wall, between the blocked postern and presumed *Halistane*, was probably cut from both sides simultaneously and may be one of those made after the Christmas Day riot of 1647 (Everitt 1960, 123-124, 140-141). By 1752, when the
