THE ROMAN VILLA COMPLEX AT ABBEY FARM,
MINSTER IN THANET.
PART 7: BUILDING 7, A LATE ROMAN KILN AND
POST-BUILT STRUCTURES

GERALD MOODY

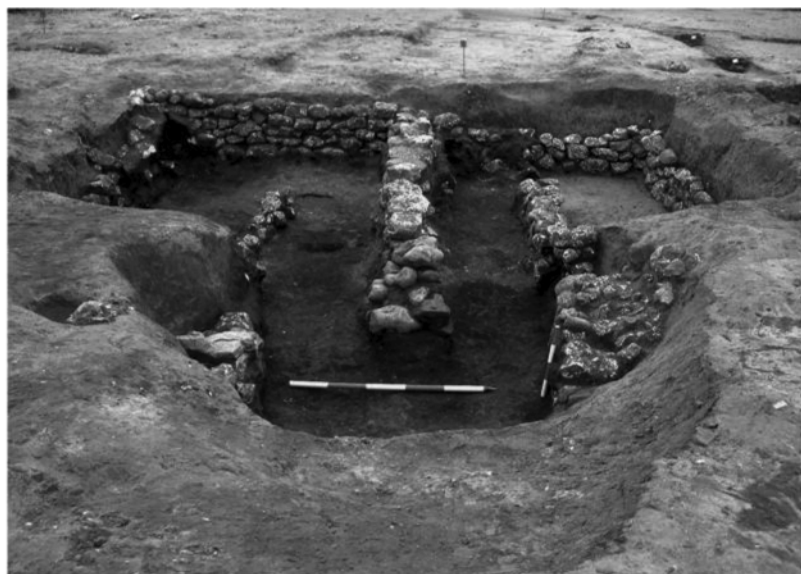
West facing view of the kiln from the stoke chamber

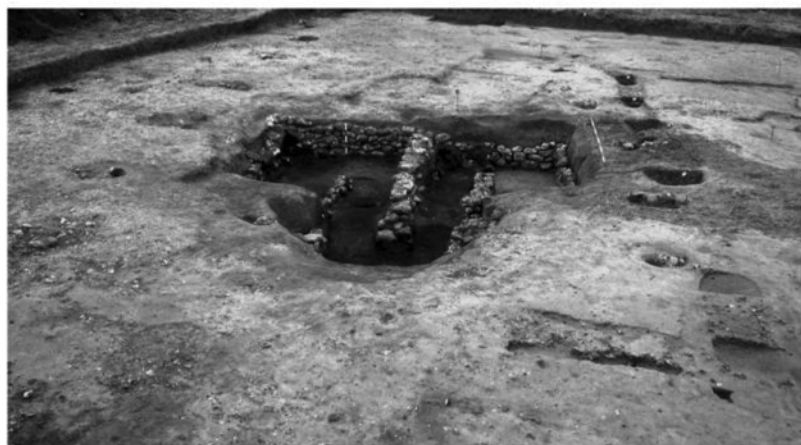
PLATE II

Overview of the kiln and associated post holes and gullies viewed from the north-east

2004), the feature in Trench 2 was targeted in a more extensive excavation area (Fig. 1, 2004 Trench 9). The full extent of the cut feature was exposed, along with gullies and post holes not encountered in 2003. The cut feature was sampled in a grid of alternate segments; the sections of these segments have been reconstructed as a continuous cross section (**Fig. 2**, Sections 1 and 2) by reversing some of the drawn sections. Excavation of the segments demonstrated that the feature was the subterranean element of a kiln or oven. Later demolition deposits were removed to expose the material created by the last use of the kiln; in some segments, the original structural cut of the kiln was exposed. Eventually the deposits in the unexcavated areas of the grid were removed so that the kiln could be planned and photographed without any later demolition or backfill material present (**Plate I**). The alignments of post holes and gullies associated with the kiln suggest it was probably protected by a post-built enclosure without a roof, or a light lean-to or barn like building (designated Building 7; **Plate II**).
