## RESEARCH NOTES – POST-MEDIEVAL

### A SURVEY OF DUTCH AND FLEMISH GABLES IN KENT

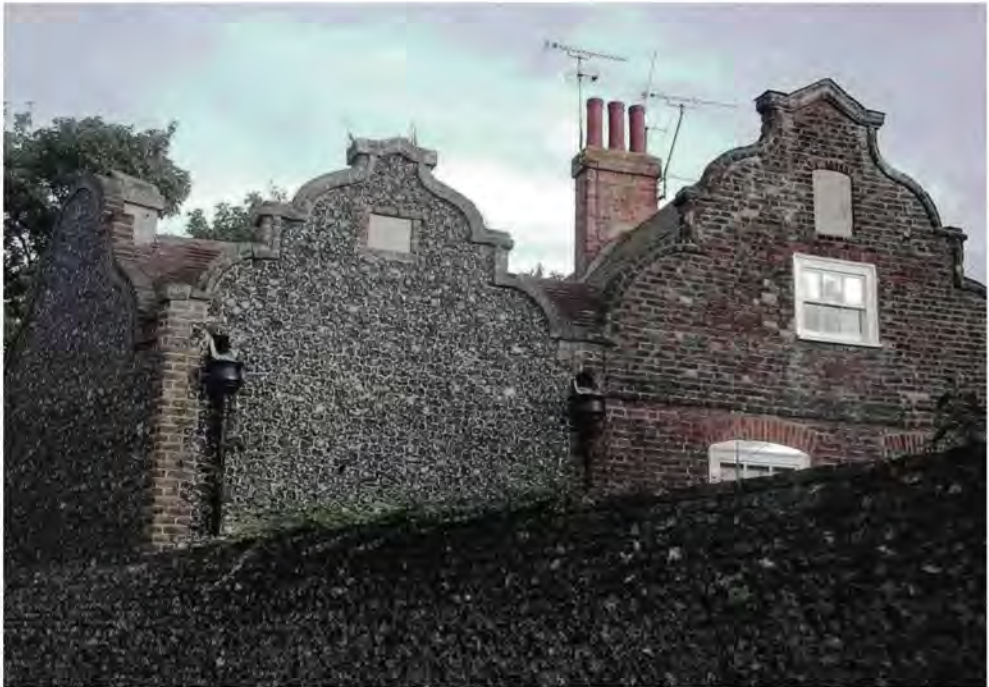
Fig. 1 Stone Farm, Broadstairs: a rare example of a property having two gables of differing shapes and/or pediment style.

*Stone Farm*, Broadstairs (Fig. 1), was built in 1710 in brick, but the later extension

of 1839 was of flint, presumably gathered from the nearby beach, to avoid the Brick Tax (1784-1850) which was still in force. Deal is a case on its own: most of the cottages there are terraced and around half of them are rendered, all being built of brick as far as can be ascertained – a number being somewhat mutilated and/or 'improved' so difficult to classify.

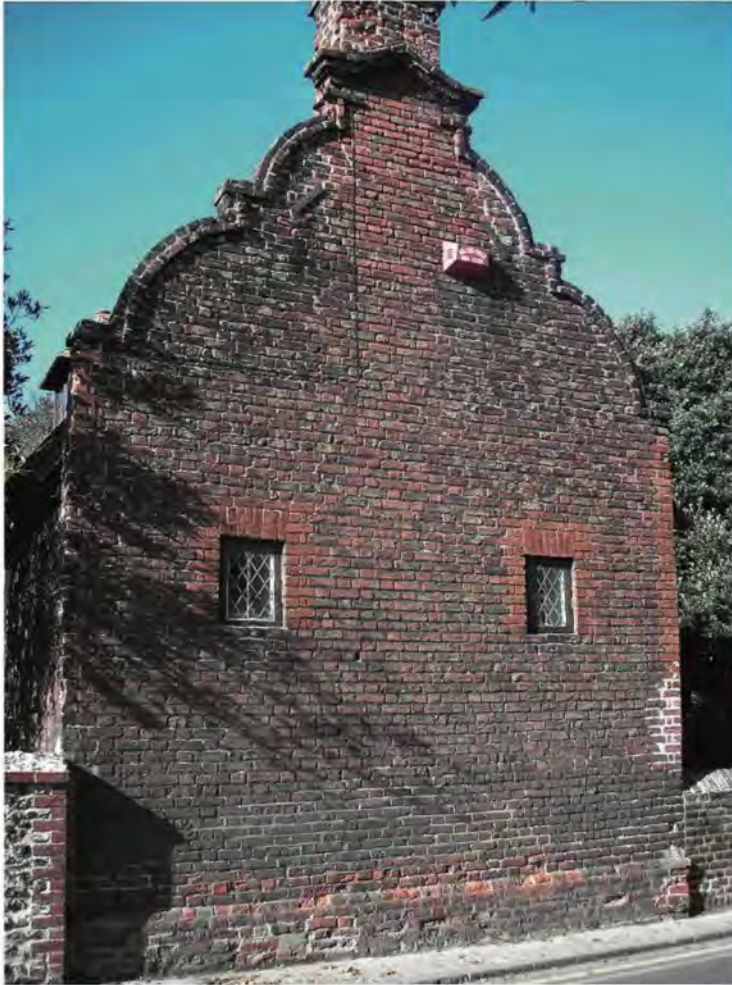
Fig. 2 St Peter's Farm, Broadstairs, showing the Thanet pediment. Owned by the Mockett family for over 300 years, now fortunately by an architect.

*St Peter's Farm*, Broadstairs (Fig. 2), has a date plaque of 1710 on the front wall; the porch has a date plaque of 1682. The house was in fact built in 1657 (on an earlier flint base, also at *Chilton Farm*), the porch was added in 1682, and the front of the house was then re-built in 1710 to satisfy the then current Queen Anne fashion with a more symmetrical frontage! (c.f. *Queen Anne House*, Deal, also 1710). Wall anchors giving a year are sometimes suggested as an indication of Dutch influence but only appear rarely, as do those with initials.

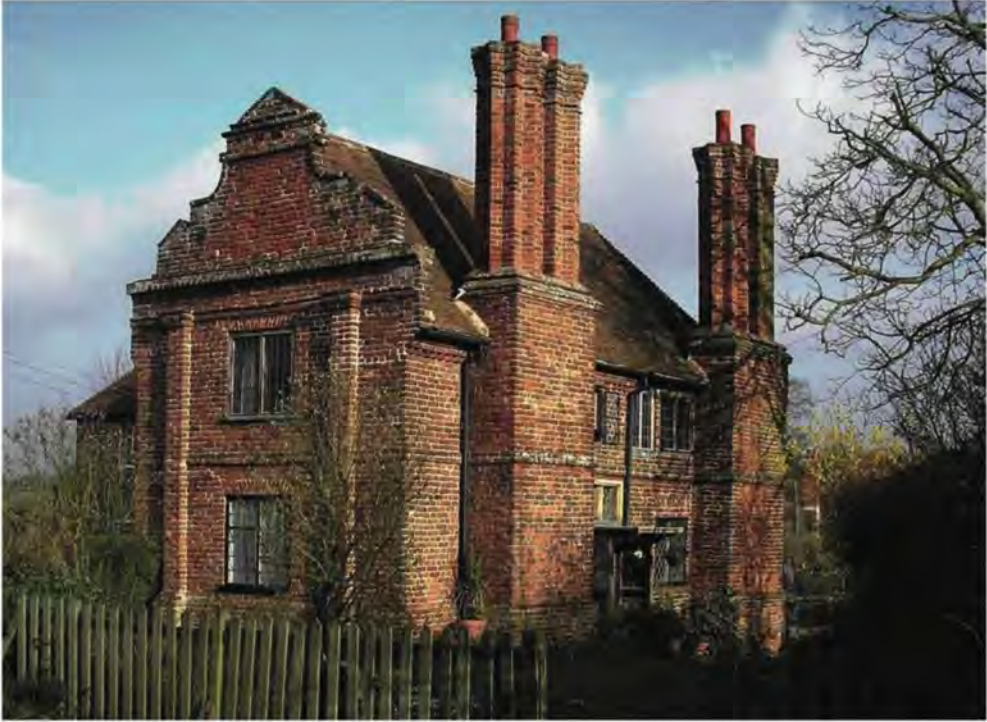
Fig. 3 Hospital Lane, Goodnestone: a feast of brickwork with large pilasters and chimney breasts and a triangular pediment.

The classic pediment of a triangle (**Fig. 3**) is sometimes quoted (Pevsner *et al.*) as an indicator of a gable being Dutch. However, of the possible 180 curvilinear gabled properties in the survey only 17 have a triangular pediment. The most common pediment or 'top' is round, (semi-circular or compass) with 26 examples and close behind is the Thanet pediment (with what one might call an open pediment reversed) with 25, of which 17 are in Thanet – the others nearby. A close third come the segmental pediments with 22 (**Fig. 4**). In 18 cases a chimney replaces the pediment (see **Fig. 5**) and there are a number with no comparables. In Littlebourne one can see two examples of a rare 'open pediment over a broken pediment' as seen also at *Tudor Cottage* at Wingham Well and nowhere else which was probably the inspiration.

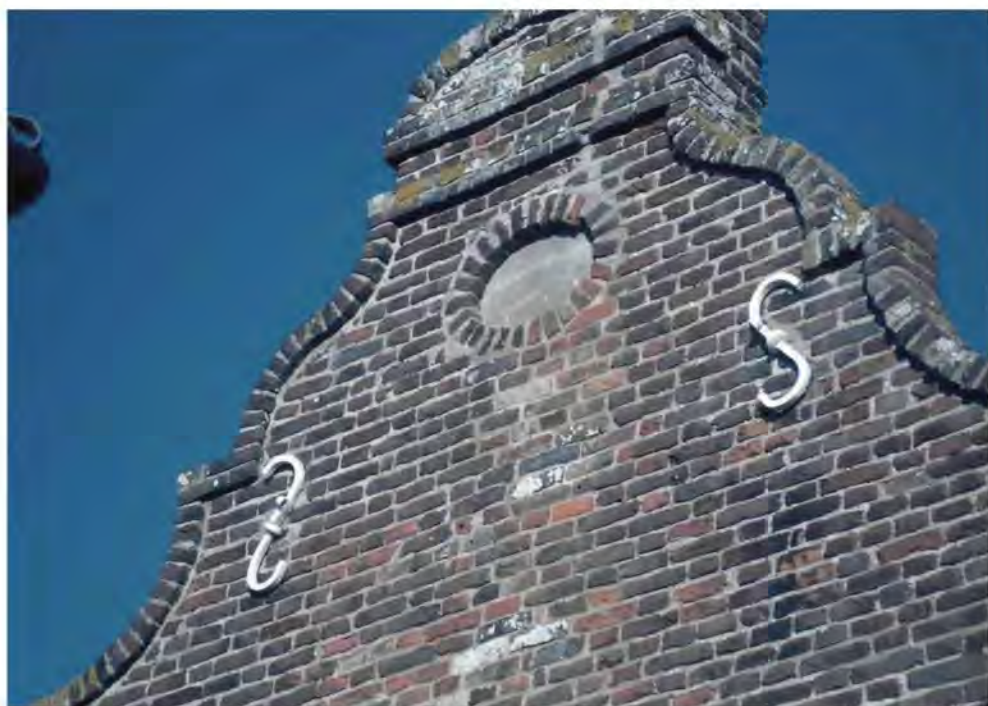
Fig. 4 Worth Farm has segmental pediments and the date 1675 inset into the brickwork.

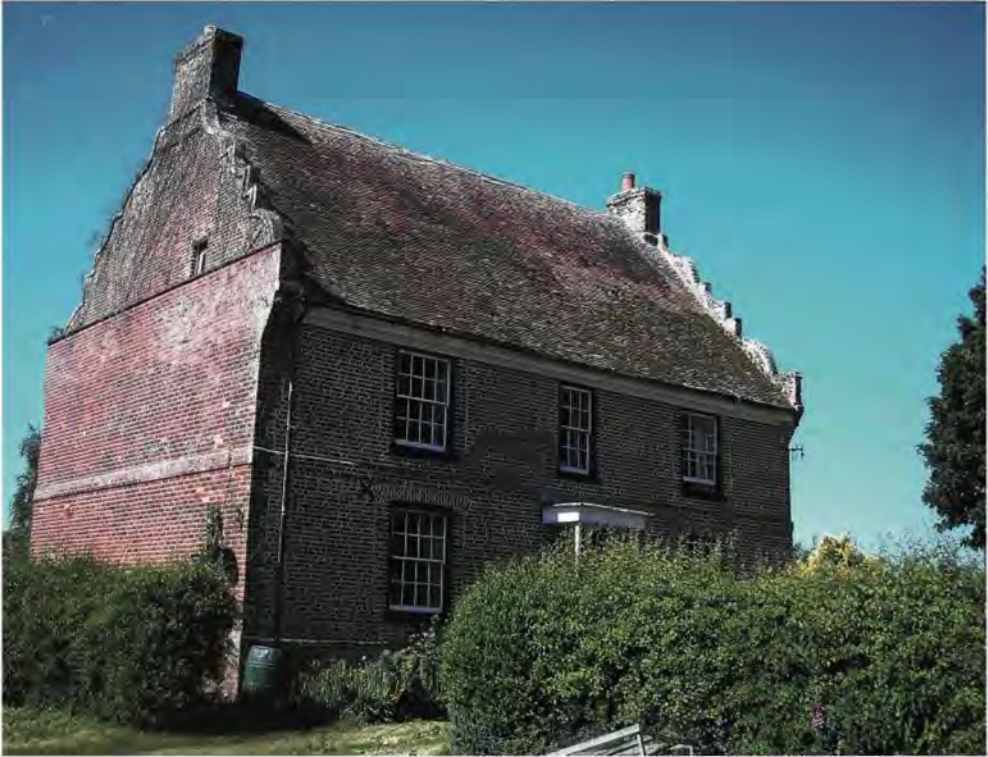
Fig. 5 Church Gate Farm, Woodnesborough: is unique in having (from the top) an ogee, step, a concave curve, step, a convex curve on both gables, the apex of the gables having chimneys.

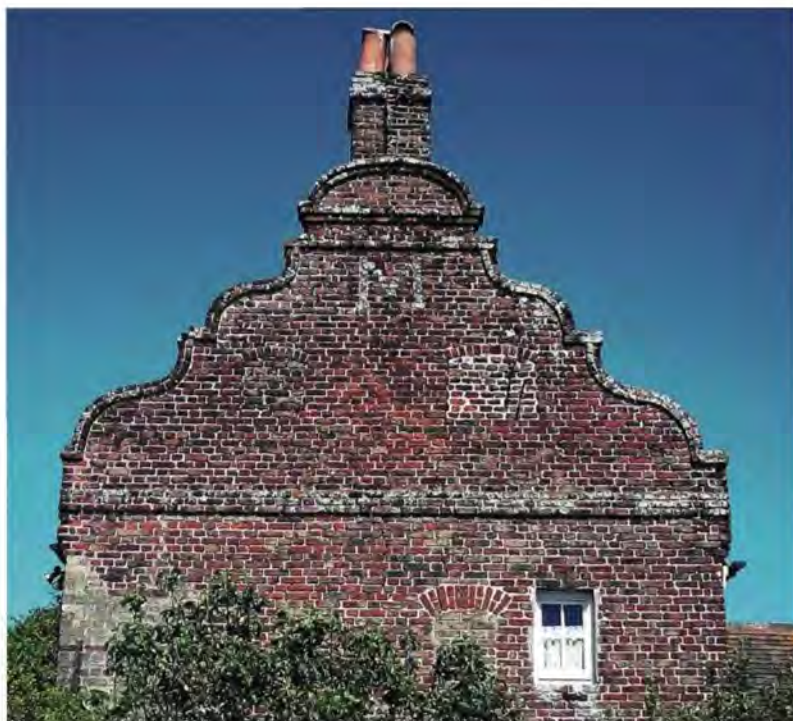
Fig. 6 Northwood, Hopes Lane: this house has a double ogee separated by a step – the author knows of only one other survivor in South-East England but has a copy of an 1881 drawing from Margate Library of an identical shape that was in King Street, Ramsgate, but long since demolished – see note 3.

([www.iotas.org.uk](http://www.iotas.org.uk)) deserve a mention for their help especially Marilyn and Roger of Northwood Farmhouse (Fig. 6) where it all started.

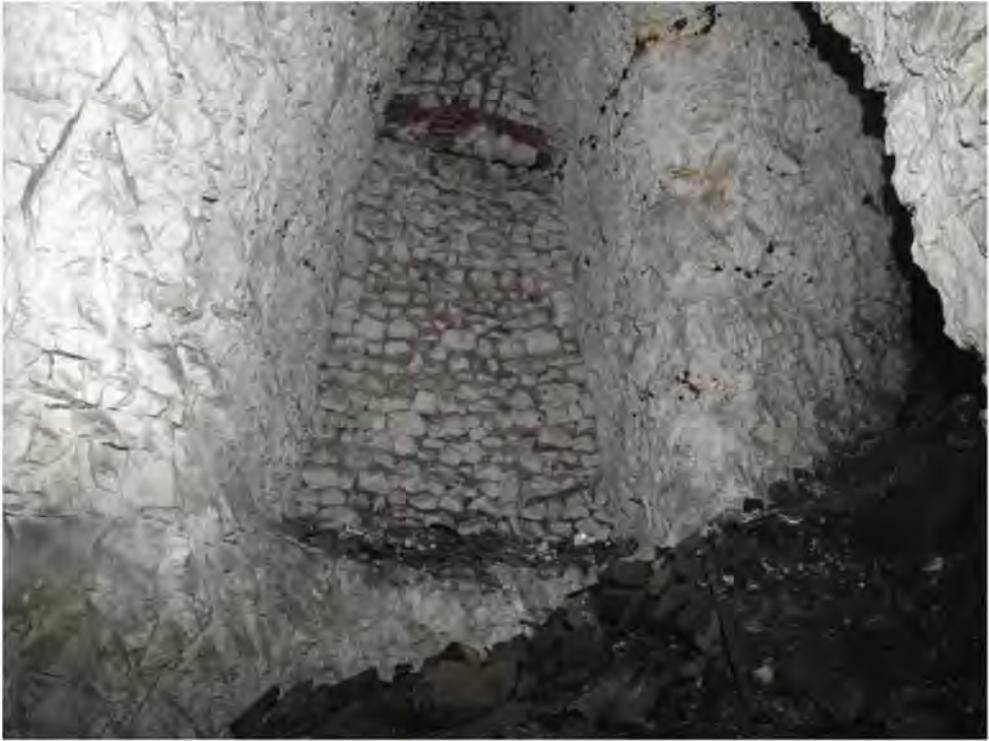
PLATE I Lees Court Road denehole: the sealed-off tunnel.

If chalk miners encountered an area of unstable ground they often sealed that section off with either flint or chalk block walls to prevent the loose material breaking into the working mine. Chalk extraction then continued away from the suspect area. This type of preventative action took place long before the chambers were dug to their full depth and the safety walls tended to be fairly roughly built in a 'dry stone wall' fashion without any mortar bonding.

The only times the writer has encountered blocked-off, full height tunnels, is when a shaft bottom was sealed off. In some areas in Kent, when mining had ceased, it was common practice to wall off the chambers so that the shaft could be economically backfilled without the spoil spilling into the tunnels. The chalk block wall in the Sheldwich denehole could, therefore, be holding back the in-fill from an older shaft which may explain the very uncommon layout of underground workings. When the newer shaft was sunk the eastern tunnel broke into the older excavation. To save the effort of abandoning the mine and sinking a new shaft in a less undermined area, the excavators chose to continue and dug out the north-west

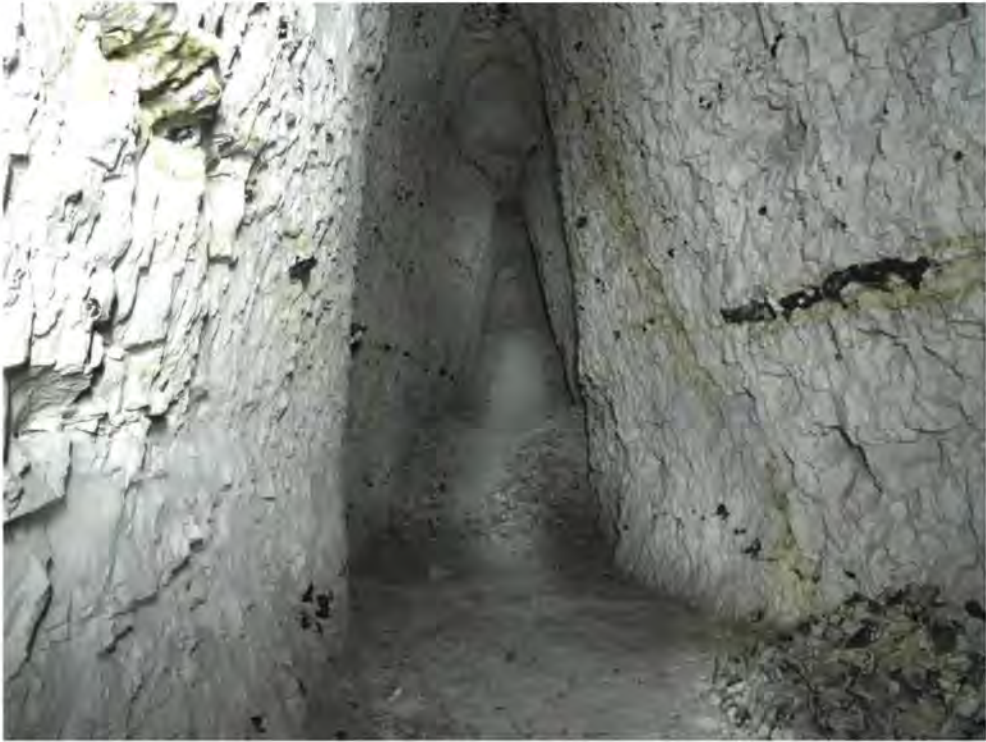
PLATE II Lees Court Road denhole: the flint pile in the north-east chamber.

On the floor of the north-east chamber is a pile of flints (**Plate II**) collected by the miners. Whilst the primary purpose of the denehole was to extract chalk, the flints were a useful by-product. A little further along is a large mound of chalk rubble – the last excavated chalk in the mine.
