## THE WESTERN BARRACK BLOCK OF THE ROYAL CAVALRY BARRACKS, CANTERBURY

KIRSTY BONE AND PETER SEARY

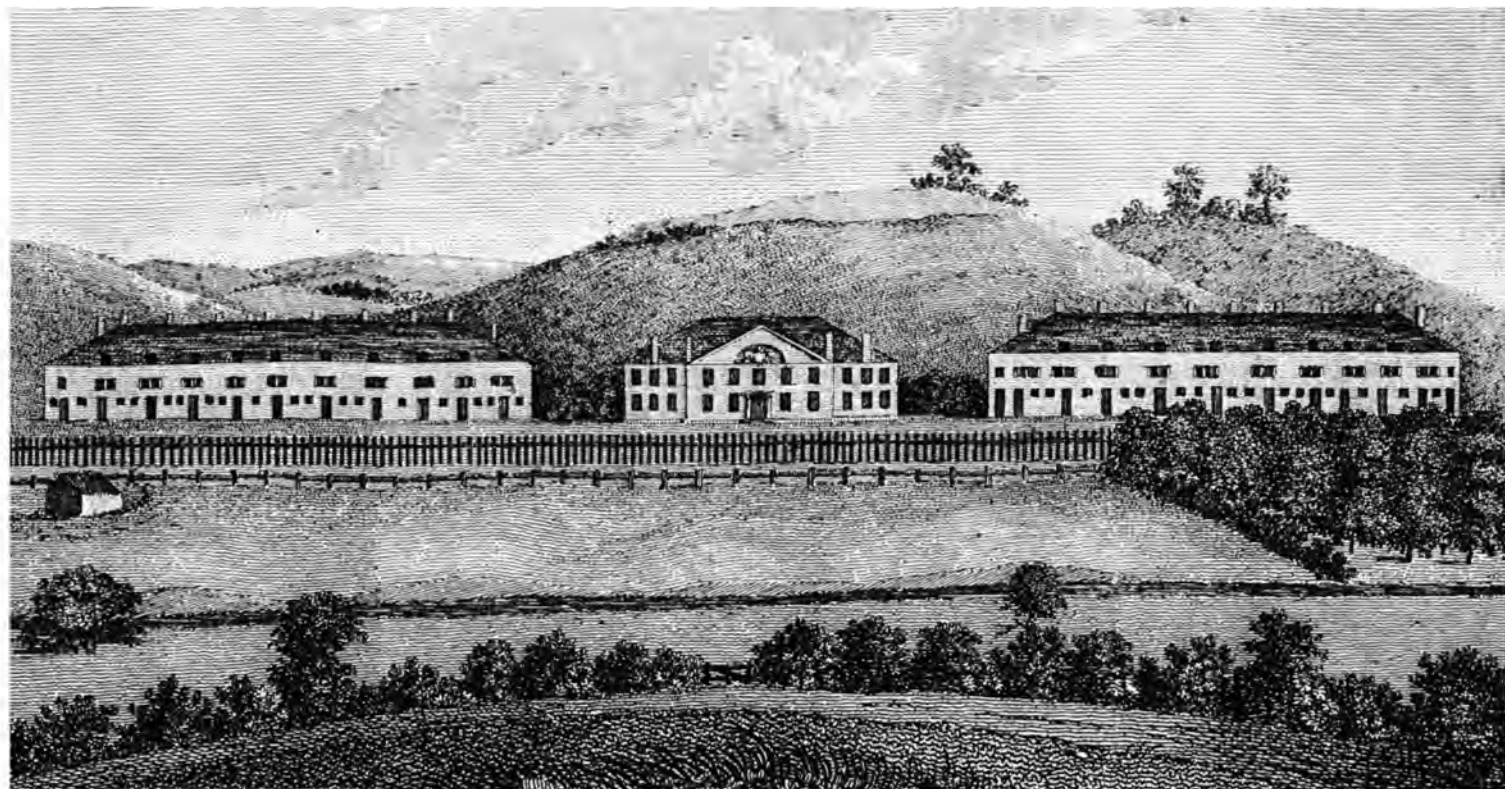
Fig. 2 Detail of Ravenhill's engraving of the *Royal Cavalry Barracks, Canterbury*, published 1 May 1796, after a drawing by L. Lawrence.

The three principal buildings formed a single row, set well back behind a large parade ground (**Fig. 2**).<sup>9</sup> They were of two storeys plus an attic,<sup>10</sup> and were of red brick, laid in English bond, under hipped slate roofs; they had sash windows with gauged-brick flat arches and stone sills. A large, central building, with a tripartite facade and a Doric porch, housed ‘handsome apartments for the officers, suitable to their respective ranks’. A blind lunette in its pediment contained ‘the royal arms, with supporters, and appropriate military emblems’ formed in fashionable artificial stone.<sup>11</sup> To either side of this, detached, stood the two long barrack blocks, containing ‘the stabling, and accommodations for the subalterns and privates, in a double storey over them’.<sup>12</sup> Together, these three ‘elegant and extensive’ buildings amply reflected Canterbury’s importance.<sup>13</sup>
