OLD ST ALBAN'S COURT, NONINGTON: AN ARCHITECTURAL SURVEY

HOWARD AUSTIN JONES

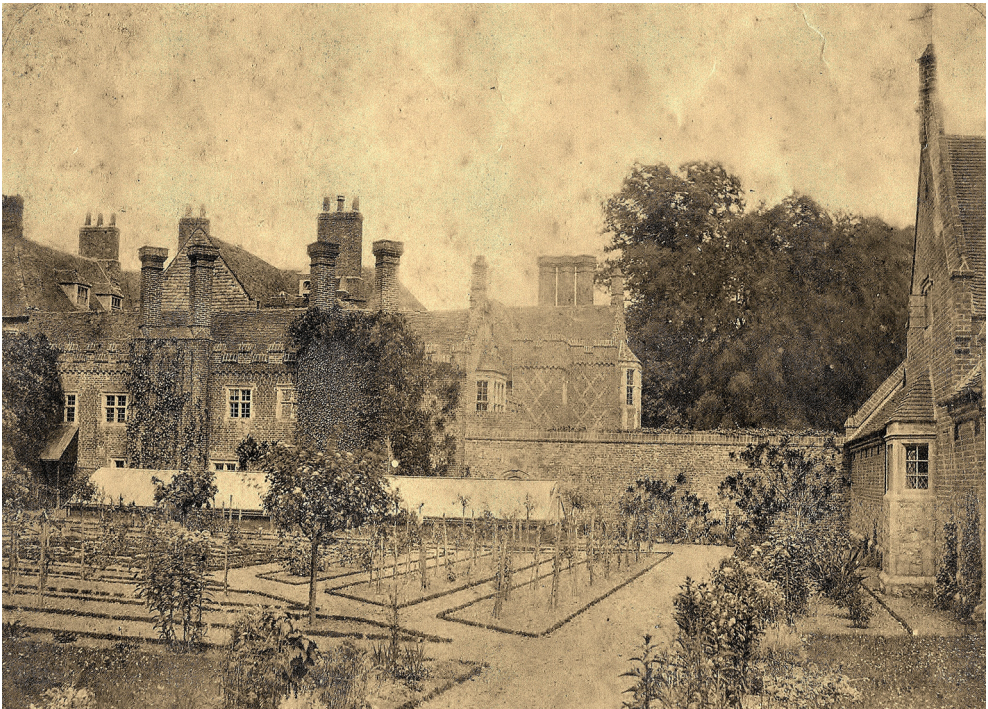
Fig. 6 Old St Alban's Court: south-west (flower garden) elevation; photo 1869.

This fronts the Drawing Room and the Dining Room, part of the kitchen block on the ground floor, and four bedrooms above. Essentially this is of similar build to the south-east (end) wall, and must therefore be of mid-sixteenth century date: small orange-pink bricks in a hard lime mortar and a brickwork plinth which is however two courses higher than the plinth on the south-east elevation. For fifteen or so courses above the plinth, an arrangement of pairs of header and stretcher bricks is staggered to give a diaper pattern. Above this is the walling in a fairly regular English bond. The wall is capped by projecting ornamental crenellations with chamfered faces and roll tops, alternately rising and falling, set off a dentil course, also of cut brick. To the north-west these stop short on the line of the north-west kitchen garden wall, the roof continuing further.

Set in the wall are several square-headed windows of four lights, slightly taller than wide, with jambs, cill, hood and single transom and mullion all in Bath stone, with the glazing again supported by iron ferramenta. Although evidently of the mid to later nineteenth century, these are fairly certainly replacements of earlier similar windows. To the north-west end at ground level is a small doorway, cut through the plinth, though appearing contemporary with it. It has a flat arch over, roughly formed in brickwork. At the other (south-east) end of this elevation is a door of perhaps the eighteenth century, with a segmental brick arch over, quite possibly formed by enlarging an earlier original window.

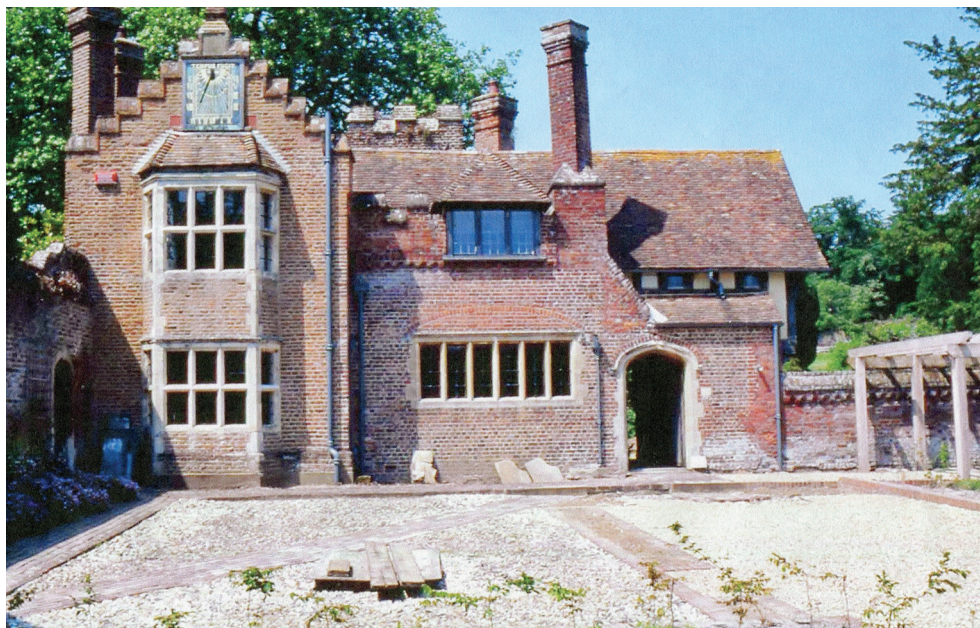
Fig. 7 Old St Alban's Court from the south-east: archaeologists have exposed the Tudor courtyard which fronted the 1556 brick build.

Facing onto the lawn, the south-east end wall of the house is quite thick (75cm), and built of small, thin orange-pink bricks off a base plinth with a chamfered top. All the brickwork is laid in English bond and has been repointed subsequently with cement mortar, but the original white lime mortar survives behind. Abutting and projecting from its south-west end is a tall (c.4m) kitchen garden wall running

Positioned at the south-west end of this elevation but centrally with respect to the Drawing Room it lights is a two-storey angled bay surmounted by a tiled hipped pentice roof. There is a window of six front- and two angled side-lights respectively to each floor of this bay, with brickwork between and quoins to the comers. These, and the jambs, mullions and transoms which are cavetto in section, are formed of reused Caen stone. It is not known from where this was sourced – Canterbury or Dover would seem the most likely places – but it certainly appears it could not have come from earlier buildings on or around the site. The glazing is supported by iron ferramenta. Above this bay is a (restored) crow-stepped gable all of brickwork, with canted tops, typical of the mid-sixteenth century, with a large sundial positioned centrally. Recent cleaning of the sundial revealed an apparently genuine inscribed date of 1556, the same as that recorded on the building stone by a doorway further north-east to this same elevation.

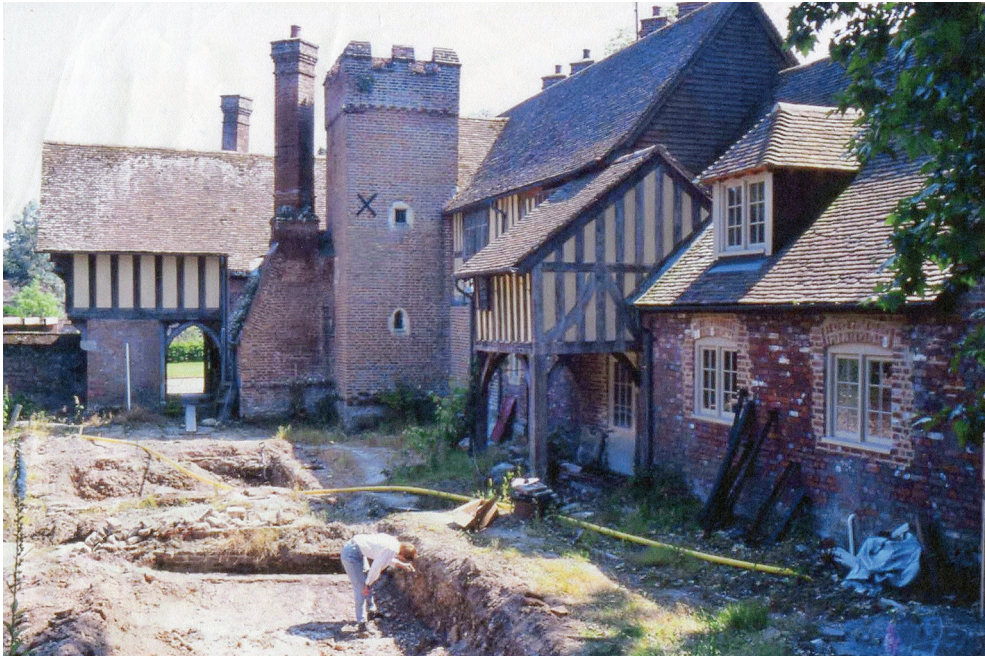
Fig. 10 Old St Alban's Court from the north-east: archaeology in progress on the foundations of the 1665 wing demolished in the late 1870s.
