# **C. N. Kidd's Chalk Mine at Shepherds Lane, Dartford**

**R. F. LeGear**

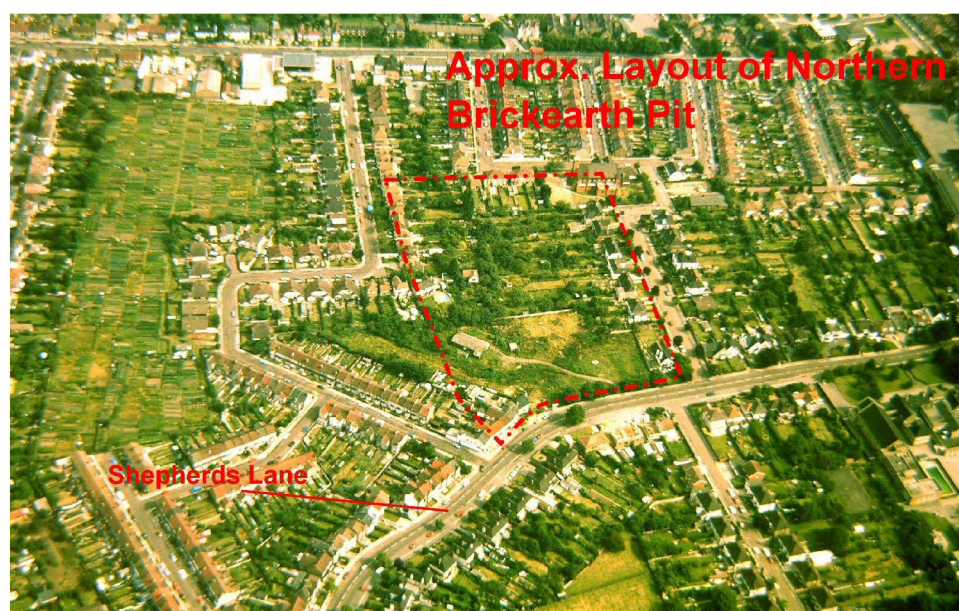
Plate 1 Aerial Photograph of the Site

In 1980, Kent County Council, who owned the site at the time, wished to sell off the land for housing development. [Plate 1] Before this could happen, it was necessary to gain entry to the mine to check the accuracy of a plan of the workings made around 1920 by the local authority. This

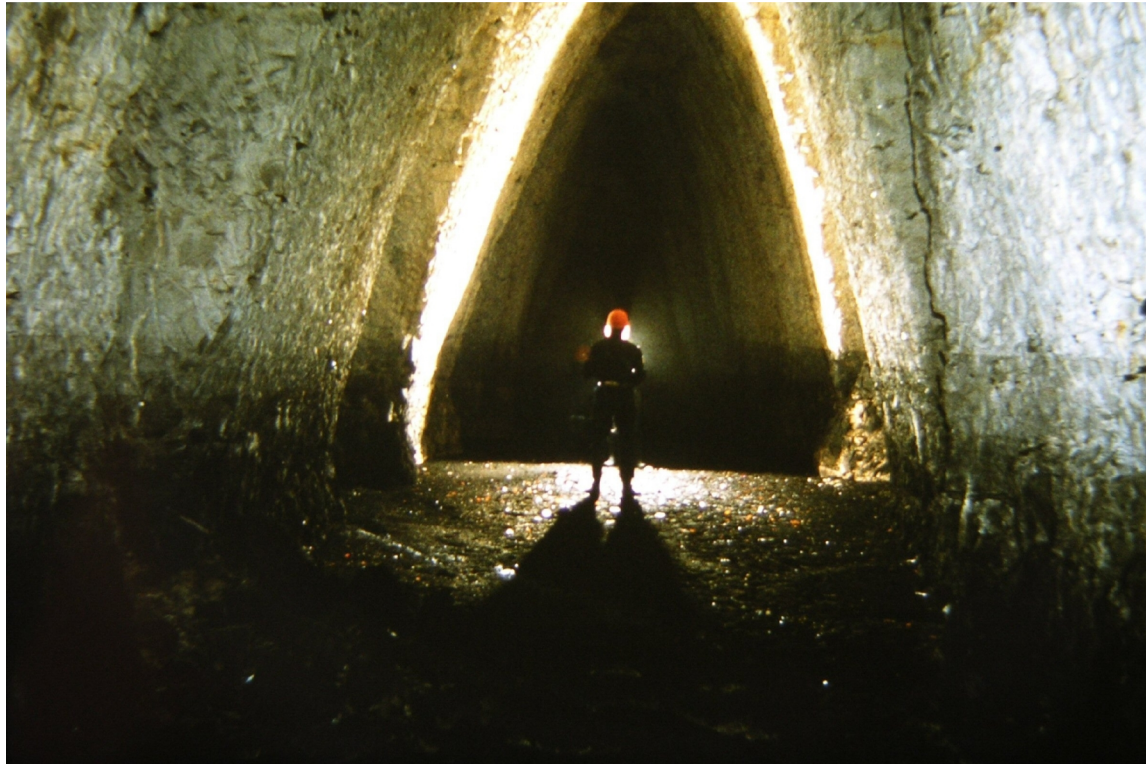
Plate 2 Typical Gallery (Photo: H. Pearman)

The shape of a chalk mine tunnel was very important to the stability of the roof and the Dartford miners had cut the galleries to a safe arched profile. [Plate 2] The galleries were, on average, 3m wide at the base reducing to 0.5 to 1.0m wide at roof level, which varied between 7 and 10m above the floor. Additional stability was gained by 'off-setting' the pillars so that the cross passages did not cross straight over the main tunnels but were staggered to lessen the risk of roof weakness at the junction of four tunnels.

The mine was found to be in very good condition, mainly due to the care with which the miners had executed their work. The chalk tunnels were dug on a 'Pillar and Stall' mining principle in which galleries were dug at right angles to each other thus leaving large square pillars of chalk to support the ground above.

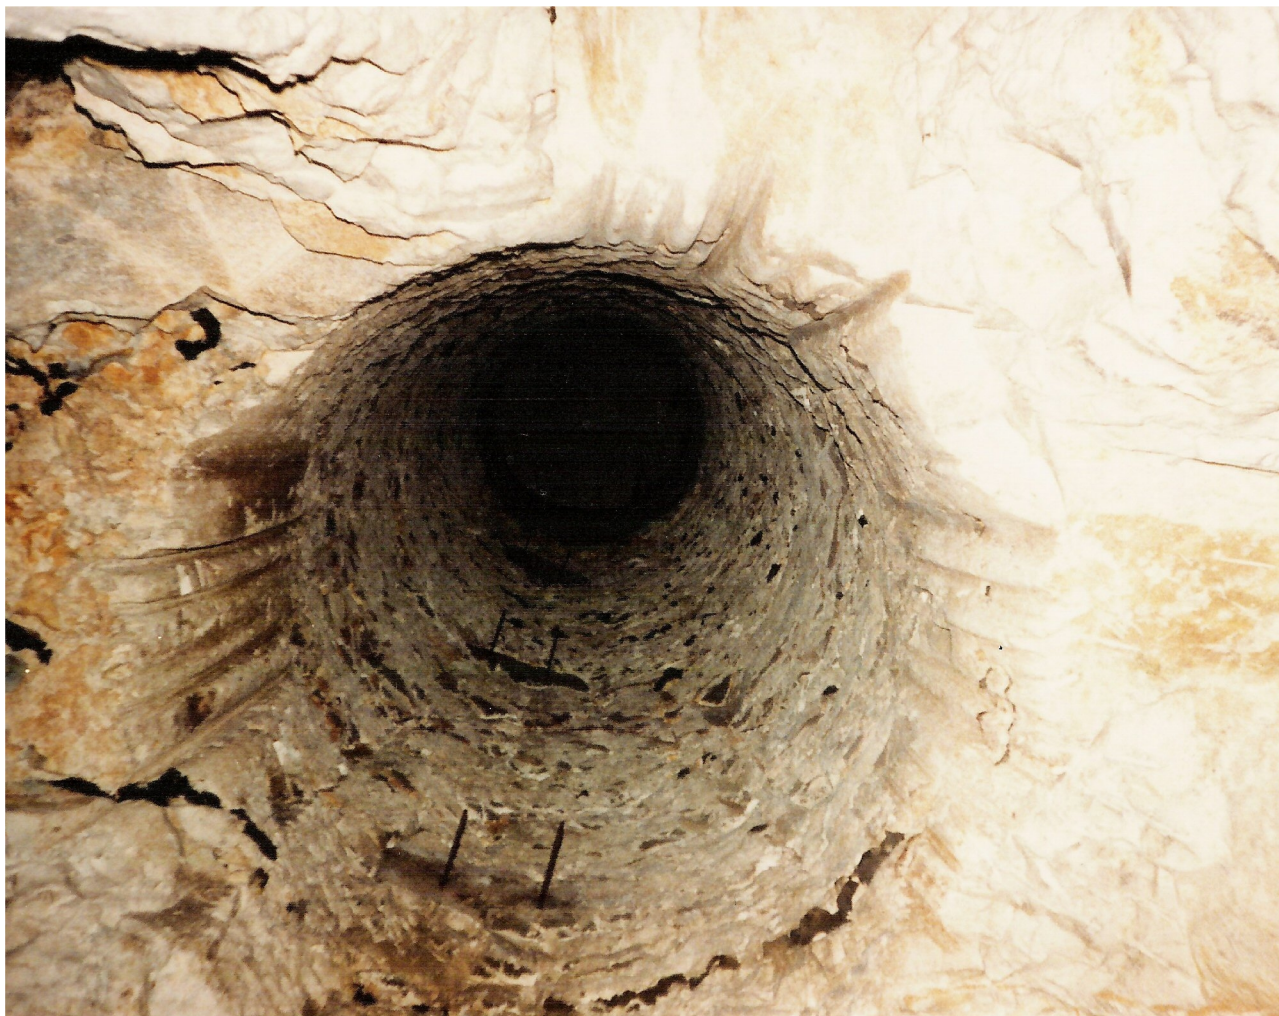
Plate 3 Main Shaft with ladder supports

Deep grooves were found at the base of the original shaft that had been formed as the heavy loads swung back and forth on the hauling rope as they were pulled up to the surface some 25m above. [Plate 3] Iron supports for a fixed ladder were still in-situ although the ladder had been removed when the mine ceased operation.

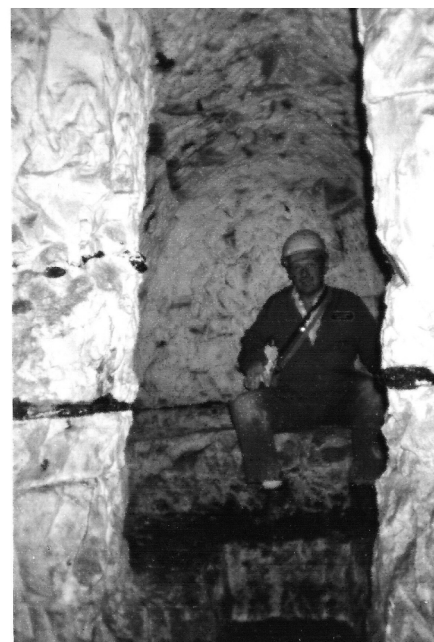
Plate 4 Small Room with Bench Seat  
Photo: H. Botterman

An interesting feature found just off a main gallery near the shaft was a small room cut inside a pillar and entered by a flight of four steps. A low narrow bench or seat cut in the chalk ran around the sides of this small room, which was probably used to store tools and where the men could take meal breaks. [Plate 4] This is shown on the plan as 'manager's room'. At this period, a manager of a chalk mine was not an executive or

administrator but more a skilled charge-hand or foreman. He would closely supervise the cutting of the roof profiles and the arching of the pillars where galleries joined.

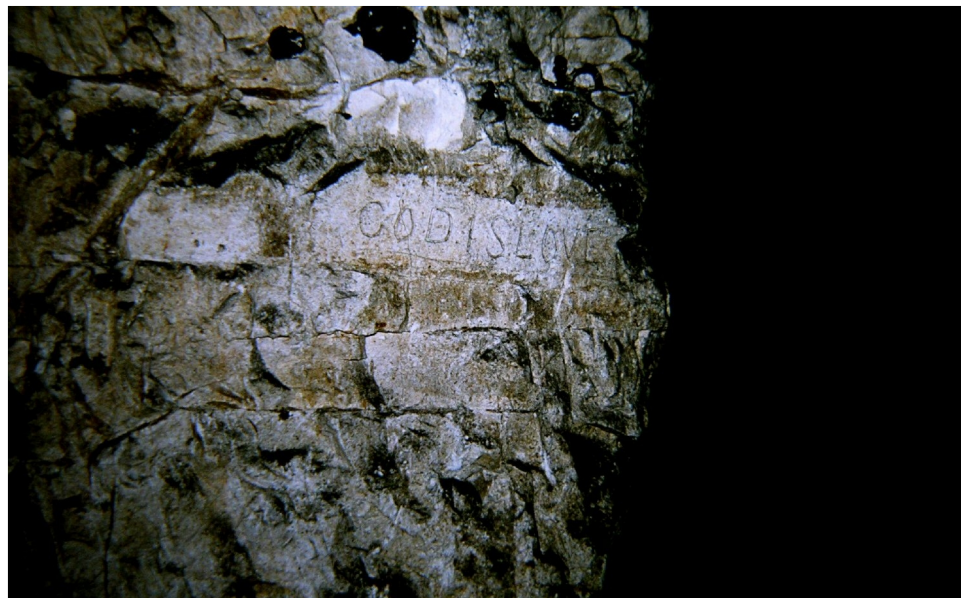
Plate 7 Base of Shaft Inscription

At the base of the shaft were a number of carefully cut inscriptions "COME UNTO ME ALL YE THAT LABOUR" and "GOD IS LOVE", [Plates 6 and 7] also the owners name "C N KIDD DARTFORD"

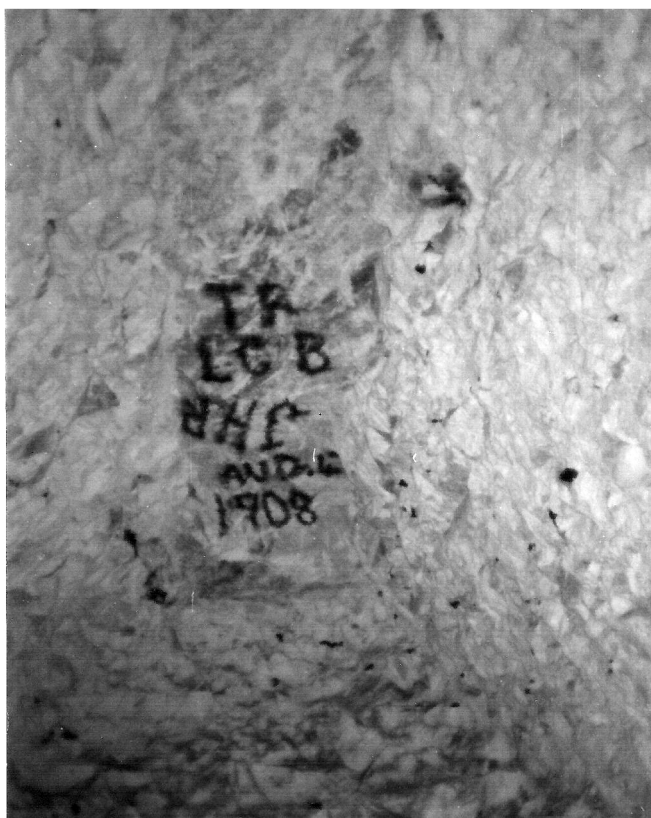
Plate 8 Smoked Initials on Roof

At the end of some tunnels, miners had smoked their initials in the roof. [Plate 8] In other places, they neatly carved their names on the walls. The mine was active from the mid 1880s to 1912 although the main bulk of dates found were between 1901 and 1911. One later inscription, "A E J PRICE 28.11.31", was probably made by a Council official inspecting the soakaway.

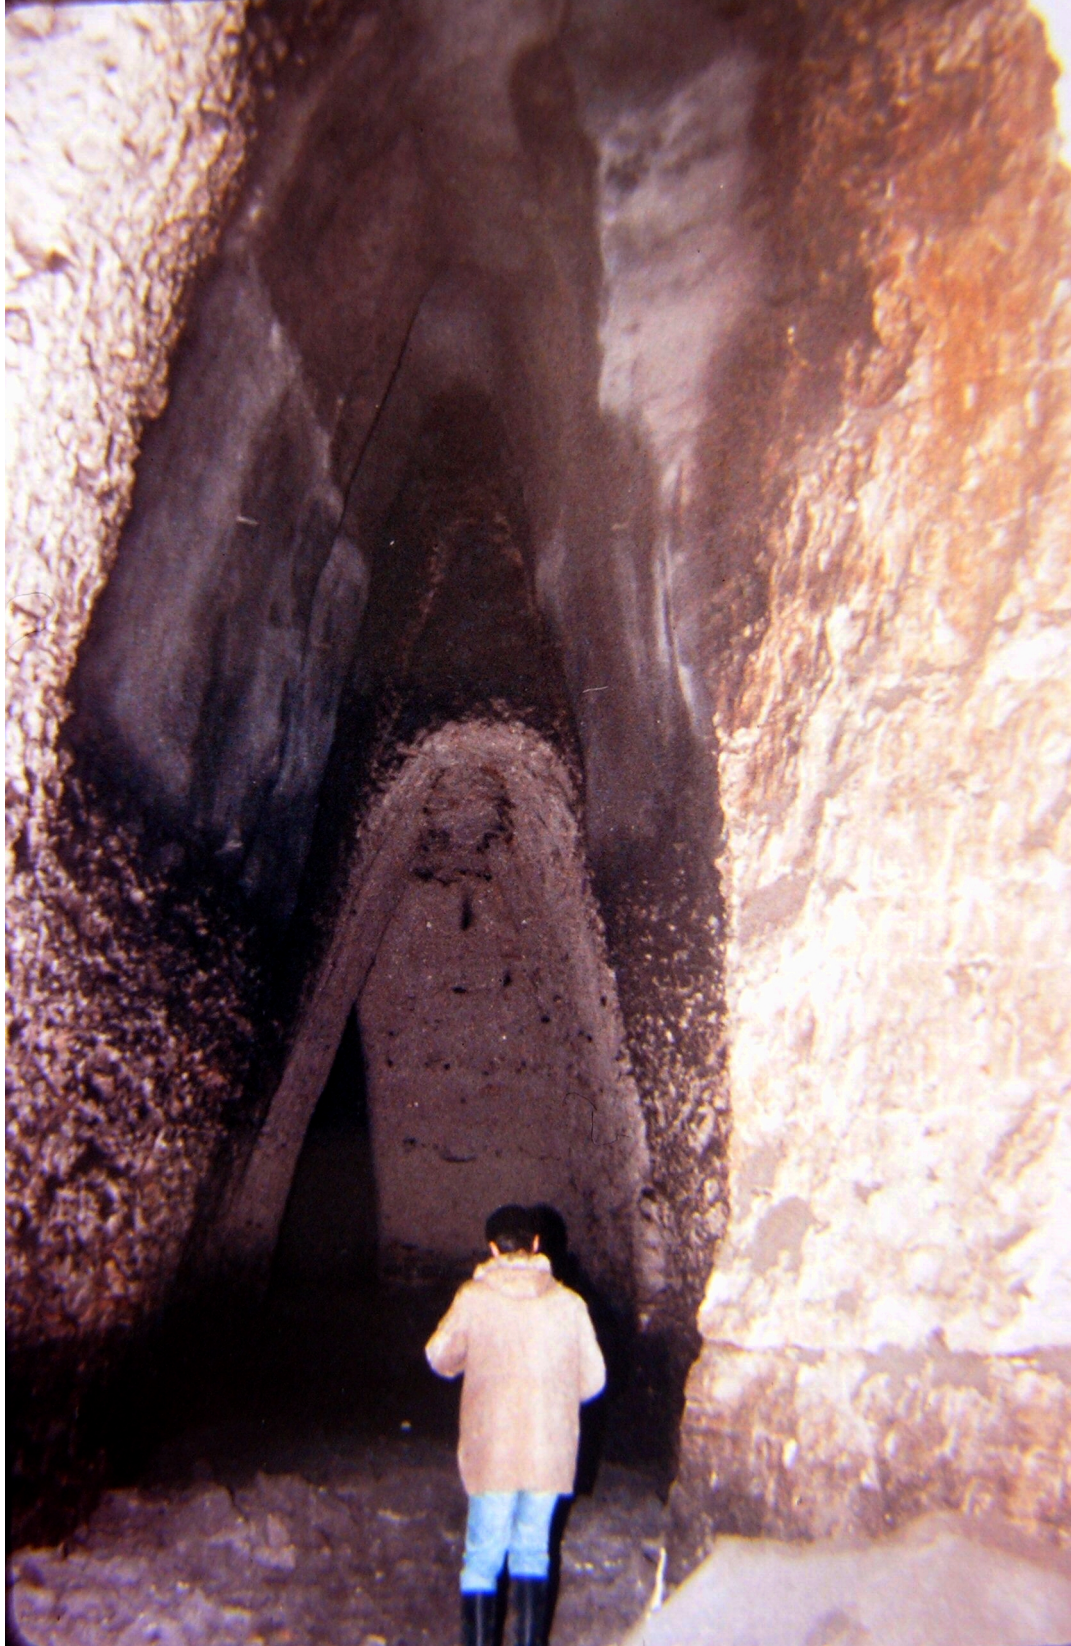
Plate 10 Remedial Works  
Photo: H. Botterman

After the 1980 examination of the chalk mine the land was finally sold off for building development. In 1986 the mine was re-entered by contractors who conducted an instrument survey of the chalk caves and undertook some remedial works to comply with safety recommendations. These measures took the form of spraying the roof in some parts with concrete to prevent small flakes of chalk falling [Plate 10] and modifications to the drain and well shaft. The Kent Underground Research Group assisted the contractors by undertaking a photographic survey on their behalf. At the same time the Group's surveyors completed their own survey, building on the measurements taken in 1980. [Fig 2]

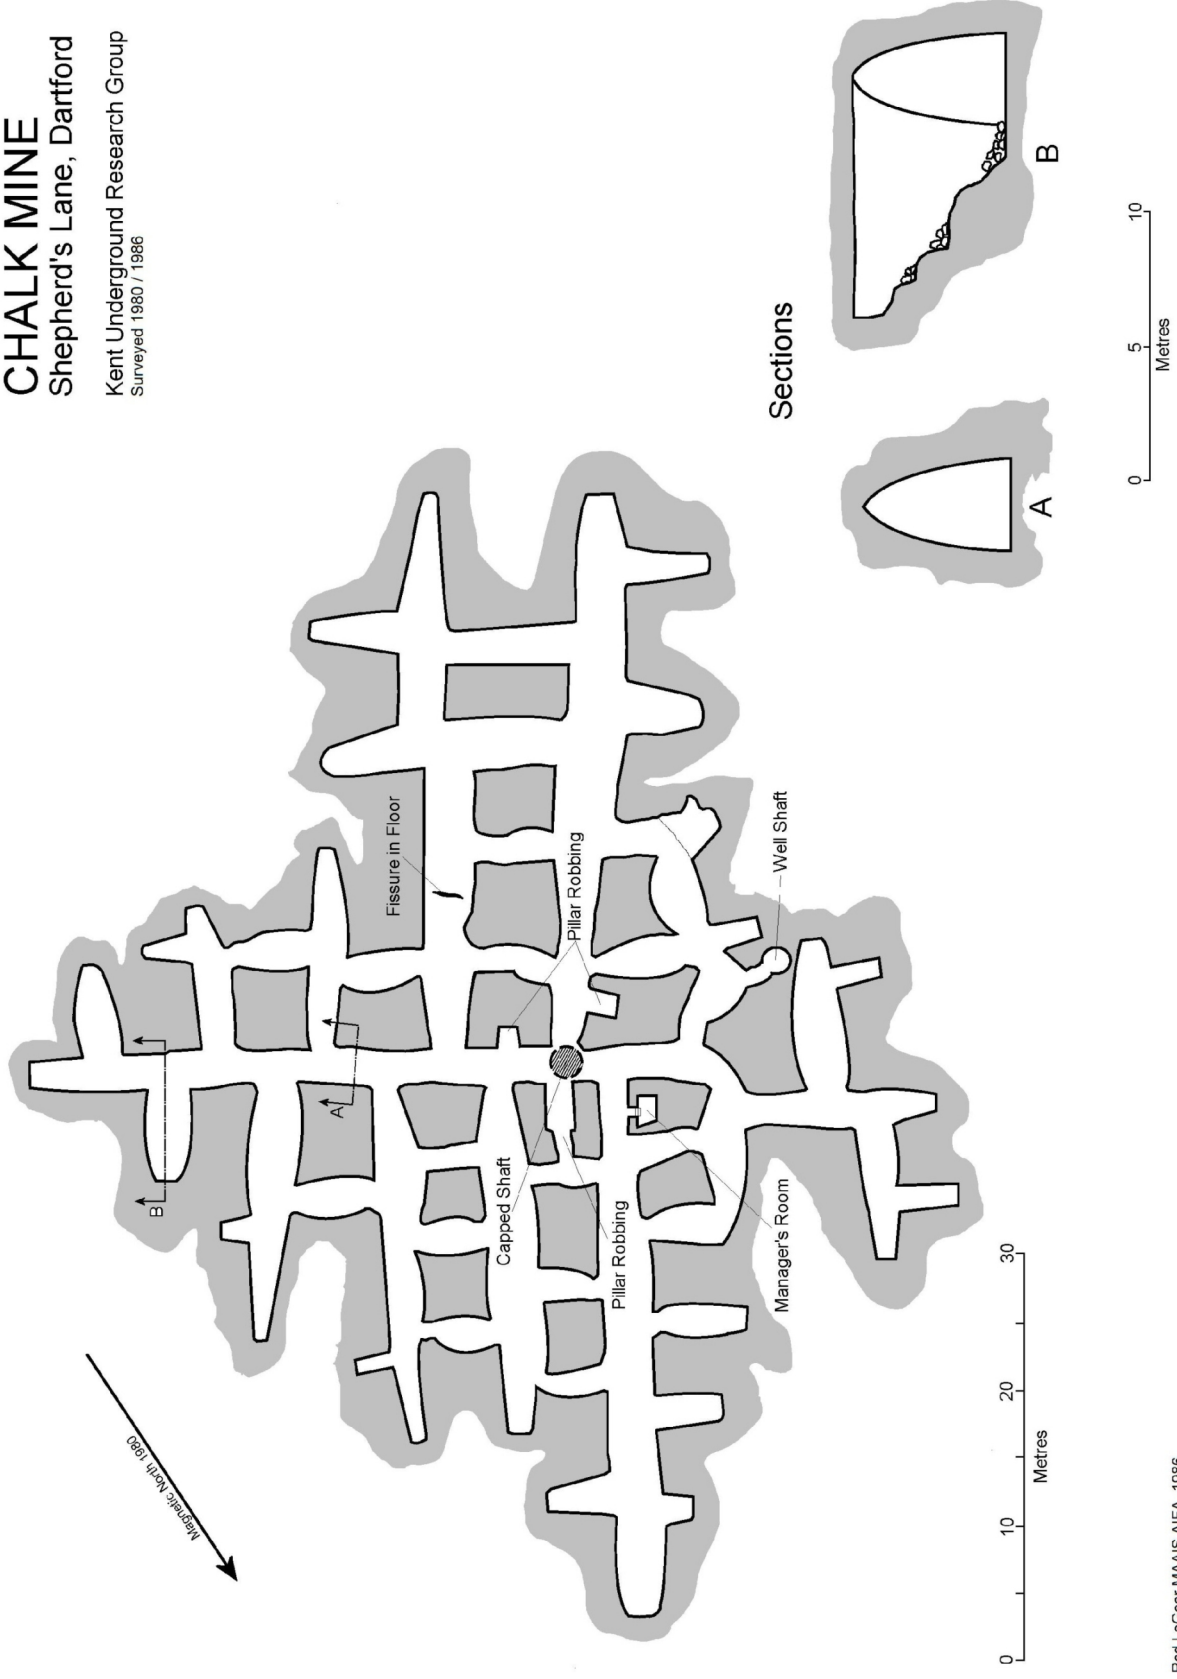
# CHALK MINE

Shepherd's Lane, Dartford  
Kent Underground Research Group  
Surveyed 1980 / 1986
