**15 KNIGHTRIDER STREET,
MAIDSTONE, KENT**

**A PROBABLE LATE-MEDIEVAL
'FUNCTION-ROOM' COMPLEX**

**A REVISED ARCHITECTURAL ASSESSMENT
AND INTERPRETATION
OF**

**Commissioned by
OSBORNE HOMES
on behalf of
ENGLISH CHURCHES HOUSING GROUP**

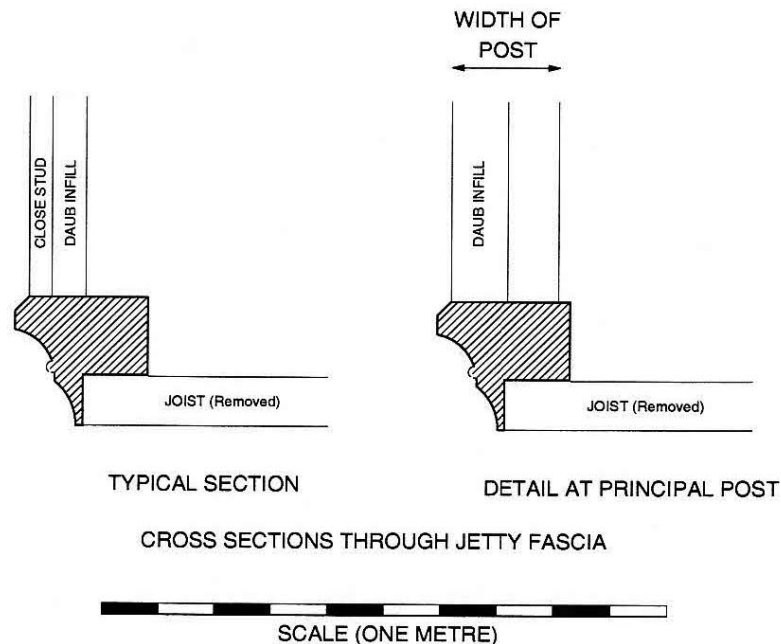
Due to the nature of the later alterations, no phase-2 first-floor joists now survive within the 'porch' wing, though some details as to the form of the phase-2 floor can be ascertained from the design of the western wall. Here, incorporated within the thickness of the later ground-floor brick wall, at the north-western corner of the wing, survives the head of a dragon post, complete with remnant of an integral bracket and the sawn-off fragment of the 165 mm x 100 mm dragon beam (see Plate 4). This is conclusive evidence that the upper storey of the 'porch' wing was jettied, and that the jetty returned along the side walls. Supported on the ends of the joists was the soleplate of the first-floor wall framing, much of which soleplate still remains (see Detail on right). This is of inverted 'L' cross section and measures 235 mm wide by 230 mm deep overall. The 'L' section is formed by cutting a 115 mm wide by 90 mm deep rebate out of the rear lower edge in order to accommodate the ends of the joists. Thus the soleplate sat over the ends of the joists and projected 120 mm forward from it. The external face of the plate extended down in the form of a fascia in order to mask the ends of the joists. This outer face is moulded with a hollow chamfer, roll, and casement mould, and incorporates a chamfer to its upper leading edge. As a result of this configuration, the face of the upper wall is stepped back 30 mm from the outermost face of the soleplate. Even so, the frame projects forward by 90 mm from the ends of the joists. Naively, this meant that most of the weight of the upper storey came down on the soleplate at a point beyond the end of the joists, giving a very weak arrangement. This is not the only known example - the same feature is to be found at a similar date at Preachers House, Ewhurst, East Sussex, where,

as a result of this detail, major structural failure occurred during the early 18th century [East Sussex Record Office HBR 1/269]. Here, similar failure appears to have been averted by underbuilding the jetty in brick during phase 5. At its northern end, above the fragment of the dragon post, the extant section of soleplate incorporates a mitre joint where it met the end of the now destroyed northern return soleplate.

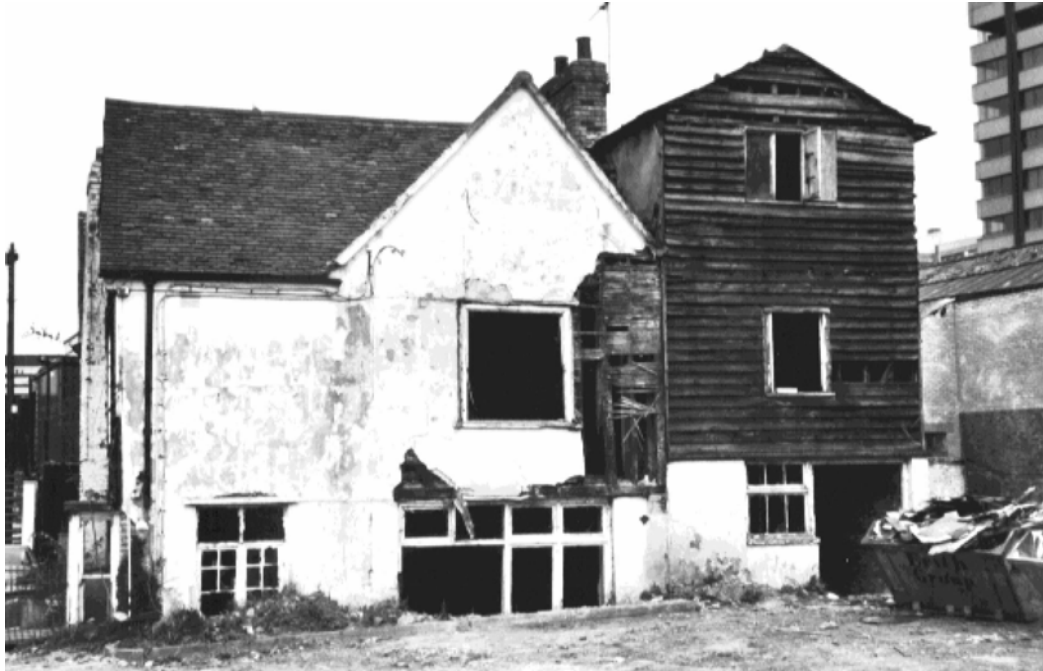
Plate 1

Exterior from south showing phase-2 main range in centre, phase-6 range on left and phase-8 range on right

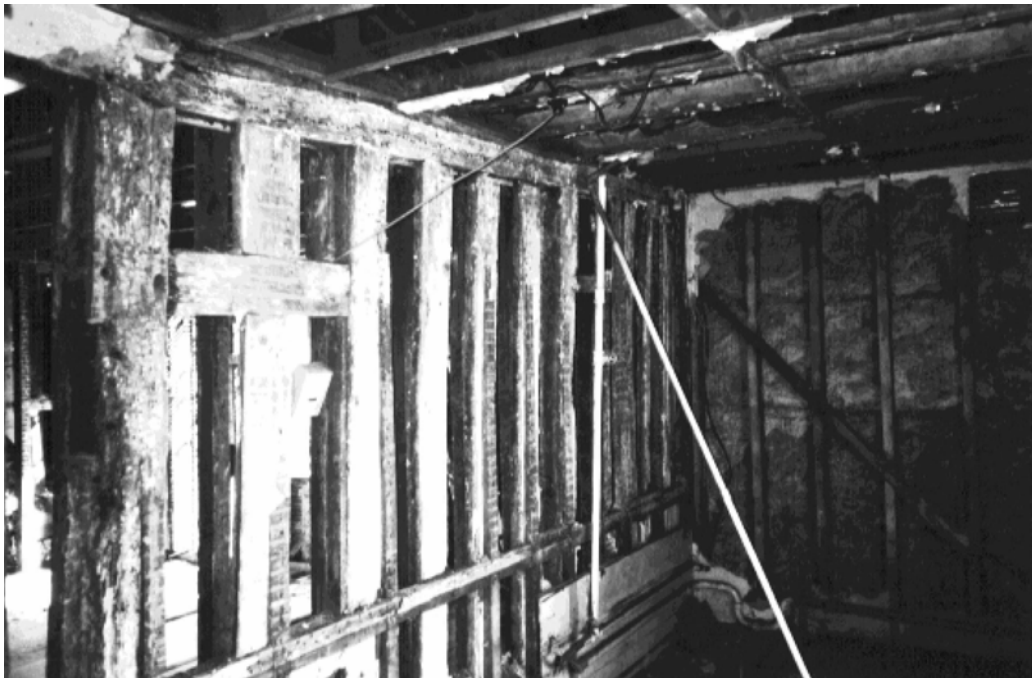
Plate 2

South-eastern corner of phase-3 'kitchen' range with remains of phase-5 range on right

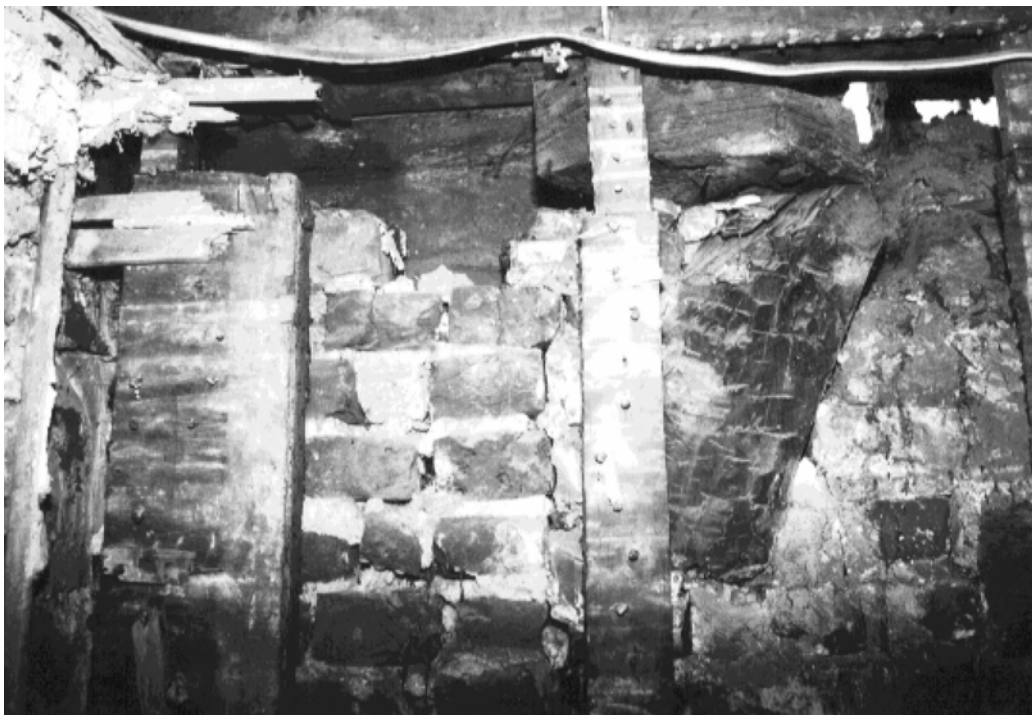
Plate 3

West wall of phase-2 main range showing external face. Note site of doorway leading into 'porch' wing on extreme left with blocked window immediately to the right.

The pair of first-floor phase-2 windows in the western wall of the 'porch' wing, and the single first-floor window in the western wall of the phase-2 main range have been blocked by nailing-in close studding and applying traditional thick daub (see Plate3). Although there is no proof that this occurred during phase 4, the added studs are noticeably weathered indicating that the wall framing remained exposed for some time after the windows were blocked. Given the new projecting window in the north elevation, it seems likely that the fenestration within the other rooms and chambers was upgraded at the same period, which would certainly be consistent with the blocking of these existing windows. If this was so, it can be certain that no windows were retained in the west wall of the first-floor hall, which was probably now served primarily by a new large central window inserted into the southern end wall, where there is certainly evidence for a large opening, albeit of uncertain date.

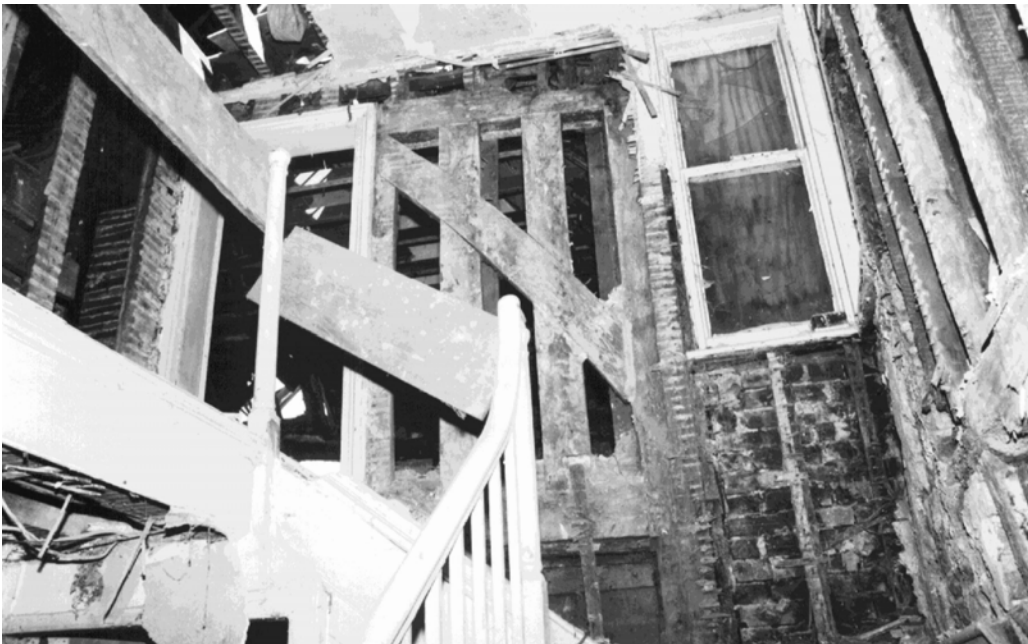
Truss E-E viewed from south showing intact arch braces of phase-2 open truss with added phase-6 infill framing visible behind 19th-century flimsy studwork. The phase-6 doorway is just visible beneath the left-hand brace, whilst the 19th-century doorway represents an enlargement of another phase-6 doorway.

The first-floor hall was crossed at E-E and F-F by arch-braced open trusses incorporating gently cambered tiebeams (Drawing No 1657/8). Only one principal post of truss F-F now remains, but truss E-E survives intact, complete with its arch braces (see Plate 5). The leading edges of all timbers are neatly chamfered, those to the principal posts and surviving tiebeam being neatly stopped at the ends.

Internally on the first floor the partition at truss D-D, between the two northern bays, was re-infilled and the former open truss at E-E was likewise infilled with framing so as to form a partition (see Plate 5 and Drawing No. 1657/19). As Drawing No. 1657/19 shows, unlike the external walls these were of more traditional small-panel design, though using flimsy timbers. The staves supporting the laths are regularly spaced and were left exposed on the partitions' secondary faces (ie facing into the enlarged porch chamber), with the daub applied between them. Within truss E-E are incorporated two doorways. The eastern of these (leading from the landing into the main room) was enlarged in the 19th century, destroying all details, but the western opening survives. It is rebated towards the main room so as to accommodate the door when closed, whilst the northern face is chamfered with cyma stops at the base.

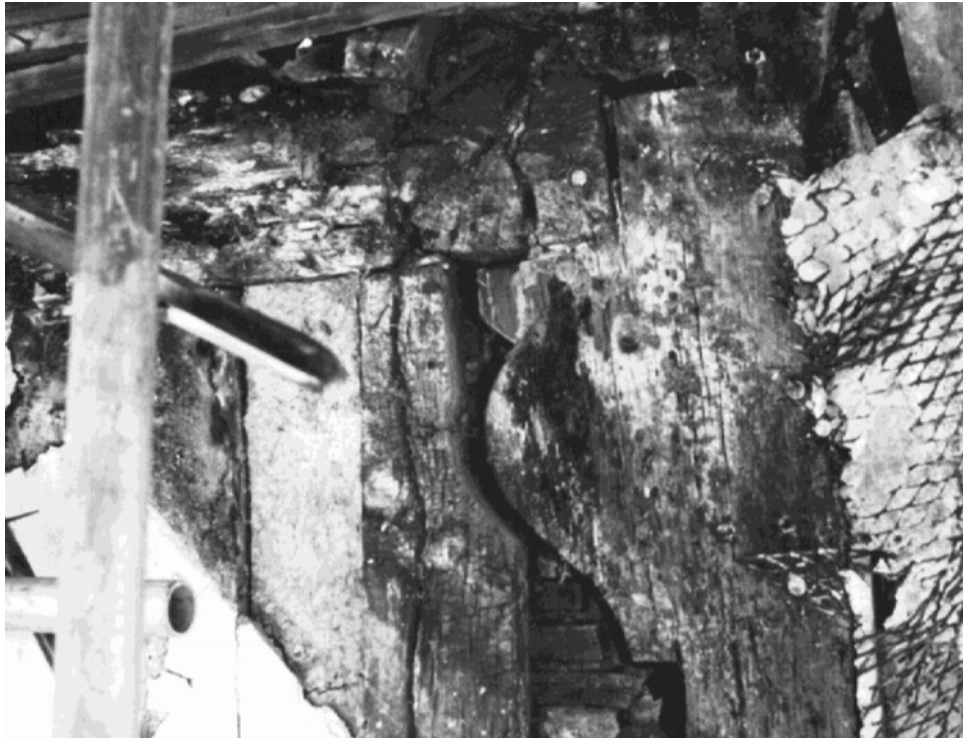
Plate 6

Western face of west wall to phase-3 'kitchen' range viewed from within the rebuilt link. Running diagonally across this wall framing from a mortice at side-girt level within the principal post is a weathering line, indicating the phase-3 roof slope.

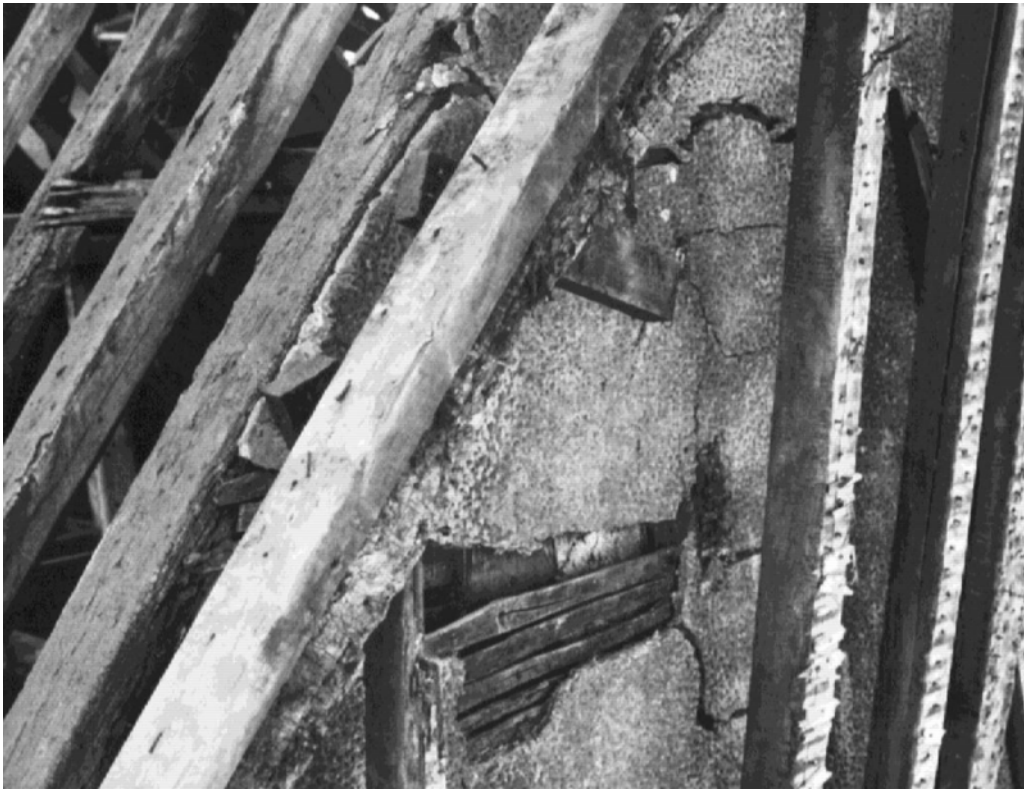
Plate 8

Reed ceiling, probably phase 5, added to underside of rafters and collars within the phase-3 'kitchen' chamber

On the upper floor the tiebeam to the intermediate truss (H-H) within the 'kitchen' range was removed and a high-level ceiling was inserted into the enlarged first-floor phase-3 chamber. This was attached to the rafters and collars. The present ceiling is of daub and lime plaster applied to reeds fixed to the soffites of the medieval timbers (see Plate 8) - its date is uncertain.

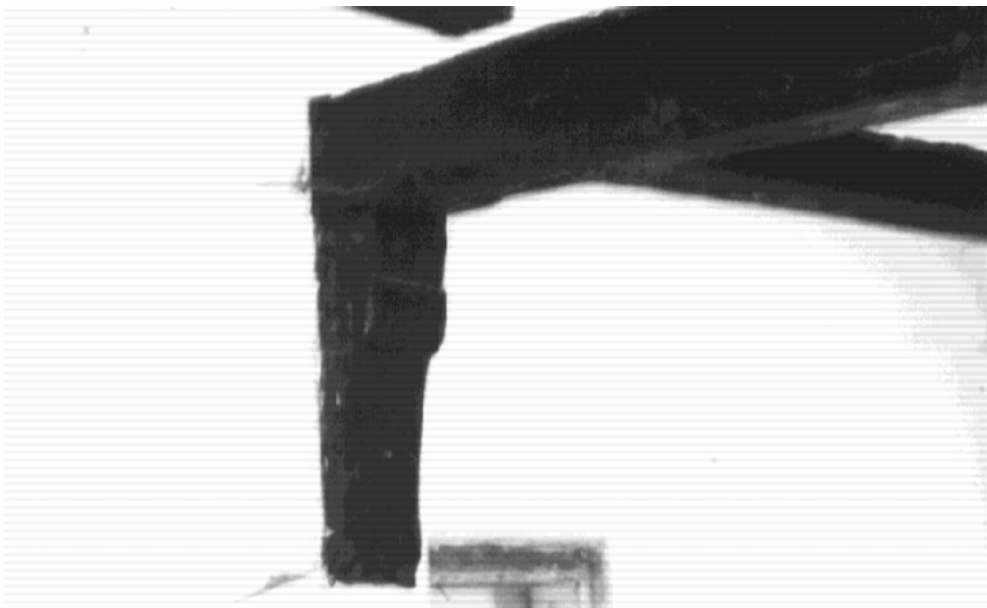
Plate 10

Phase-6 decorative bracket fixed to the northern face of principal post of truss E-E in order to help support the phase-6 replacement wallplate following removal of the infill framing to the phase-2 western wall of the main range.

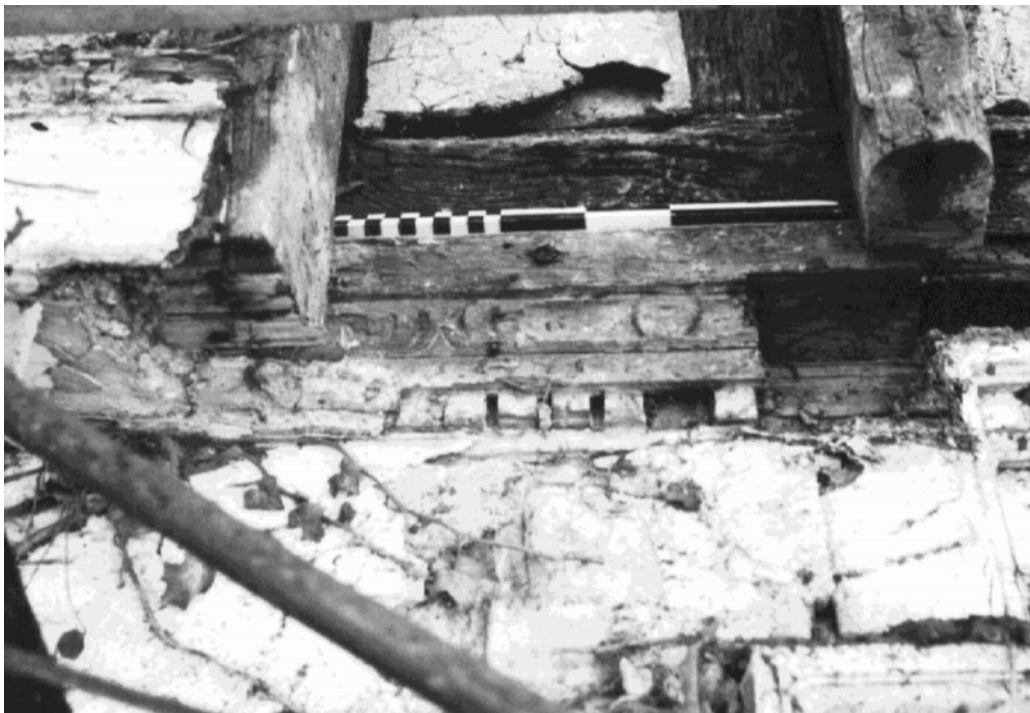
Plate 11

Remains of phase-6 decorative timber fascia at junction between ground-floor brickwork and first-floor weatherclad timber framing within west elevation.
