**Kent Archaeological Society
Archive Box No.3 P.J.Tester FSA
Boxley Abbey**

Review of Contents

by
N.J.Hill B.Sc, C.Eng, FICE

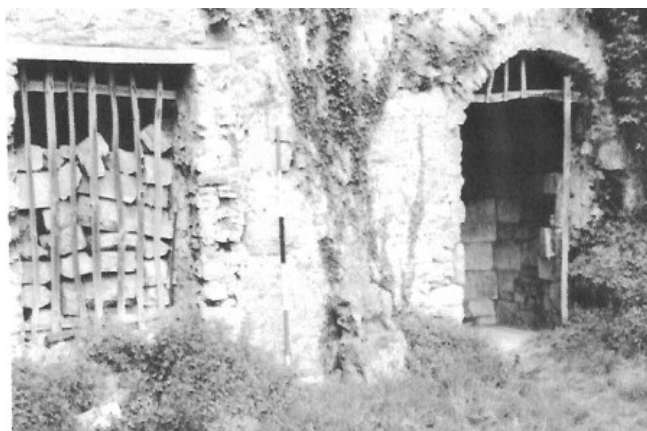
The outline of the nave of the mid-twelfth-century church is represented by standing walls, largely rebuilt or re-faced, on the north, west and south sides, now enclosing the remains of a derelict water-garden. The western part of the south wall is original and contains a round-headed doorway. This and the rectangular opening just west of it were unblocked by Payne, and subsequently a small area was enclosed to the north and roofed over to form a modern chapel. In the west wall the splayed jambs of a blocked medieval window are apparent.

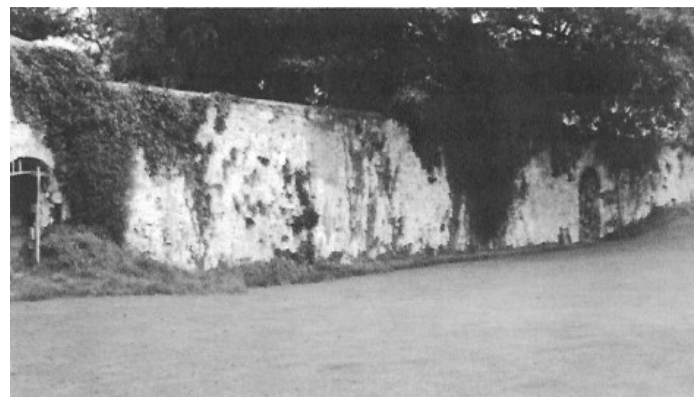
The rectangular opening in the south wall shows little evidence of medieval origin and has jambs of much-weathered Tudor bricks. Payne is said to have found it blocked by numerous fragments of a late-medieval canopied tomb, now preserved. in the modern chapel. Here can be seen the angle of the western respond of the south arcade, built of chalk ashlar. The plain round-headed doorway referred to above is undoubtedly twelfth-century and formed the south-west entrance to the church. Further east, there is another round-arched opening, turned in brick, forming the entrance to a tunnel passing under the terrace covering the site of the south aisle and possessing no signs of marking a medieval entrance. Just east of it is a further brick arch, almost at ground level, possibly related to the drainage of the water-garden. The main entrance to the church from the cloister would have been in this south wall near its junction with the transept, but all trace of it has disappeared with modern re-facing.

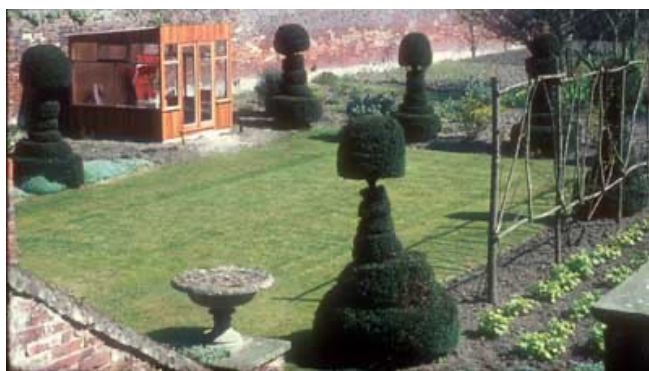
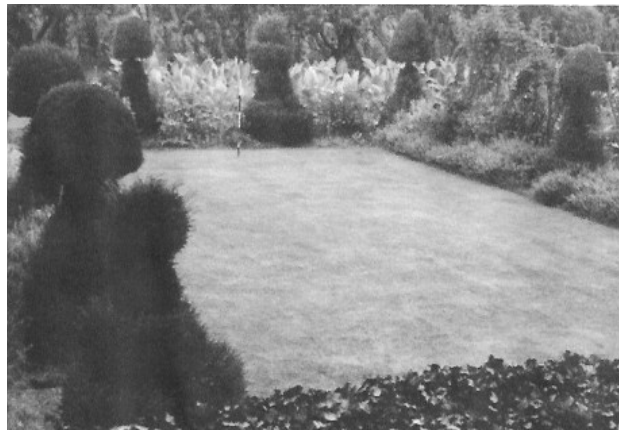
Bordering three sides of the raised lawn now covering the area east of the nave are nine clipped yew-trees planted in times past to mark the foundations traced by Payne (Plate IA). They form the outline of a typical short square-ended eastern limb of the church, such as the Cistercians frequently constructed before the relaxation of their customs in the late-twelfth and thirteenth centuries. To verify the traditional significance of these trees, we excavated between two in the eastern alignment and found, at a depth of 3 ft. 9 in., a massive rubble foundation marking the eastern limit of the church. The presence of flower beds prevented us from confirming the north and south walls in similar manner.

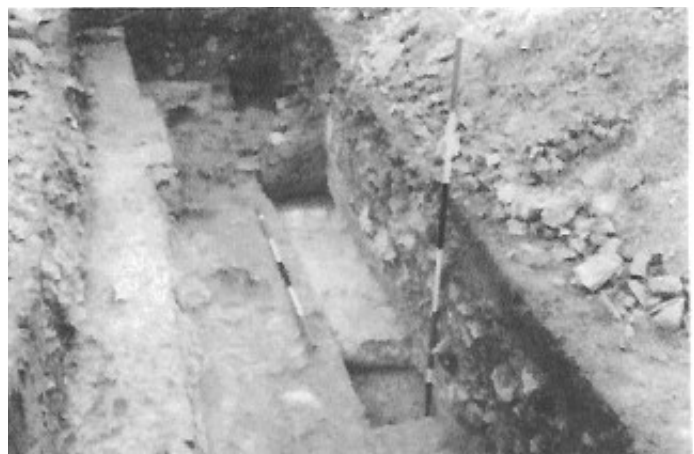
Trench 1 followed by Trench 4

The base of the altar in the north chapel was uncovered, and it appeared that this had been reconstructed at one time, and the floor raised about 6 in. The first altar was 5 ft. 6 in. long and

backed against the east wall. Later it seems to have been rebuilt to stand 1 ft. 6 in. from the wall, its width (east-west) being 3 ft.

Originally the floor was laid on rammed chalk and had been raised by a layer of clay and chalk capped by a thin spread of mortar intended as a bedding for tiles. Both lateral walls of this chapel retained traces of plaster.

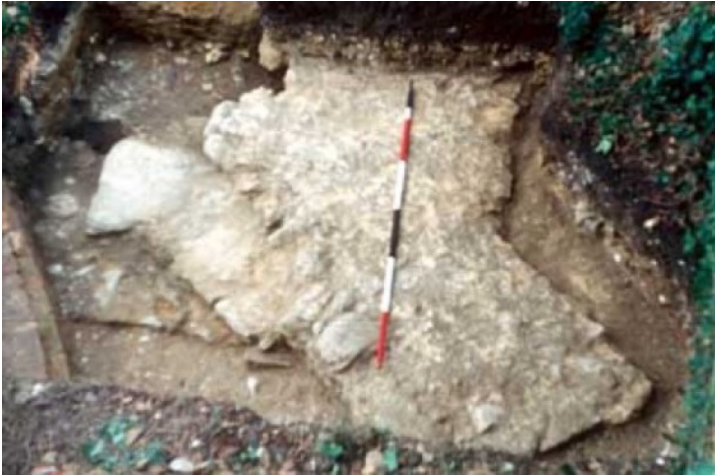
An unexpected result of excavating outside the west end of the church was the discovery of foundations of an attached structure with diagonal buttresses at its south-west and north-west corners.

This was clearly a late addition, probably built in the fourteenth or fifteenth centuries, and forming either a porch or a tower. It is more probable that it was the latter although it is impossible to establish this with certainty. The footings seemed more substantial than required for a porch—even one with an upper storey. On plan it may appear disproportionately small for a tower, although its actual dimensions are no less than many of those attached to parish churches. It is known that a

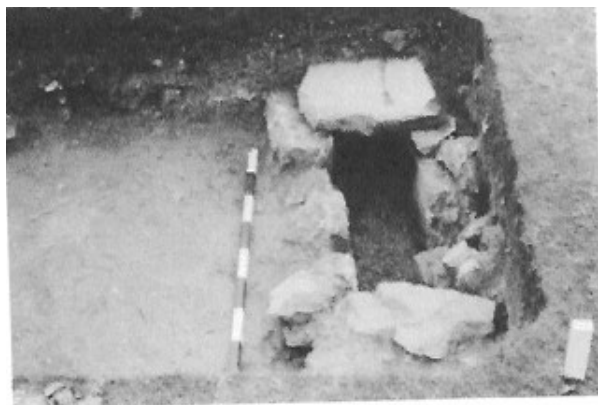
Excavation has shown that the north and west alleys were wider than those on the south and east and that the arcades rested on narrower footings. There is documentary evidence that rebuilding was put in hand in 1373 when the abbey employed a mason named Stephen Lomherst to demolish the old cloister and rebuild it, one alley at a time, but from the excavated remains it seems likely that only the north and west alleys were in fact reconstructed (Appendix II).

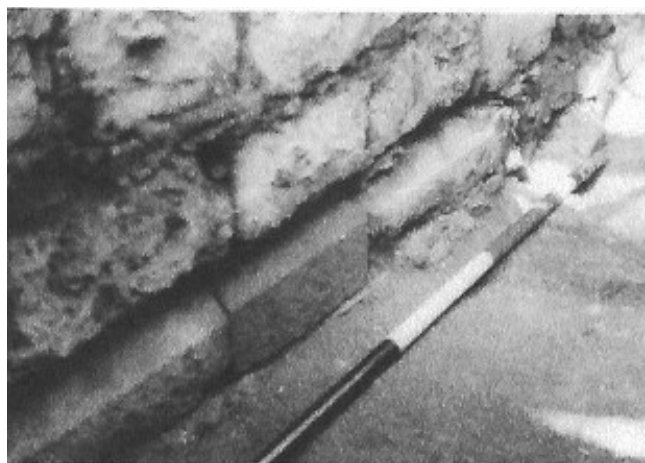
West wall of Chapter House cill of opening covered by later blocking

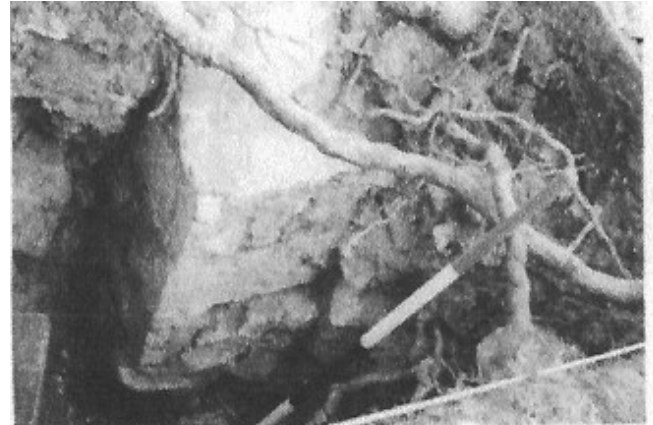
Entrance to Parlour

Remains of the lower part of the parlour entrance were found to be well preserved, the unraoulded jambs being of chalk, with a stone cill set in the floor immediately inside the opening. Probably there was also a doorway in the east end. A short length of the return wall on the south side was observed, sufficient to indicate the width of the apartment.

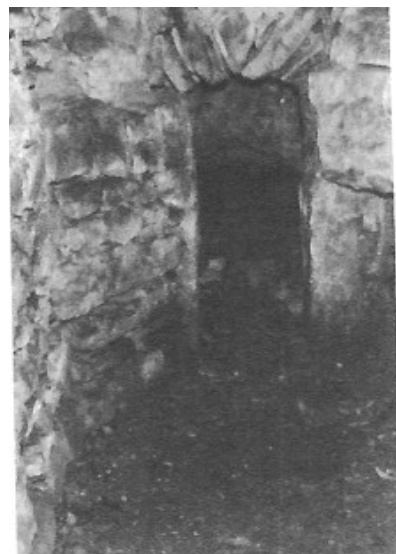
Sluice Gate

The sanitary arrangements at Boxley seem to have been similar to those at Kirkstall and Valle Crucis where instead of the latrines being housed as usual in a building projecting at right-angles to the end of the dormitory, they were situated in the end of the east range itself with a drain passing beneath.¹² At Boxley the drain is well preserved, its course continuing some distance to the east where it is covered by a pointed barrel vault. Water was conducted from a source to the north, where rivulets still run in the fields, and made to flow westward through the vaulted drain. Immediately on the line of the east face of the dormitory range there is a constriction in the drain with vertical grooves on each side where a wooden sluice-gate held back the water before it passed beneath the latrines (Fig. 2). When the gate was raised from above, the water flowed with sudden force to scour the area under the privies, apparently escaping into a ditch running southward for about sixty yards into an existing pond. Surface indications of this ditch remain in the field between the pond and the Abbey. In the wall forming the south side of the drain are openings to provide access for the purpose of removing accumulated silt.

Following site investigations by Kent Underground Research Group (KURG) in July 2020 an alternative postulation has been offered. This proposes that rather than the latrines being situated at the end of the east range of the dormitory, they are instead in a building projecting at right angles to the end of the dormitory, the reverse of the suggestion above. The sluice gate is at the downstream end of the reredorter. Hence, in a form a little like a communal form of a modern WC, latrine waste falls into a channel that is normally full of water. At intervals, the sluice gate is lifted and the backed-up water in the reredorter channel surges downstream taking the accumulated waste with it. (with thanks to Robert Hall, KURG)

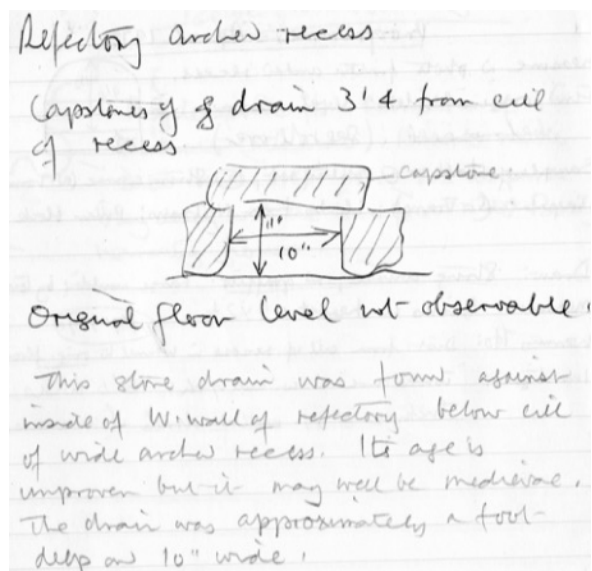
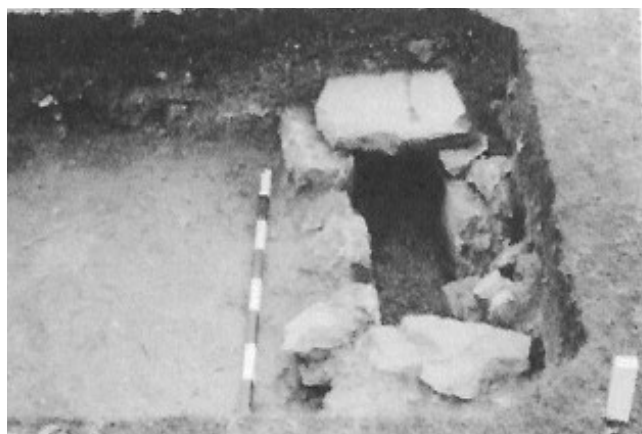
Inside the west wall there occurs a wide but shallow round-arched recess, 8 ft. high and 9 ft 6 in. wide, its cull being 2 ft. above ground level or about 1 ft. more from the refectory floor (Plate IB). If it were situated in the cloister, it would be unhesitatingly accepted as the site of the lavatorium, where the monks washed their hands before and after meals. In the position it occupies, however, it would be unwise to assert that this was its function without strong supporting evidence. A small excavation below this recess disclosed a stone drain running north-south against the foot of the wall. Just to the south, a blocked doorway can be observed in this wall and most likely it communicated with the monastic kitchen.

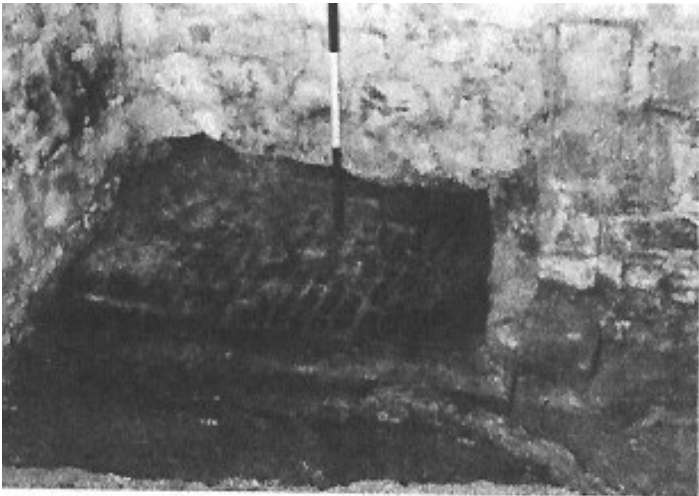
Warming House

lower part of B is blocked at later date.
 windows & door in both A & B are later
 insertions - the two pointed windows
 probably modern.
