**An Archaeological Evaluation at  
The Command House Public House, Gun Wharf, Dock Road,  
Chatham, Kent, ME4 4TX**

**Project No: 5115  
Site Code: GWC 11**

**ASE Report No: 2011249**

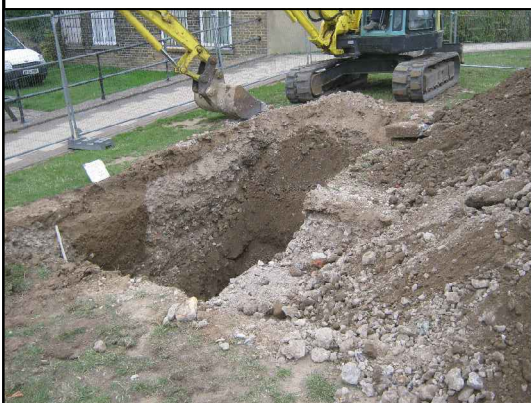
Fig. 3.1: Trench 1, looking north-east

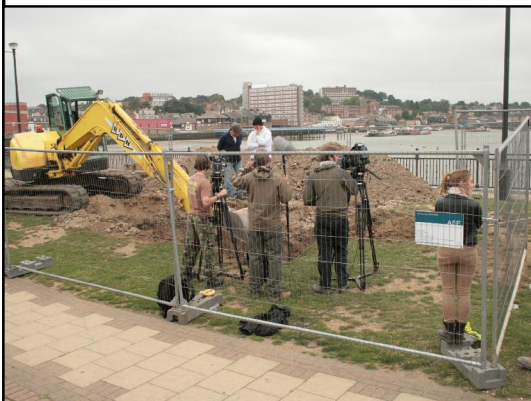
Fig. 3.2: Trench 1 looking south-west

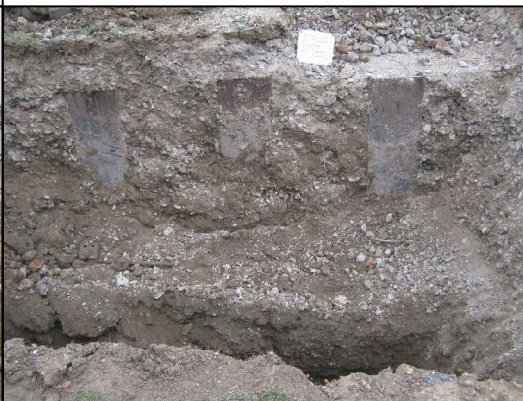
Fig. 3.3: Sheet piling in trench 1, looking south-west

- 3.2.2 Trench 1 was 4.00m by 1.80m and centred on a ground penetrating radar anomaly close to the sea wall. This trench immediately identified the anomaly just below the existing ground level, which proved to be a section of metal sheet piling. The trench was rotated by 90° and excavation continued down the landward side of the piling in order to fully confirm that this was the origin of the anomaly and that there were no other features in the area.
