Archaeological Watching Brief Report Emmett's Gardens, Near Brasted Kent

Planning Reference: SE/10/02220

ASE Project No: 4773 Site Code: SEG 11

ASE Report No: 2012003 OASIS id: archaeol6-116737

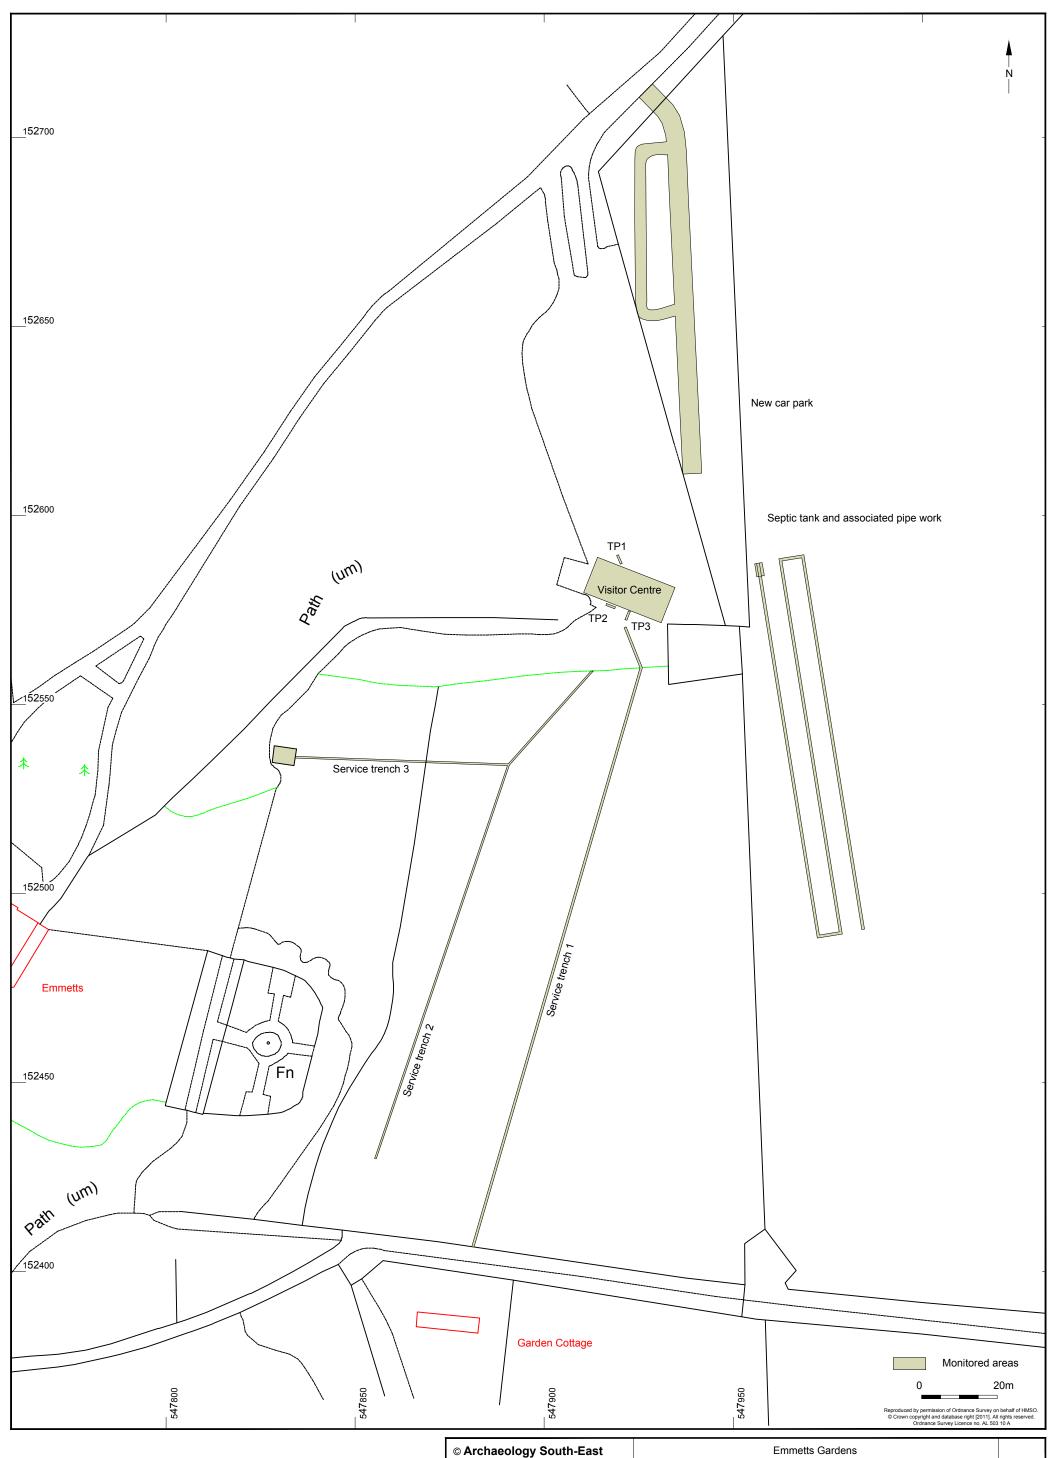
© Archaeology South-East		Emmetts Gardens	Fig. 2
Project Ref: 4773	Jan 2012	Dian of manifered areas	1 1g. 2
Report Ref: 2012003	Drawn by: JLR	Plan of monitored areas

4.0 RESULTS (Figure 2)

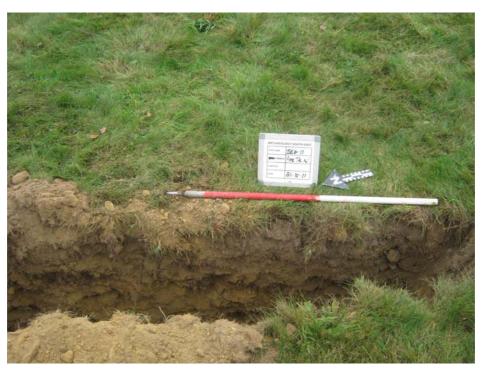
- 4.5.2 Trench 1 encountered the geological substrate at 0.23m BGL in the south west and at 0.33m BGL in the north east. This was overlain by 0.16-0.26m of subsoil [002] and 0.07m of topsoil [001]. A single flint flake was recovered from the subsoil during the excavation of this trench.

Trench 1, sample section looking east

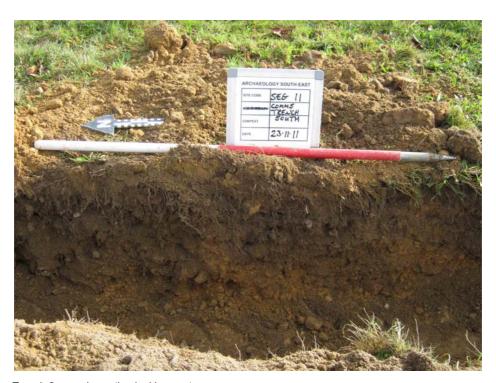
- 4.5.3 Trench 2 revealed geology [003] at 0.35m BGL in the south west and 0.28m BGL in the north east overlain by 0.20-0.25m of subsoil [002] and 0.08-0.10m of topsoil [001].

Trench 2, sample section looking east

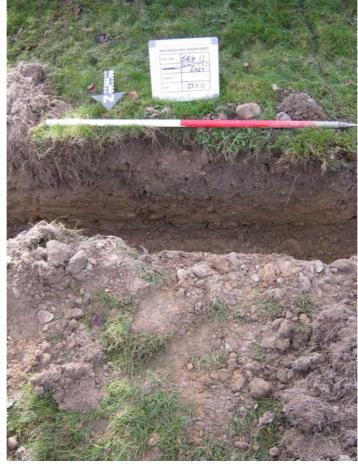
- 4.5.4 Trench 3 encountered the geological substrate [003] at 0.31m at both ends of its course. This was overlain by 0.22-0.25m of subsoil [002] and 0.06-0.09m of topsoil [001].

Trench 3, sample section looking south

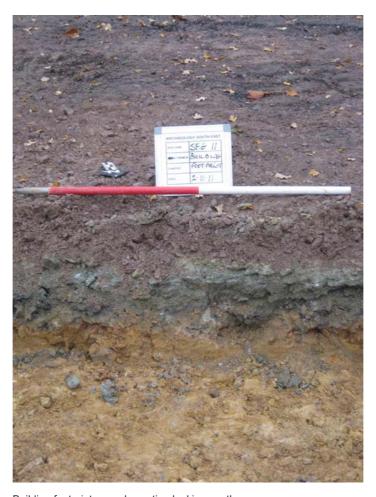
- 4.3.1 Ground reduction in the footprint of the new visitor centre revealed 0.15-0.40m of made ground directly overlying the geological substrate [003]. The geological horizon was observed to be heavily rutted and disturbed, presumably by activity associated with the construction of the existing car park.
- 4.3.2 No archaeological finds or features were observed.

Building footprint, sample section looking south

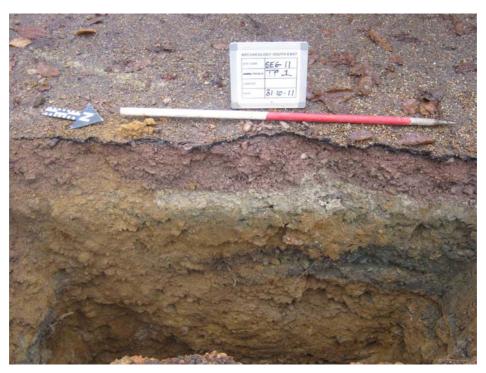
- 4.2.1 Three geotechnical pits were dug in the existing car park area adjacent to the footprint of the new visitor centre.
- 4.2.2 Test Pit 1 was 2.5m long and 0.55m wide and revealed made ground [004] to a depth of 0.80m BGL directly overlaying the natural substrate [003]. This made ground consisted of alternating layers of tarmac, type 1 crush and redeposited natural presumably forming the base for the existing car park.
- 4.2.3 Test Pit 2 was dug to similar dimensions and revealed 0.40m of made ground [003] directly overlying the geological substrate [003].
- 4.2.4 Test Pit 3 was dug and backfilled before measurements could be taken but given that it was dug in close proximity to Test Pit 2 as well as the visitor centre footprint it is safe to assume that the stratigraphy in this test pit was similar.

Test pit 1, sample section looking west

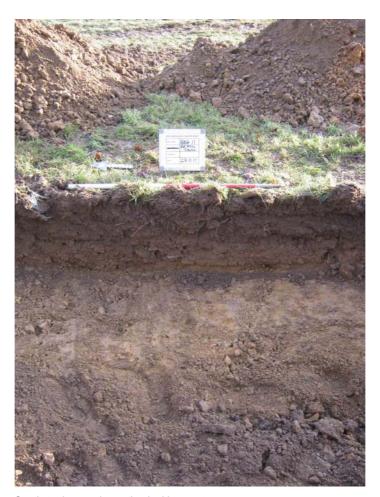
- 4.4.1 A small area measuring 2.0 x 3.5m was dug to accommodate a septic tank in the field to the east of the existing car park. This was stripped to the geological horizon under monitoring. Associated with this were three pipe trenches 100m long, 0.70m wide and dug to 0.9m deep. These were linked by two 6.0m returns.
- 4.4.2 The footprint of the septic tank showed the geological substrate [003] at 0.50m BGL overlain by 0.40m of subsoil [002] and 0.10m of topsoil [001]. No archaeological finds or features were observed.
- 4.4.3 Monitoring of the associated pipe trenches revealed identical stratigraphy with the geological substrate encountered at a maximum depth of 0.49m, the subsoil overlying it [002] seen to a maximum depth of 0.37m and a maximum depth of topsoil [001] of 0.15m. A selection finds were recovered from the subsoil. No archaeological features were observed.

Septic tank, sample section looking east

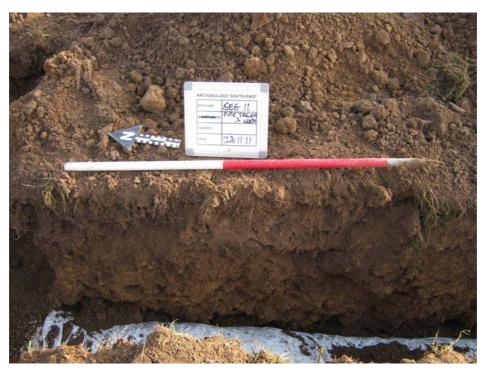
Septic tank associated pipe trench, sample section looking east

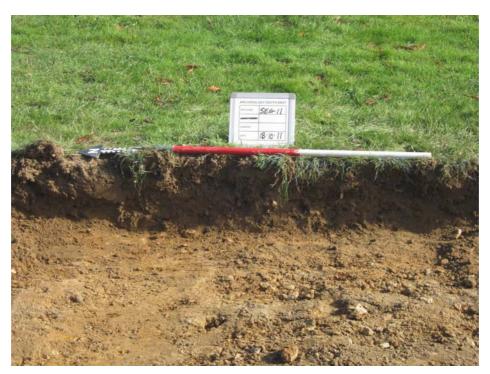
- 4.1.3 The southern part of the road strip revealed geological substrate [003] at 0.30m BGL, overlain by 0.23m of subsoil [002] and the whole capped by 0.07m of topsoil [001]. An identical sequence was noted at the midpoint of the road strip and at its northern extent. Wheel rutting was noted in the geological horizon consistent with this area being used as an overflow car park. No archaeological features were observed although some finds were recovered from the subsoil.

New car park, sample section looking east
