**An Archaeological Watching Brief  
On Land at Groombridge Place,  
Groombridge, Tunbridge Wells, Kent**

**Project No. 3089**

**November 2007**

**Archaeology South-East  
Units 1 & 2  
2 Chapel Place  
Portslade  
East Sussex  
BN41 1DR**

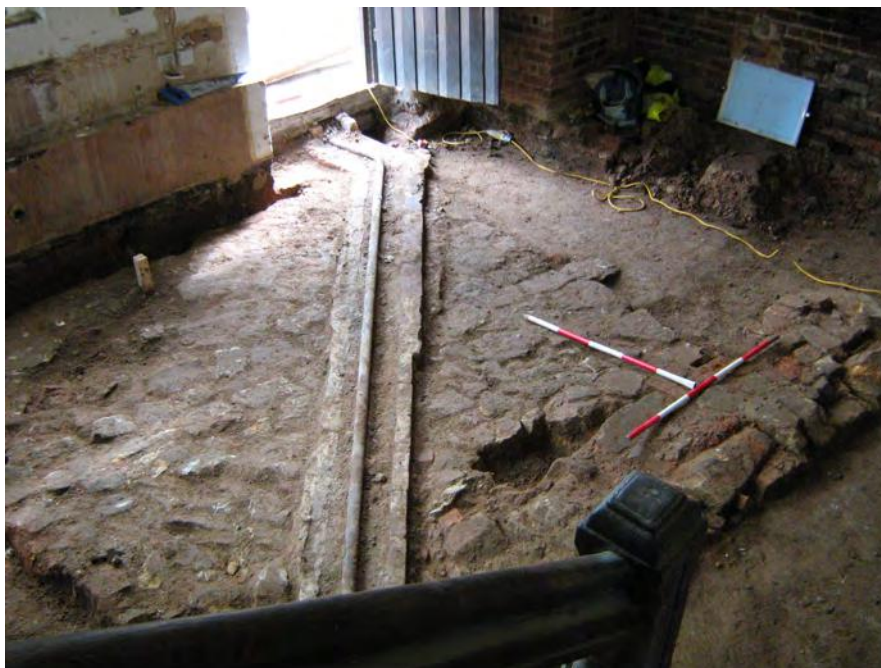
- 4.2 Located below Context **100** a sandstone and brick surface was encountered (Context **101**) (Plate 1). The exposed extent of this layer measured approximately 3.32m by 2.94m, and was truncated to the north and east by the main external walls of the house (Fig. 4). The surface was composed of varying sized blocks of Wealden sandstone and red brick. The stone blocks were irregular and roughly hewn, but mainly roughly square with a maximum size of 300mm<sup>2</sup> by 200mm deep. The brick existed as occasional fragmentary blocks infilling across the layer. No coursing or mortar was evident. This layer had been laid abutting structure **102** to the west and had a clearly defined southern edge. A cavity in the floor surface was noted adjacent to the probable wall footing **102**. This measured 280mm by 100mm by 150mm and perhaps represents the location of a structural or tethering post. A line of regular sandstone blocks was also noted running north to south within **101**.

Plate 1: SE facing shot of Context 101

- 7.2** The fragmentary survival of both the wall footing **102** and layer **101** prevents a clear interpretation of their function. However, the unfinished surface of layer **101** indicates a floor surface, possibly external. This interpretation is supported by the presence of a regular line of smooth sandstone blocks orientated N-S, extending beyond the edge of the layer to the south and following the orientation of the wall footing **102**. This feature may possibly represent an alignment of a barn or byre compartment. No discernable reduction of floor level at this point perhaps precludes the possibility of the feature forming a drain, although the regularly spaced blocks and smooth surface may have facilitated water run-off. The presence of a cavity in the surface of **101** close to the wall footing perhaps represents the location of a structural or tethering post.

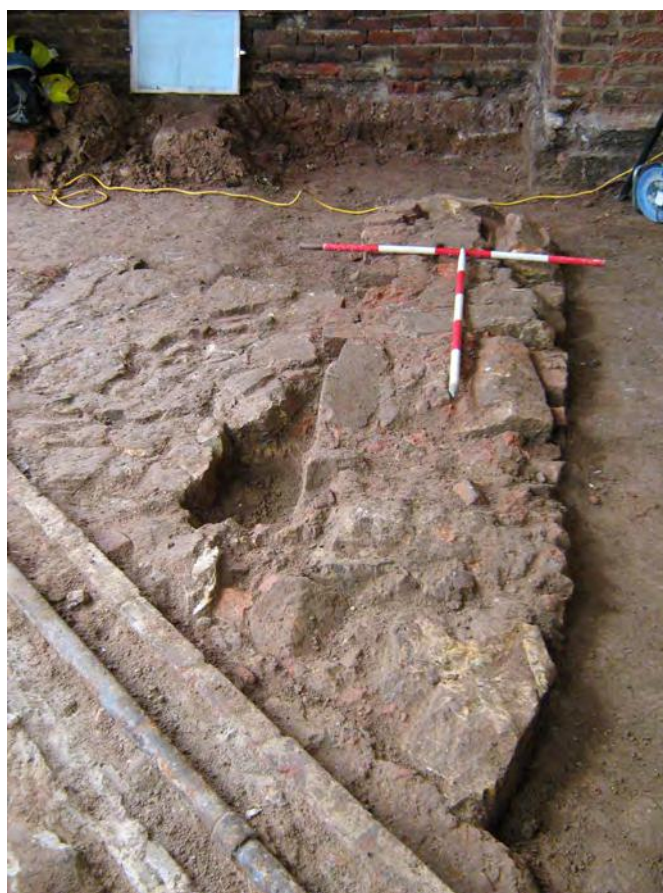
- 4.3 A wall footing was identified abutting floor surface **101** to the west (Context **102**) (Plate 2). This was orientated N- S with a maximum length of 3.20m, a width of 670mm and a depth of 200mm (Fig. 4). The line of the wall appeared to be slightly curving at its northern extent, although this could not be conclusively established due to the level of truncation in this area from a modern concrete pipe run (context 104, Fig. 4). The wall footing was constructed of sandstone blocks and red unfrogged brick. The sandstone blocks were generally rough and

unfaced within the core of the wall, with some examples of larger, rectangular worked blocks (maximum size 620mm x 260mm x 230mm) positioned on the external faces (Plate 2). No clear coursing was discernable; however there was trend towards the use of faced edges to define the outer edges of the wall footing, and particularly on the western side. These worked blocks appear to have been reused masonry, as in several cases the hewn faced edges were orientated inwards, towards the core of the wall. The red brick contained within the wall comprised substantial sized unfrogged blocks, measuring approximately 200mm x 110mm x 60mm. They were poorly finished and often badly damaged. A single block was removed from the wall and returned to the office for dating. This provided a late 16<sup>th</sup> to 17<sup>th</sup> century date.

Plate 2: S facing shot of Context 102

- 7.3** The layer and wall foundation appear to have been laid directly on the surface of the natural, and have been truncated by the external wall of the later house. It is known therefore that the structure predates the construction of the current house in the mid seventeenth century. A spot date of late 16<sup>th</sup> to 17<sup>th</sup> century date has been obtained for the wall

footing **102** suggesting that the structures derive from an earlier phase of post-medieval occupation of the site. However, this date has been obtained from inspection of a single brick, and must therefore be viewed with caution. It is also possible that prior to construction of the new house for Philip Packer the ground was prepared, with any existing upstanding structures potentially reduced down to ground level. The use of late 16<sup>th</sup> to 17<sup>th</sup> brick may, consequently, relate to the preparation of the floor surface and wall footing immediately preceding the process of house construction. If so, the structures could potentially have an earlier origin.
