An Archaeological Watching Brief at The Stables, Scotney Castle Estate, Lamberhurst, Kent

Planning Ref: TW/06/03797

Project No:3434 Site Code:SOB08

ASE Report No. 2008169 OASIS id: archaeol6-49053

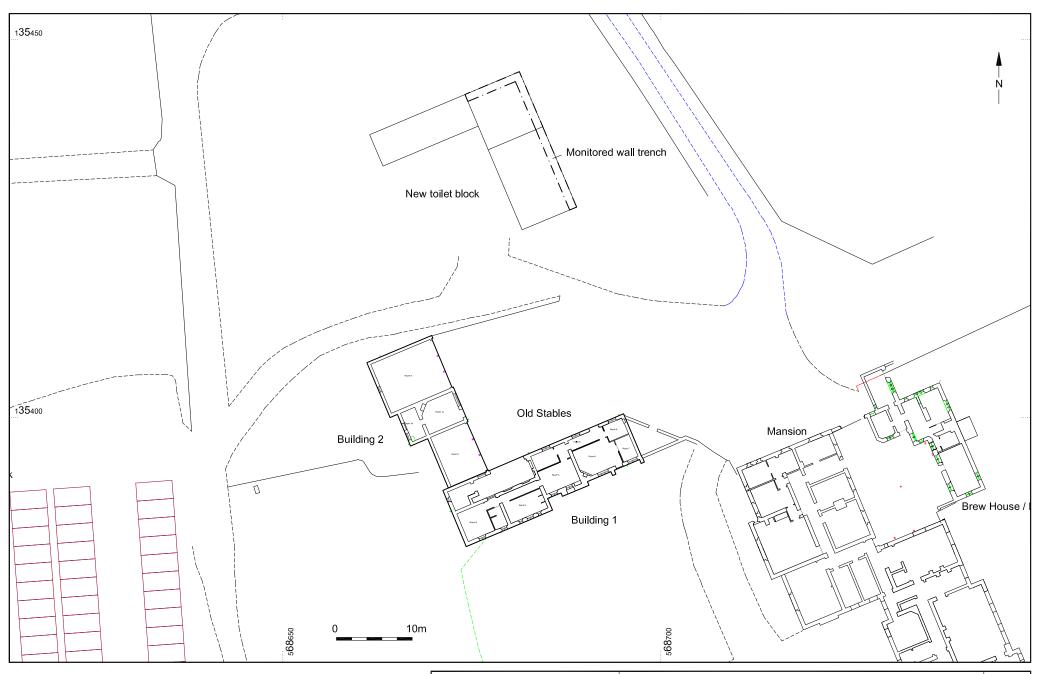
© Archaeolo	gy South-East	Scotney Stable Block	Fig. 2
Project Ref: 343	4 Oct 2008	Site Plan	119.2
Report Ref: 200	B169 Drawn by: JLR	Site Plan

4.2.1 This building is situated to the south of building 2 and is orientated on an approximate east- west alignment. This building is formed of Rooms 3, 4, 5, 6, 7 & 8.

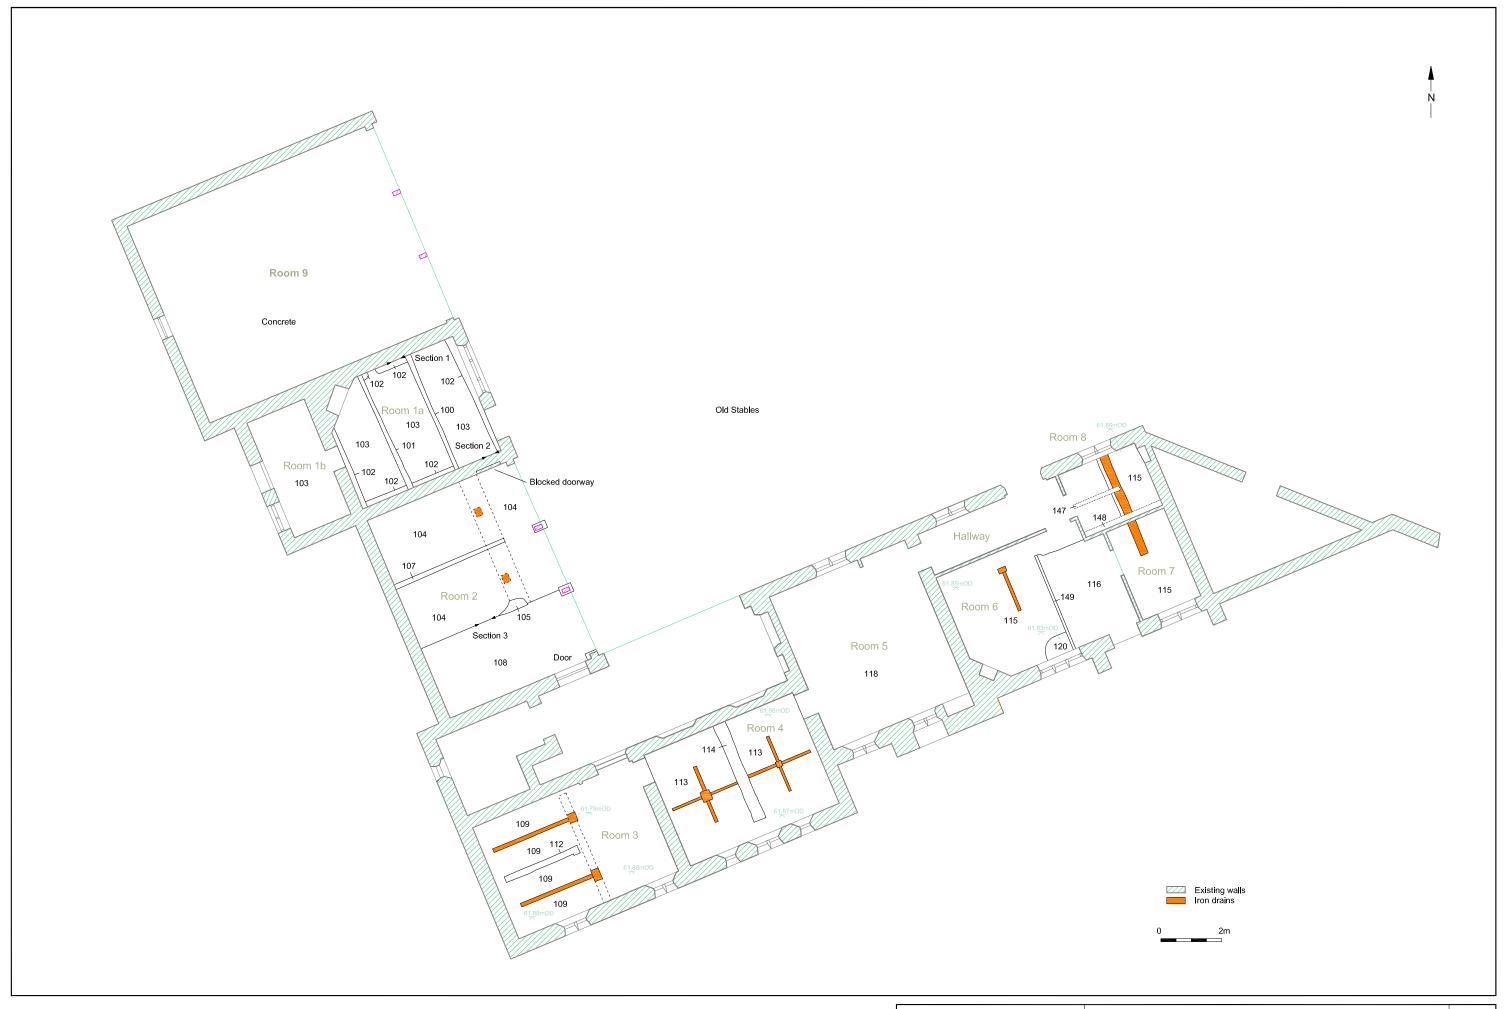
© Archaeology S	outh-East	Scotney Stable Block	Fig. 3
Project Ref: 3434	Oct 2008	Plan, Spit 1	1 19. 3
Report Ref: 2008169	Drawn by: JLR	Tian, Spit i

- 4.4.7 Bricks were laid flat in the centre of the room where an earlier partition wall probably existed. Larger bricks of a similar colour were laid flat around the edges of this room (Fig. 3).

- 4.6.2 Room 6 was composed of the following deposits and floor surfaces. The earliest recorded deposit was the natural clay. Directly above the natural clay was deposit [121], a bright yellow sand deposit of a soft consistency which contained occasional CBM (Fig. 5). Above the sand deposit in the centre of the room were the remains of a probable thin partition wall [149] orientated north-south. To the east of this was [119], a small area of red bricks (<0.22m x 0.10m) (Fig. 4) which were probably part of a similar floor surface as the red brick floors within Rooms 3 & 4. This floor surface was mostly destroyed by deposit [116], a c. 0.15- 0.25m thick deposit of concrete (Fig. 3).

- 4.6.3 Above the natural clay to the west of [149] was context [142], a c. 0.20m mid yellow brown clay silt (Fig. 4). Directly above this deposit was a thin layer of level concrete [146]. The herringbone styled floor constructed of brick tiles was seen above this, [115] (Fig. 3). One iron drain was recorded on a north-south orientation within this room. On a level with the herringbone styled floor was [120], an area of rectangular shaped red bricks (<0.25m x 0.20m) laid flat (Fig. 3). The bricks may represent a repair to the floor.

- 4.6.4 Within Room 7 (eastern side of the building 1) the same sand deposit was recorded, [121], beneath the herringbone style floor [115] (Fig. 3), cut by a drain. The ground reduction did not exceed the depth of the sand deposit.

- 4.6.5 Within Room 8 (eastern side of the building 1) the earliest recorded deposit was the sand deposit [121] seen beneath the mid orange brown herringbone styled floor [115]. Along the northern side of the room and the southern edge of the room were bricks (measuring 2.8m x 0.60m and 2.8m x 0.30m respectively) laid flat. An iron drain cut through the floor of this room (Fig. 3). Two sleeper walls were recorded in this room, [147] & [148] (Fig. 3), which would have provided support for floor boards.

- 4.7.2 Room 9 was built of red brick in Sussex Bond. The floor was reduced during the works and the following stratigraphy was observed. The earliest recorded deposit was [123], a mid brownish yellow clay (natural) (Fig. 5). Overlying this deposit was context [122], a c. 0.20m thick mid greyish brown silty clay of a firm consistency which contained brick (some frogged, some unfrogged) and other crushed building materials including CBM (<50%) and iron nails and other scrap metals (2%) (Fig. 4). The latest deposit was the concrete which formed the current hardstanding. No finds or features were recovered from this room (Fig. 3).

- 4.7.3 Room 1a was 5m x 4m in dimensions and underwent a ground reduction of c. 0.35m. The earliest recorded deposit was context [143], a mottled brown yellow clay silt which contained occasional CBM (Fig. 5). This deposit had a minimum depth of c. 0.15m. Overlying this deposit was context [103], a c. 50mm thick concrete levelling deposit (Figs. 4, 6; Section 2). Above [103] was context [102], the stepped foundation of the building which was constructed of sandstone blocks set in a thin mortar (Figs. 3, 4, 6; Section 1). Also above [103] were two sleeper walls (supports for floor boards) which were constructed of sandstone (<0.20m x 0.10m) and red bricks (0.20m x 0.10m) contexts [100] & [101] (Fig. 3).

- 4.7.4 Room 1b (a later addition to the original building), revealed the same stratigraphy as described above for Room 1a.
- 4.7.5 Room 2 measured 7m x 5m and also underwent a 0.35m ground reduction. The earliest recorded deposit was context [106] (Fig. 5) a 0.20m thick imported deposit of mid blackish brown silty clay of a firm consistency which contained occasional CBM. Above this was deposit [108], a c. 0.10m thick light orange yellow crushed sandstone deposit (Fig. 4). This was an imported deposit almost certainly laid down as a bedding for [104], the red brick floor (Figs. 3, 6; Section 3). The bricks (<0.25m x 0.10m) were laid on edge and covered the entire barn floor set within a sandy cement mortar. The floor sloped gently towards a central drain. In one small area a thin deposit of concrete overlay the bricks, [105], which was laid down to repair to the floor. A partition may have existed within the centre of the room, [107] (Fig. 3)

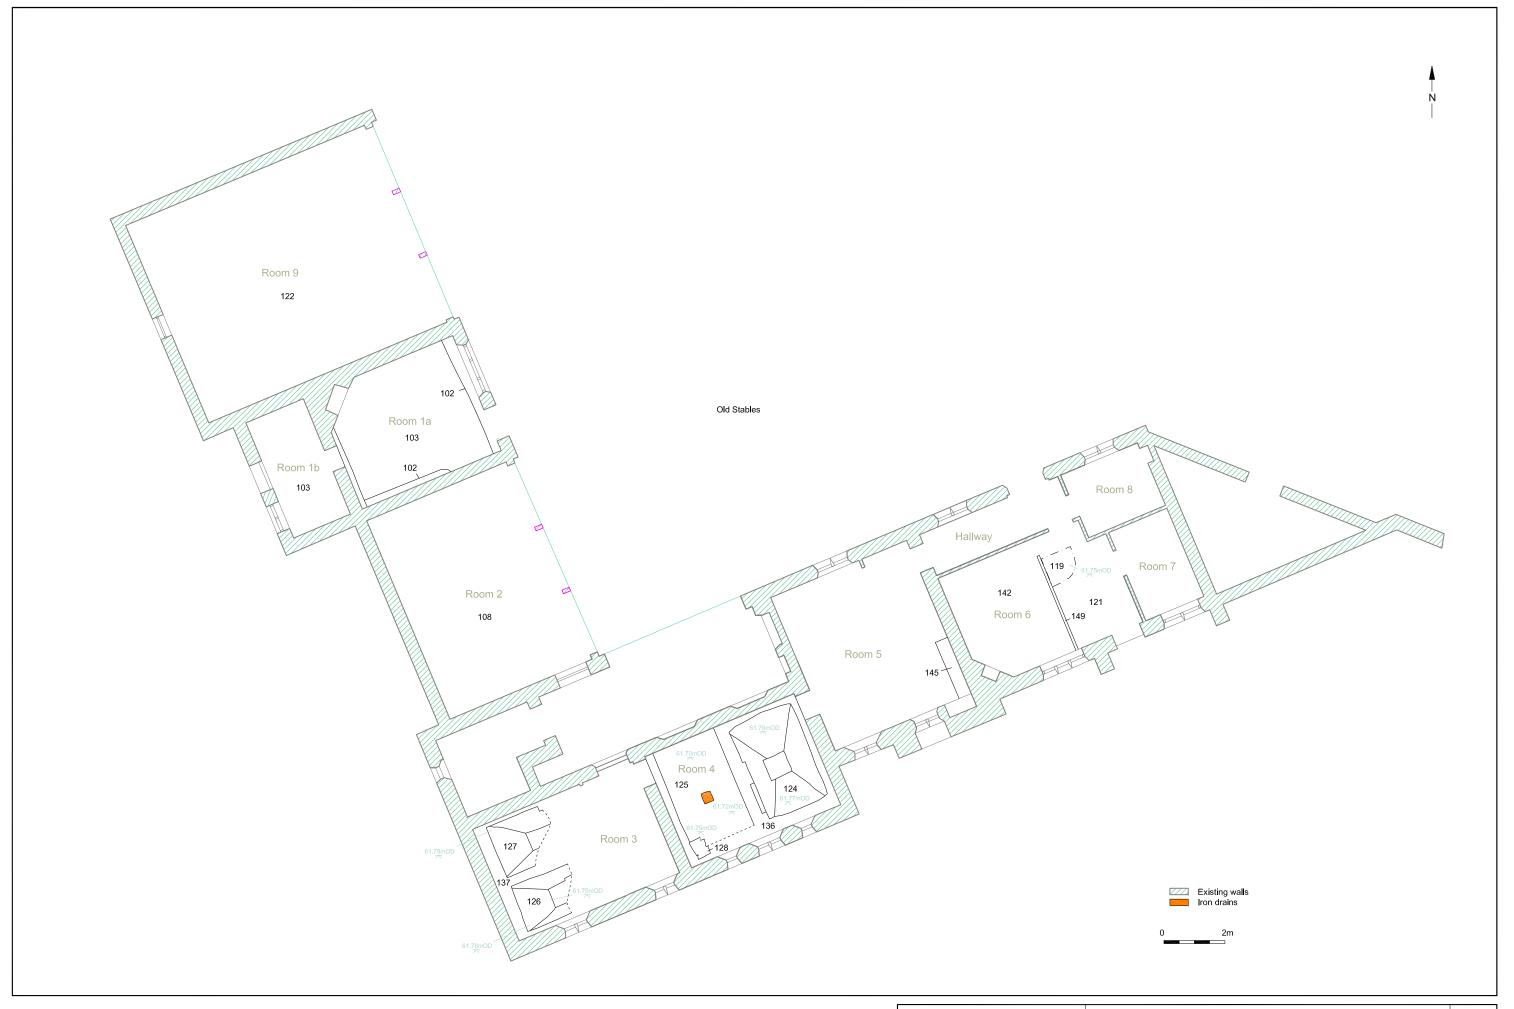
© Archaeology S	outh-East	Scotney Stable Block	Fig. 4
Project Ref: 3434	Oct 2008	Plan, Spit 2	1 19. 4
Report Ref: 2008169	Drawn by: JLR	Fian, Spil 2

- 4.3.3 At the western end of Room 3, the original floor of the stable block was seen above [137]. There were two surviving rectangular shaped floor areas [126] & [127] (Fig. 4 & Fig. 8) composed of red bricks with no (or very little) bonding material between the bricks. Floor [126], seen on the southern side of the room, was 1.60m x 2m in size and it had bricks set in a way to enable water to drain to the centre of the floor (Fig. 4). Floor [127] located adjacent to [126] was almost identical in size and construction methods (1.80m in width x 2m in length). Less than half of both floors were surviving. Above floors [126] and [127] was a thin layer of concrete [138]. This was a levelling deposit cast over the original floors and context [137].

- 4.4.3 On the western side of the room was floor surface [125] (3.8m x 2.2m), which was constructed of small rectangular shaped mini bricks (151 x 55 x 46mm). The blocks were set in a thin mortar mix and were mostly laid on edge (Fig. 10). In one small area the blocks were laid flat which may have filled a previous post hole (Fig. 4).

- 4.4.4 Above floor surface [125] was a section of surviving floor [128] (Fig. 4), this was constructed of red bricks (<0.22m x 0.10m) which were laid flat and would have formed a similar floor to that of [124] but was mostly not surviving.

- 4.4.5 Floor surface [124] was on the eastern half of the room. It was constructed of red bricks (<0.22 x 0.10m) of a rectangular shape (Fig. 4). The bricks were arranged to form a rectangular floor surface which measured 3.20m x 2.10m, set to lead water to a drain in the centre of the floor (same as Room 3- [126] and [127]).

4.5.1 Room 5 measured 5.5m x 4.8m and contained two deposits seen above natural ground. Deposit [144] was a c. 0.20m thick light orange yellow colour which contained a high frequency of Ceramic Building Material (CBM) throughout (Fig. 5). Directly above this, a very small area of *in situ* tiles was seen on the eastern side of the room butting up against the wall. These tiles [145] were 0.40m² and were made of a dark coloured stone (Fig.

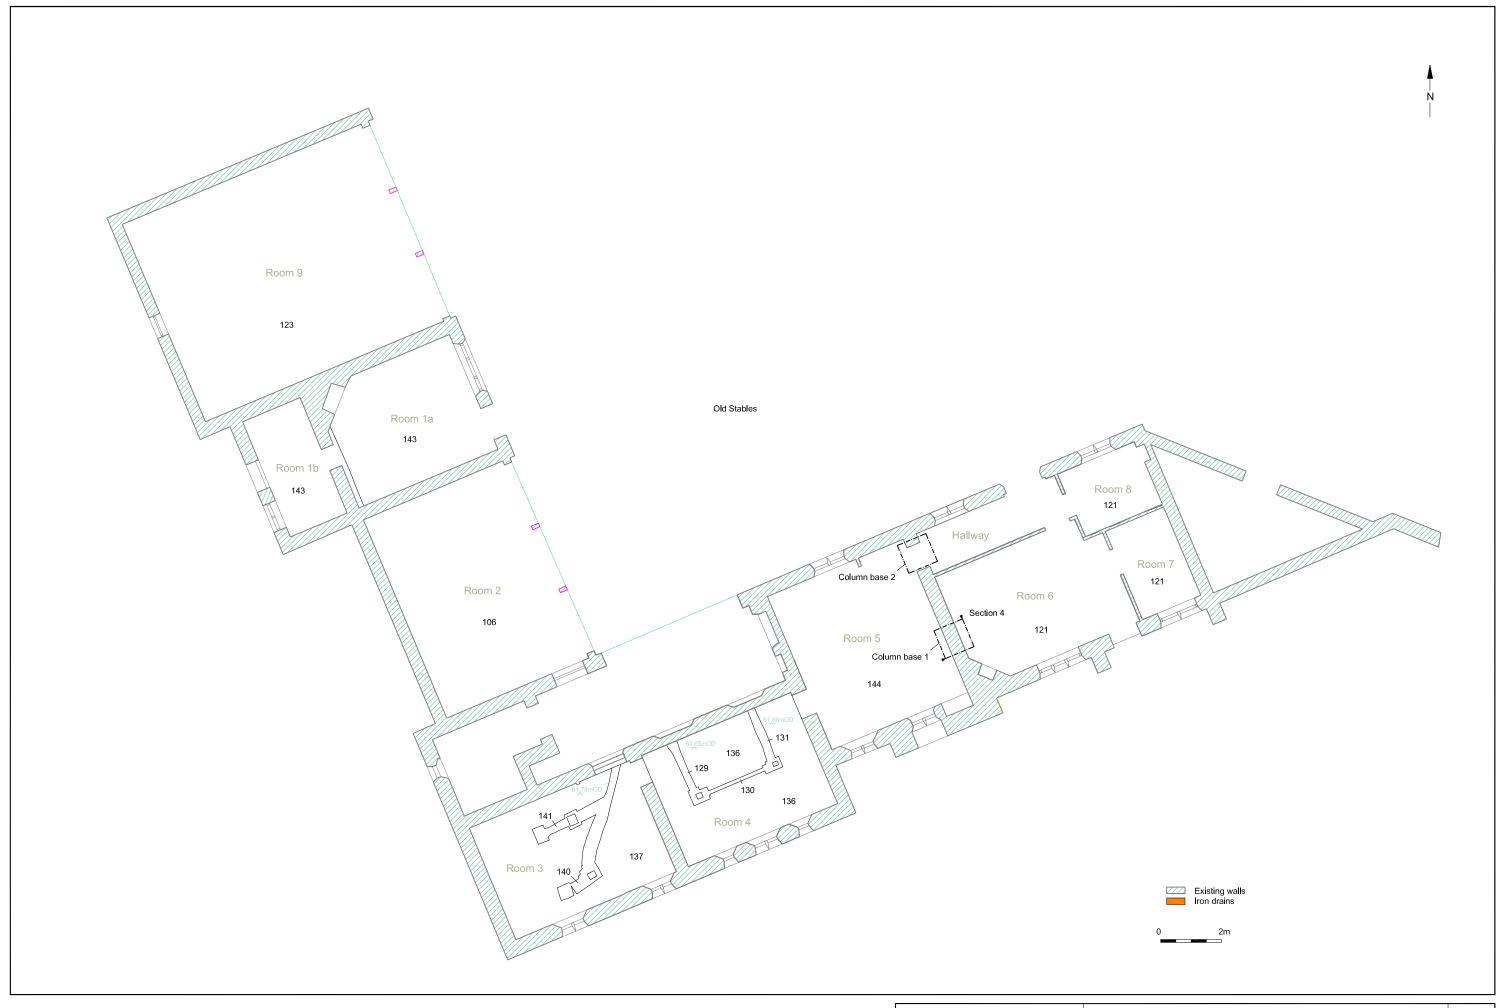
© Archaeology South-East		Scotney Stable Block	Fig. 5
Project Ref. 3434	Oct 2008	Plan, Spit 3	1 ig. 5
Report Ref: 2008169	Drawn by: JLR	Fian, Spit 3

- 4.3.2 Room 3 measures 5.5m x 4m and was excavated to a depth of 0.55m. The earliest recorded deposit was context [135], the natural mid brownish yellow clay. Above this was [137], a c. 0.10m thick mid brownish yellow imported levelling deposit of a silty clay texture. Within this deposit two drains were recorded, [140] & [141]. These were constructed of red unfrogged hand made bricks (Fig. 5)

- 4.4.1 Room 4 measured 5.2m x 4m and was excavated to a total depth of 0.55m. The earliest recorded deposit was [135], the mid yellow natural clay. Directly above the natural clay was context [136], a c. 0.20m thick mid brownish yellow silty sand with clay patches throughout. It contained frequent crushed building materials, slate and stone inclusions (Fig. 5).

- 4.4.2 Within deposit [136] were two drains [129] (Fig. 12) and [131], both of which were constructed entirely of red bricks (<0.22m x 0.10m) mostly laid flat (Fig. 5). A ceramic pipe ran east-west between the drains [130]. Above the drains were floor surfaces [124] & [125] (Figs. 4, 11).

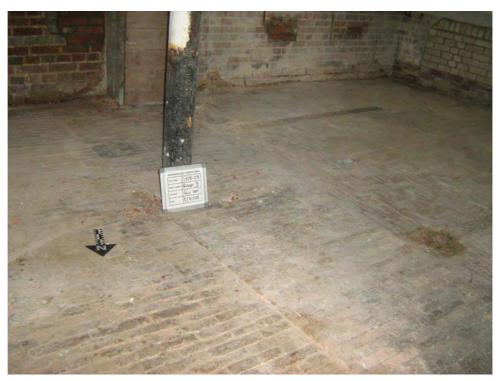
Fig. 7: Room 3; floor surface [109] Spit 1

- 4.3.4 Above [138] was the high quality herringbone styled floor constructed of mid brownish yellow cut down bricks, [109]. Within this floor were two drains constructed of iron, [110] and [111] running on an east-west direction (Fig. 3). The eastern end of the room was constructed of the same bricks but not

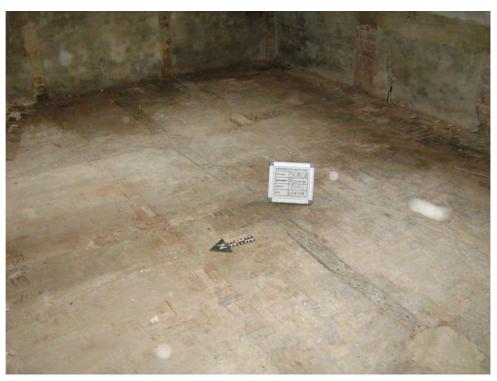
Fig. 9: Room 4; Herringbone floor surface [113] Spit 1

- 4.4.6 Above floor surfaces [124], [125] & [128] was a thin layer of concrete [139] of a mid grey colour laid down as a levelling deposit before the later herringbone styled floor was laid, [113] (Figs. 3, 9). This floor was constructed of cut down pale orange bricks laid on edge set within a hard mortar. Drain runs were laid in two cross patterns directly above the drains from the earlier floors.
