**AN ARCHAEOLOGICAL WATCHING BRIEF
AT
HARRIETSHAM WASTEWATER TREATMENT WORKS,
FAIRBOURNE LANE, HARRIETSHAM,
KENT.**

**Project No.4693
Site Code: HWT11**

**ASE Report No. 2011053
OASIS ID: archaeol6-94-006**

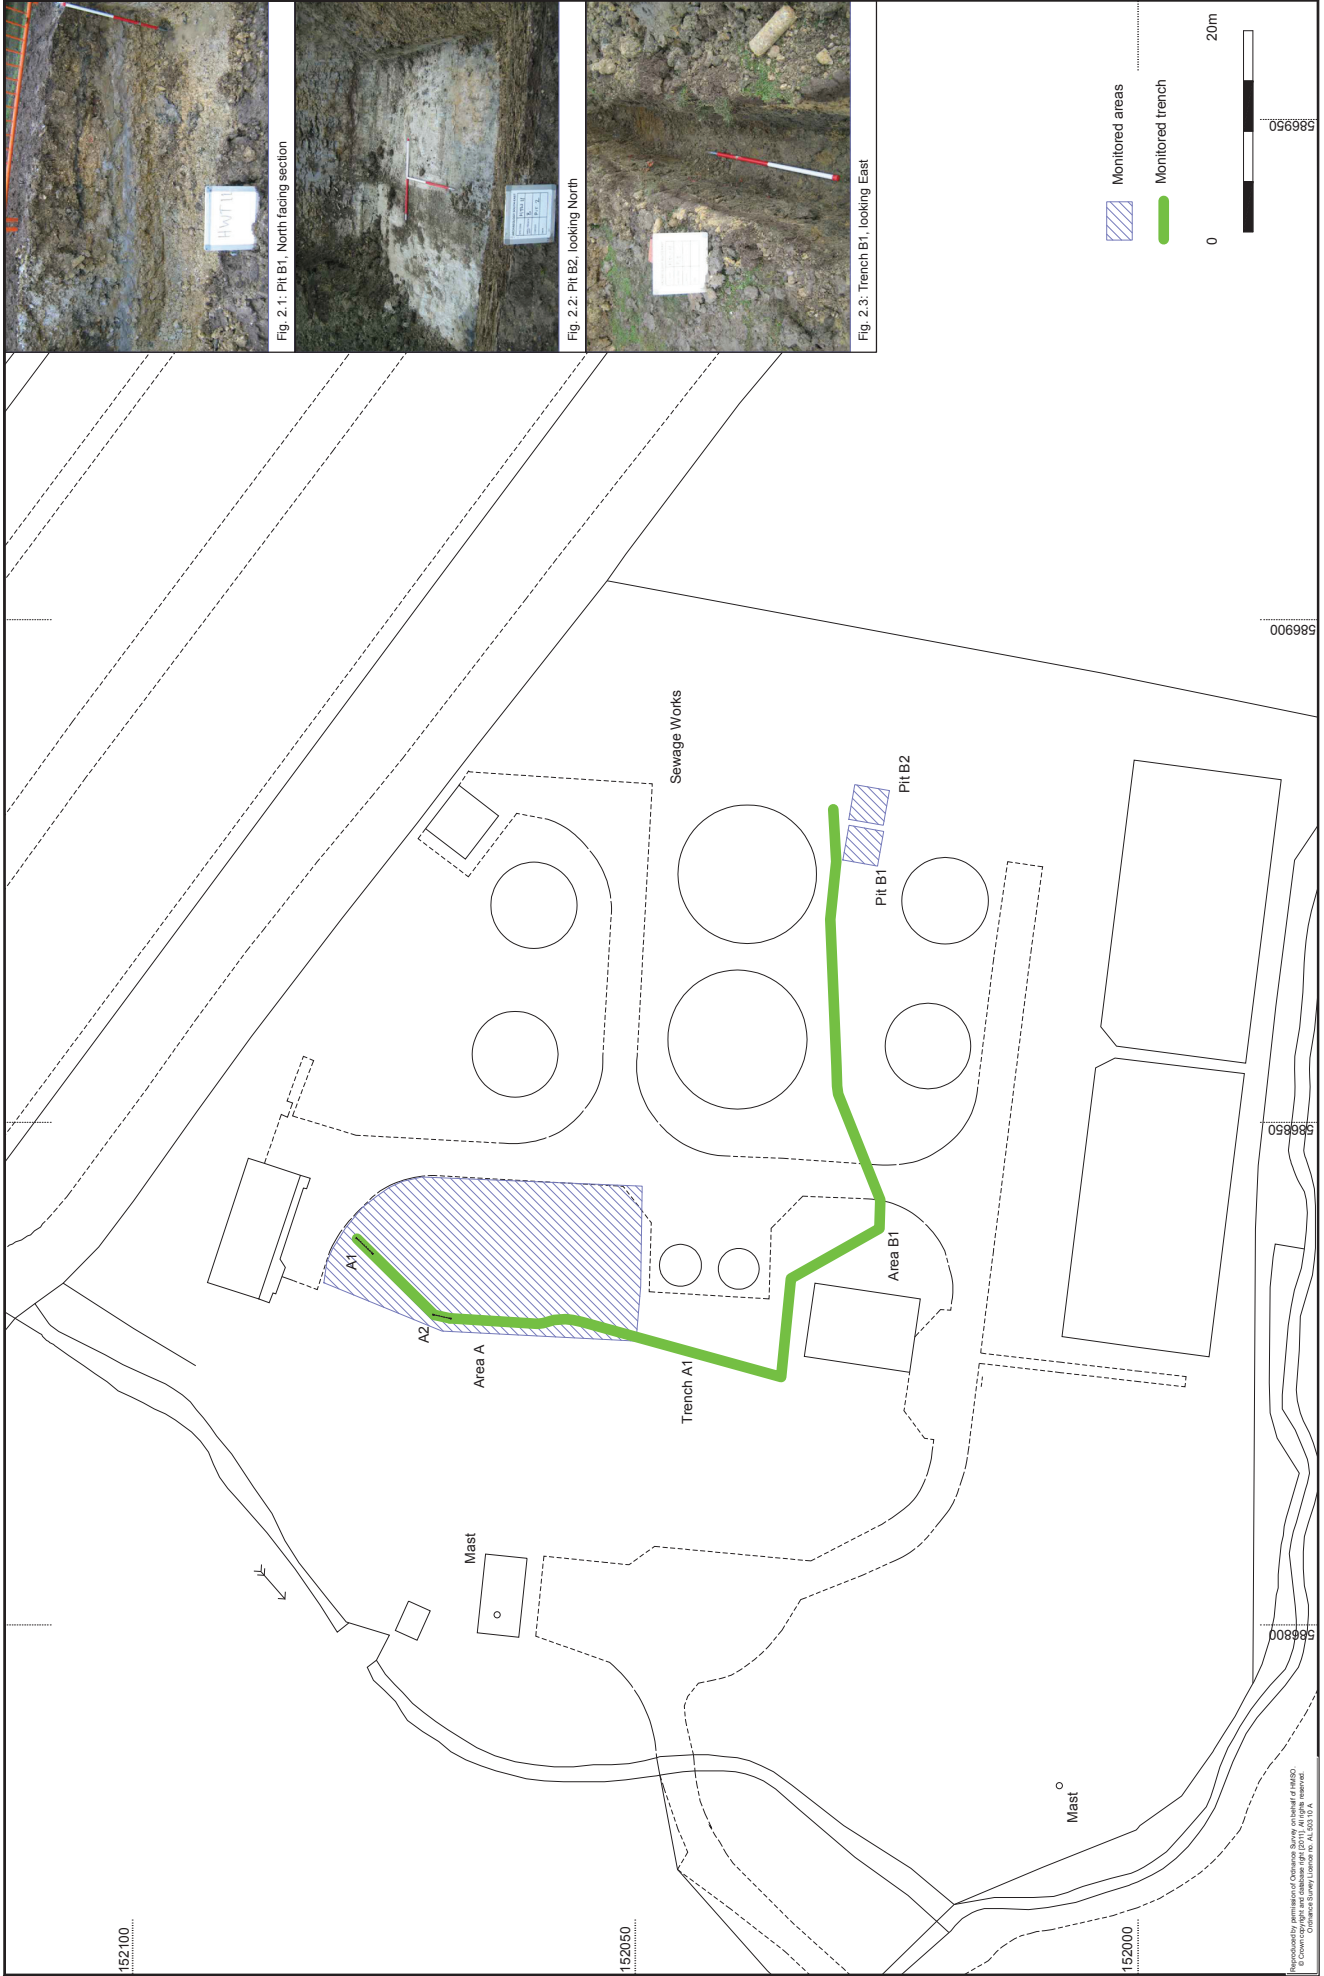
4.1.1 The following areas of the scheme were subject to archaeological monitoring (Figure 2):

- *Area A*: Ground reduction of to a level of 80.47m OD for the installation of a new ferric dosing unit, followed by:
- *Trench A1*: North-south cable trench measuring c. 0.50m wide and up to 0.80m deep
- *Area B*: excavation of two pits (Pit B1 and B2), each measuring c. 3.5m², followed by:
- *Trench B1* East-west cable trench measuring 0.50m wide by up to 0.80m deep.

4.1.2 Monitoring of cable trenching demonstrated that depths of made ground exceeded the depth of the trench (c. 0.80m) across almost the entirety of the site, with only occasional small areas where the underlying natural geology was proved. Indeed, a site walkover showed that much of the site has been previously subject to extensive landscaping works, often utilising upcast derived from deep excavations for existing filter beds. Where depths of made ground were deemed to exceed the depth of excavations, these groundworks were not monitored. These areas are shown on Figure 2.

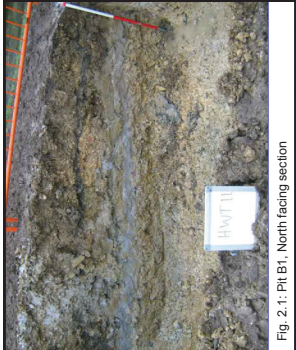
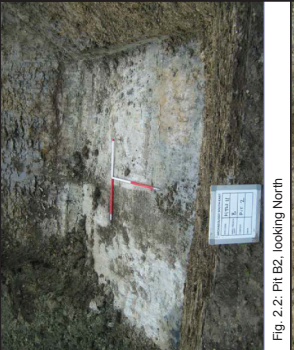
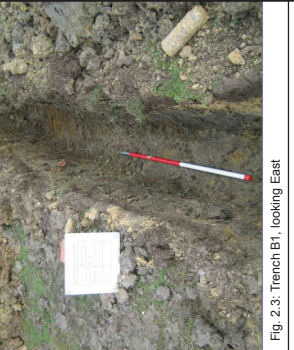
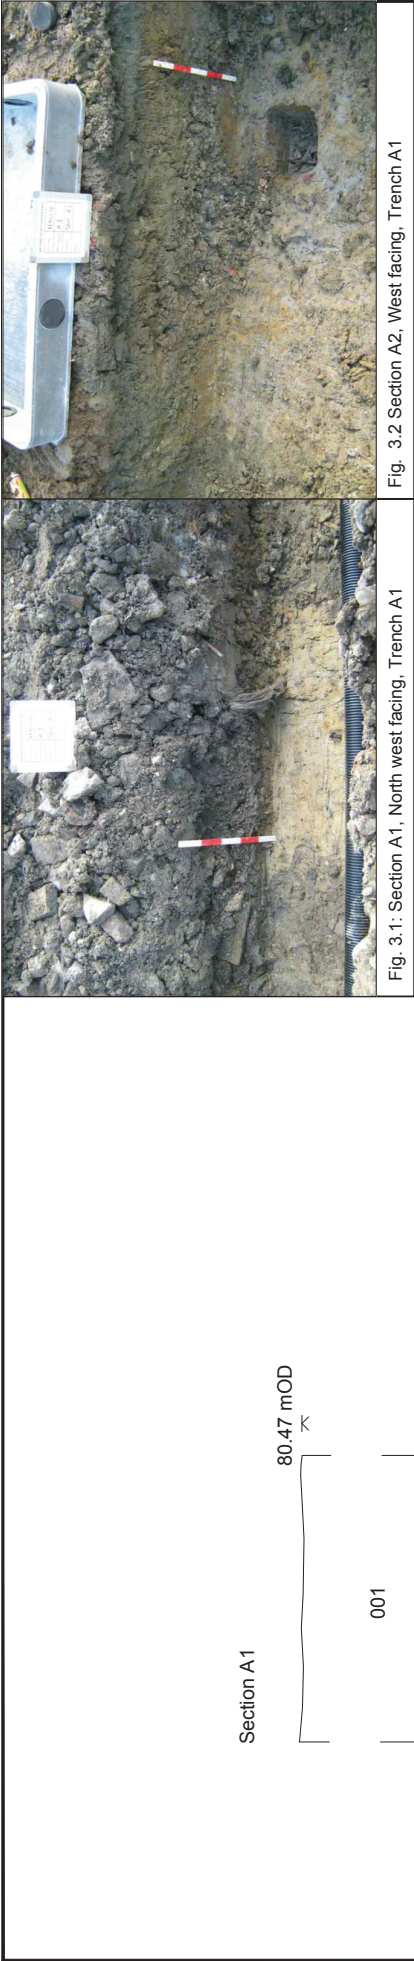
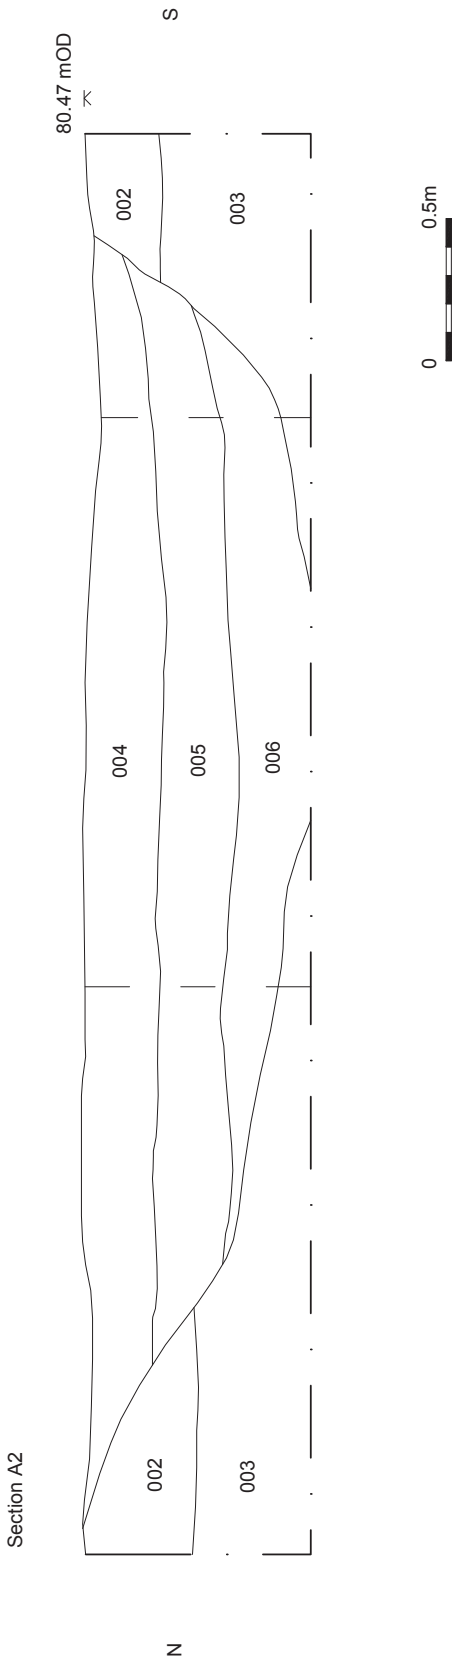
Fig. 3

4.2.2 Natural geology, consisting of stiff mid yellow Weald Clay (003) was observed towards the northern end of Trench A1, at a maximum height of 80.20m OD (Figure 3), Section ?). This was sealed by a layer of mid reddish brown silty clay alluvium

- 4.2.3 A small irregular palaeochannel [007] was seen to cut through this alluvium on an east west orientation. This feature contained a primary fill of loose, coarse gravel (006), overlain by a deposit of light brownish grey silty clay (004), in turn sealed by a deposit of mid grey silty clay (004).
- 4.2.4 Extensive deep truncation associated with pre-existing filter beds was observed at the southern end of Area 1. Excavation of a small trial pit to a depth of 79.20m OD showed this truncation to extend well below the level of the natural Weald Clay.
- 4.2.5 The sequence described above was capped by a thick layer of modern made ground (001) associated with prior landscaping of the WTW site. No archaeological features or finds were observed.

© Archaeology South-East		Harrietsham Wastewater Treatment Works	
Project Ref: 4693	March 2011	Selected sections and photos	
Report Ref: 2011053	Drawn by: LD
