**An Archaeological Watching Brief Report
Land to the rear of 94-100 Union Street
Maidstone, Kent**

**Project No: 4801
Site Code: USM11**

**ASE Report No: 2011230
OASIS ID: archaeol6-110494**

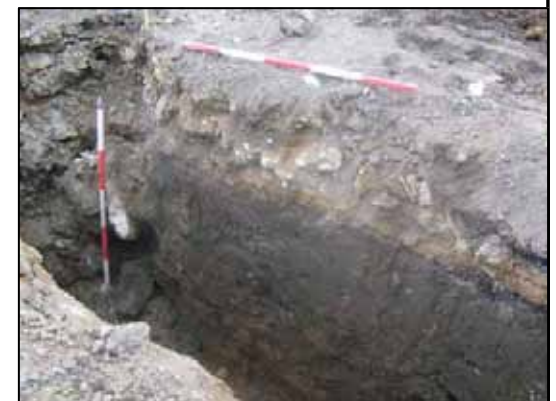
- 4.3 Cutting buried soil [004] the construction cuts for three stone wall footings [011], [017] and [019] were recorded.
- 4.4 Only the southern edge of construction cut [011] was seen and this measured 0.6m wide and 1.4m with a vertical side. Cut [011] was constructed for ragstone masonry wall [010] which was made of uncoursed, unworked blocks in a white lime mortar with occasional brick fragments. Wall [010] formed the south-west corner of a stone-built building.

Wall 010 and cobbled path 013 facing east

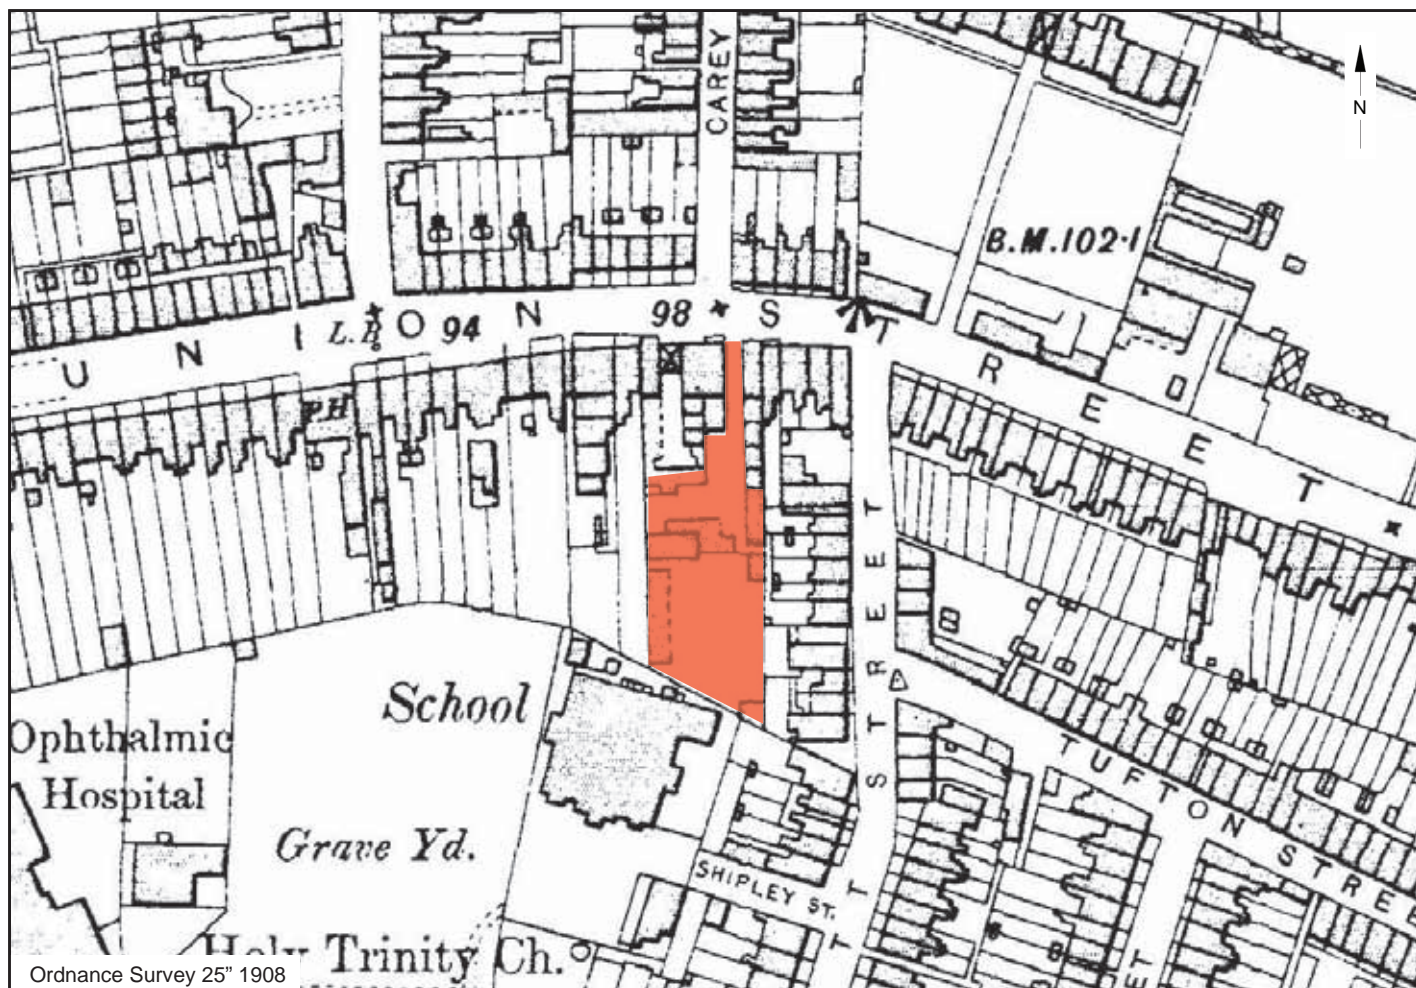
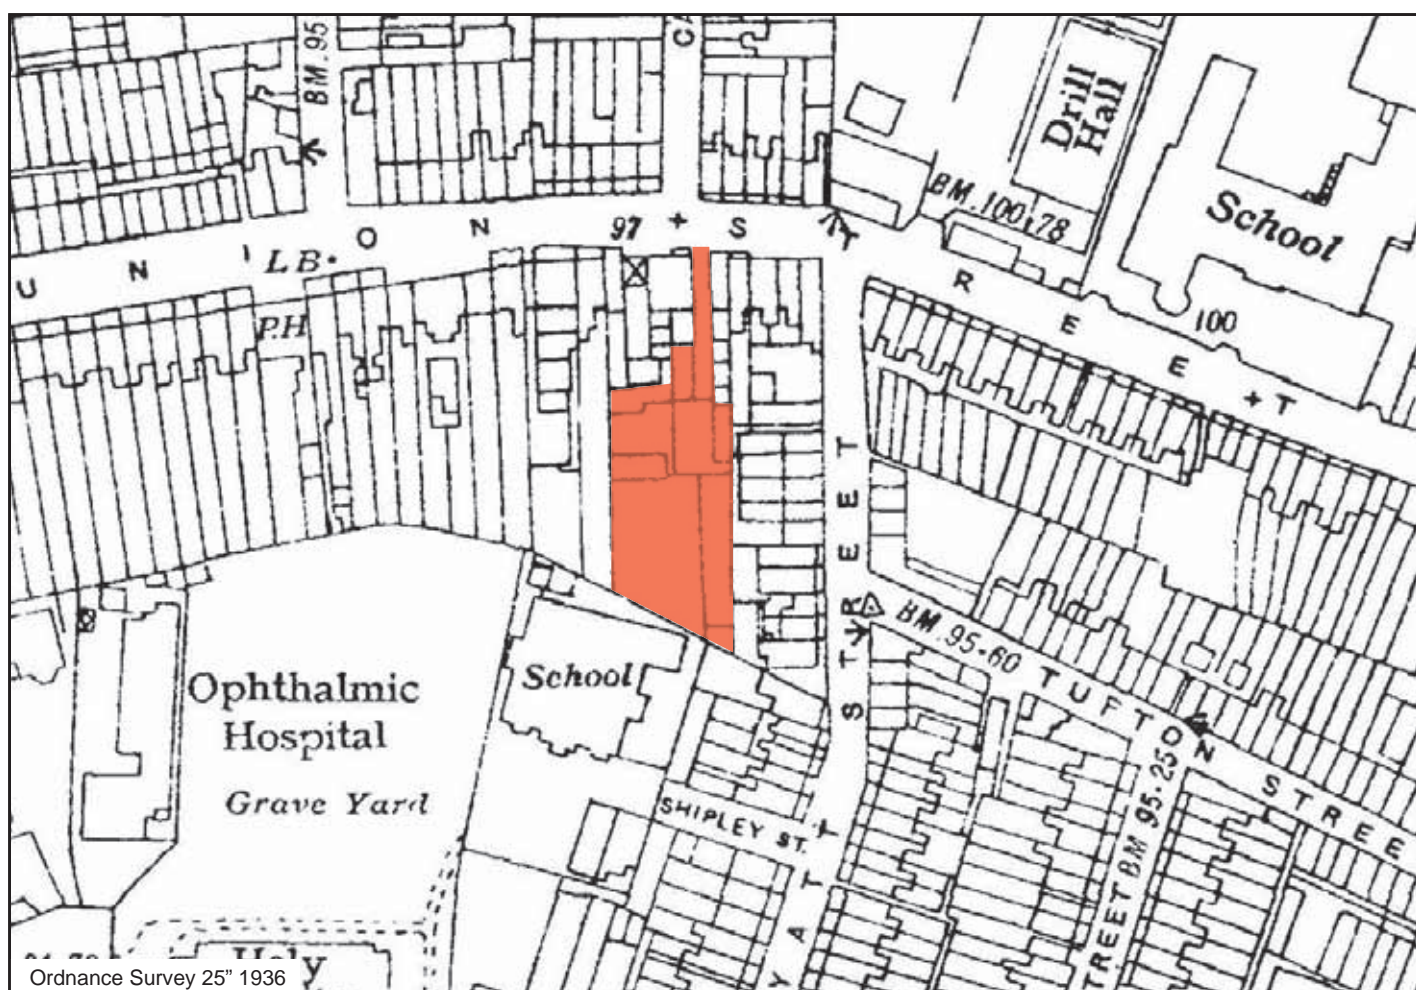
© Archaeology South-East		96-100 Union Street, Maidstone	Fig. 6
Project Ref: 4801	Sept 2011	OS maps 1883 and 1896	
Report Ref: 2011230	Drawn by: JLR

- 2.2.6 The 1908 edition map (Figure 6) shows significant changes to the central and southern sections of the west plot. The former ranges surrounding the open areas have been removed, with new structures built on the boundary between the central and southern parts of the site. Within the south section, the building shown abutting the west boundary is new and is shown as open-fronted on the east elevation.
- 2.2.7 Within the narrow east plot, the boundary between central and southern sections of the west plot has been extended across, and a new rectangular plan building built against it and the eastern boundary wall.

- 2.2.8 The 1936 edition map (Figure 6) shows further demolition with the two structures that had been added to the south section of the site by 1908 now removed. The arrangement of structures against the central/south boundary has also been altered with only one rectangular structure retained, abutting the west perimeter wall. New boundaries have been added, or re-instated, separating the west and east plots within the south section of the site.

- 6.3 Wall [020] is likely to be the east-west boundary wall in the centre of the site shown on both the 1883 and 1897 Ordnance Survey maps. Wall [016] is probably part of the north-south aligned narrow building in the south of the site, again shown on both the 1883 and 1897 maps. The identification of wall [010] on the maps is not obvious but may be part of the north-south aligned narrow building in the south-east. The later map evidence shows that the buildings and these walls were demolished and the site redeveloped by 1908.
