**An Archaeological Excavation
at Church Field, Otford, Kent
Interim Report 2015-19**

Kevin Fromings BA(Hons) MA

January 2021

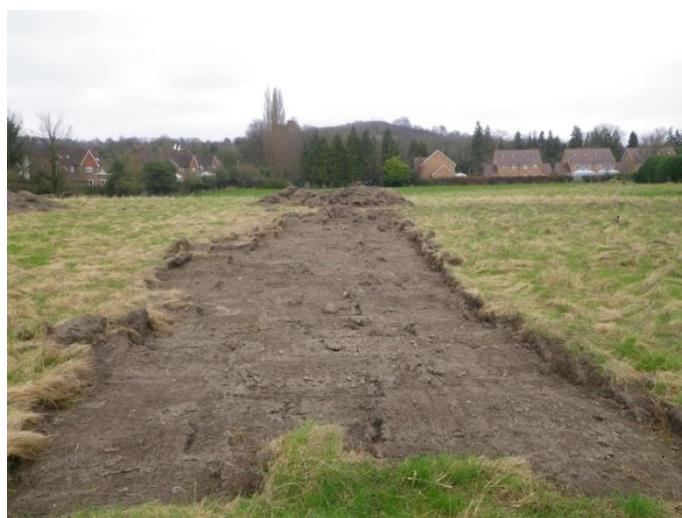
The soil is a dark greyish brown, containing many plant roots. There were occasional pieces of cbm, the odd coin, and the odd piece of pot. Also, at this level, there was a fair amount of 19th – 20th century domestic rubbish. Interestingly, considering the length of time the field was used as a hop garden, there is very little hop growing detritus. What also became clear was that pieces of the same broken item can appear anywhere on the site, for example a piece of china cup was found above room 1, and a joining piece was found about 40m away over room 7. We have found beads from (probably) the same Roman bracelet/necklace in both trench 1 and trench 2. In 2018 a late Iron Age copper alloy *fibula* was revealed by the digger, over room 4, but had no context other than topsoil.

Topsoil over trench 3

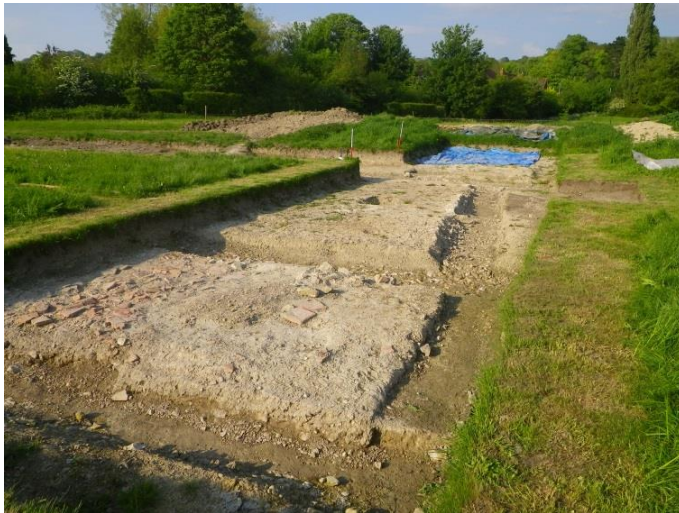
(1002) over rooms 7 & 9. Note how in room 9 we are already down onto (1003), but in room 7, and the wall trenches, there is still a substantial layer of (1002).

This was dug entirely by hand, using spades, mattocks and shovels, but also trowelling as appropriate. Depending on the thickness of the lower context (1003), (1002) could be very thin, or up to tens of mm deep. It appears to be a levelling layer, covering the archaeology, and may represent the post-demolition ground level. Although some post-Roman material is present, the majority of finds are contemporary with the villa. It is from spoil in this layer that many of the coins have come. More Roman pottery is present, and fragments of cbm and mortar.

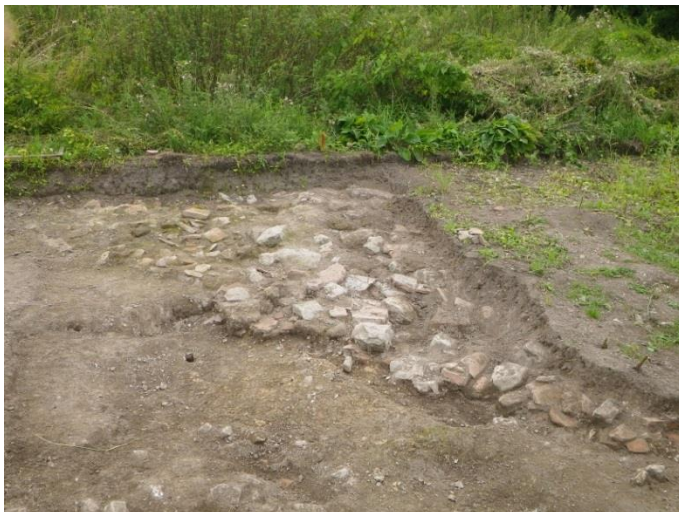
(1003) in main range.

A layer of demolition rubble that overlays the majority of the excavated site. In places it may be tens of mm thick, in others it may consist of a couple of pieces of CBM sitting on an archaeological feature such as an in-situ floor. What should be noted from the start is that from 2013-2019 not one single complete brick or tile has been found. All usable material – even down to clipped tile *tesserae* - has been systematically removed. There are *tesserae* strewn around the site (and in a couple of places in –situ), but all other useable material has been disposed of, leaving just hardcore. This in itself has been spread around the site – possibly as part of a levelling process, so the find site may not be where the item originated.

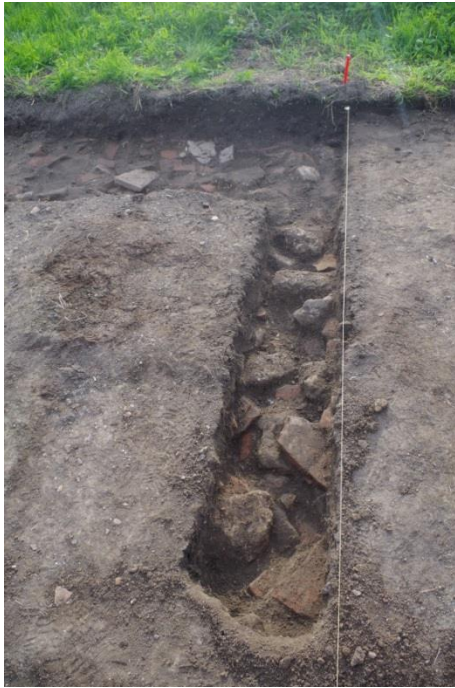
(1003) with a very thin (1002) above it

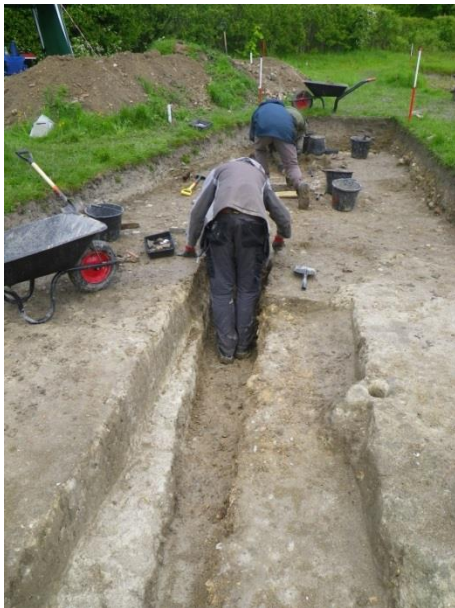
(1004) on left hand side of trench where person is standing

This refers to the gault clay natural. It is a distinctive whitish-grey colour, and underlies all the wall foundations, and occasionally some of the floors.

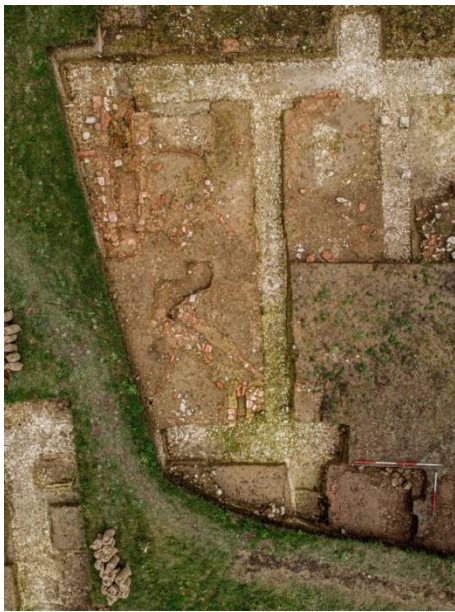
Rooms 1(left) & 2, October 2019

Chalk foundations to a probably solid wall, W1045, divide rooms 1-2, at 0.7m wide. Chalk foundations also divide room 1 from rooms 10/11. A buttress foundation in the NW corner, B1083, is now part of W1042, but indicates that the ‘bath house’ was almost certainly a separate building from the main range when it was first built.

Within the room itself, once (1003) had been removed we came down onto a heavily degraded *opus signinum* (henceforth *op.sig*) surface. That this was a sub-floor was proved by some floor tiles resting on it in-situ half way across the room. This layer of *op.sig* is 70mm deep, and has possibly been laid onto an earlier sub-floor of a similar construction. This, in turn, was laid onto the undisturbed layer above the natural. In places tile-lined channels 230mm wide and 180mm deep have been cut into the undisturbed layer, and these also contain compacted degraded *op.sig*, along with some pieces of building rubble. Two of these channels appear in the section of W1026 and W1045. Also visible halfway along the section of W1045 is a rubble filled semi-circular depression (as yet unexcavated), 0.5m wide x 150mm deep. It is suggested that this may be a linear feature, possibly dividing the room in two. At present there is no indication of this feature on the surface.

At a central point in this room the putative linear feature should cross a tile lined channel, again containing broken *op.sig*, and identified by large floor tiles – possibly specially made – that were level with the floor surface but have now broken and collapsed into the channel.

This is wider than the other two channels at 0.76m. The large channel leads to a gap in W1042, which contains no chalk foundation, and shows signs of intense heat. This has been interpreted as a main opening and stoke hole for a channelled *hypocaust* system that runs under the whole room.

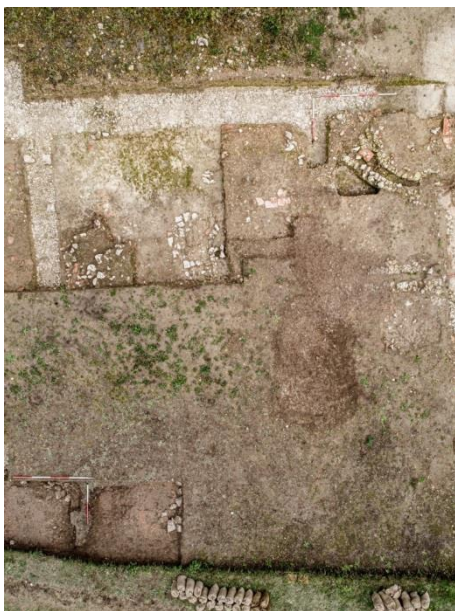
'Room' 3, with room 4 centre right. Tree root depression is green area in room 3.

Adjacent to W1140, (1003) was composed of substantial pieces of cbm, mixed with larger undressed ragstones, all churned up with topsoil. When this layer was removed it was discovered that everything was sitting on scoured natural. This was uneven, and contained a clean depression that has been interpreted as a space for a tree root. If you remove room 4 and take room 3 to butt up to room 5, then the root bole depression is exactly halfway across the space. This area may have been a garden, initially measuring 8m x 6.67m. A large amount of ragstone laying on this could indicate a fallen wall, which may have separated room 3 from room 4.

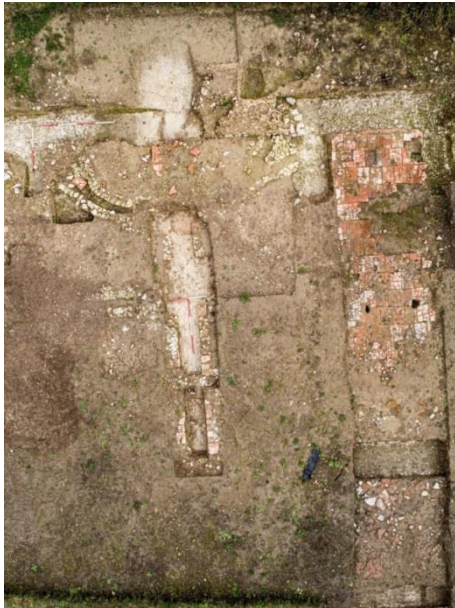
Room 5, with stoke hole, extant wall and buttress top centre. Room 6 is on the right

W1172 has not been excavated enough to know if it has a chalk foundation. It is 0.52m wide. W1042, at this point, loses its chalk foundation layer just after passing the junction with the W1172. This is likely to have been removed as part of the process for demolishing the wall above it (a process that was not repeated on the SE part of W1042). 1.7m along from the wall junction there is an area of burning at the foundation level, which has been interpreted as a stoke hole from a furnace set outside W1042, and leading into a channelled *hypocaust* system under room 5.

Outside W1042 is a large depression, which is abutted to the SE by the remains of a buttress, B1044. This still contains part of its ragstone/mortar construction due to having been subjected to large amounts of heat (when the furnace was operating). The furnace area itself, a sub circular depression 1.7m x 1.78m, was quite clean, and has been scooped out of the natural. It showed no signs of burning, implying that most of the firing probably took place within the wall cavity itself, or that this area was regularly scoured clean. On the other side of the buttress there was a smaller, smooth depression, 0.8m x 0.9m, filled with pottery rubble, including large sherds of a *mortarium*. Again, the natural in this depression was clean and smooth. It may have been created by the action of water dripping/running for some considerable time.

On the main wall, W1042, directly abutting the stoke hole, was a large part of the ragstone/mortar wall construction 1m (NE/SW) x 0.93m (NW/SE). This, like the buttress, had been baked into a solid mass by repeated firing of the *hypocaust* furnace. Beyond it the chalk wall foundation continued SE, adjoining rooms 6 and 7, and disappearing under the SE-most section by W1300.

The stoke hole led into a collapsed channel under the floor of room 5. This main channel was filled with rubble and degraded *op.sig* from the floor above. When part of this fill was removed, it could be seen that a very pink burnt layer of natural continued on through the stoke hole and into the channel, fading as it went further away from the actual burning material that would have fed the *hypocaust* system. The stoke hole was 0.57m wide x 330mm high, and the channel continued across the whole width of the room at this size.

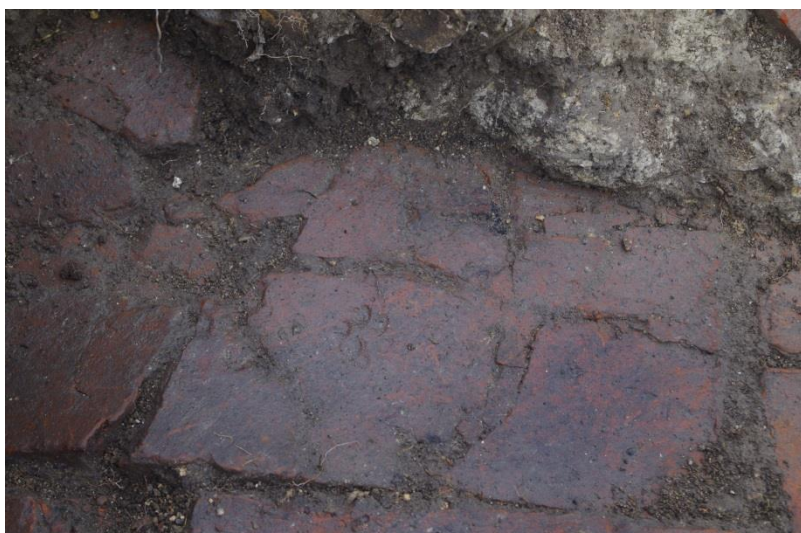
As with a number of the tile sherds found on site, there is evidence of animal/human intervention pre-firing, in the shape of a paw print, and what may be a child's footprint in the surface of a couple of the tiles.

Paw print from a dog

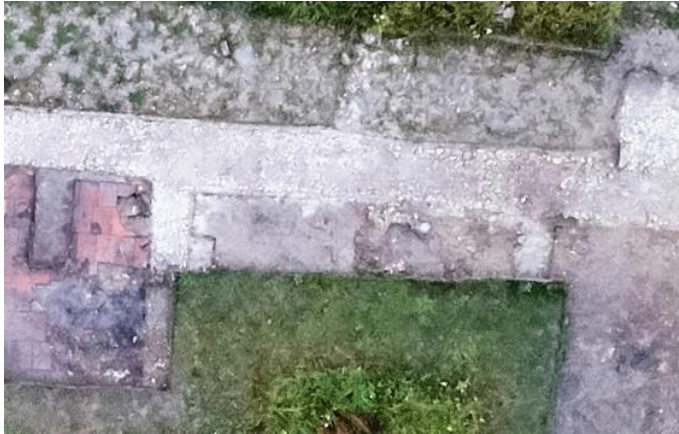
Cooking hearth (centre)

In the rubble layer (1003) abutting W1042 is a scooped hollow (5012-14), 470mm internal diameter, and around 130mm deep. The base of this was covered in ash. Current interpretation is that it was a cooking hearth created by the demolition team. The significance of its positioning may relate to one of the functions of room 6.

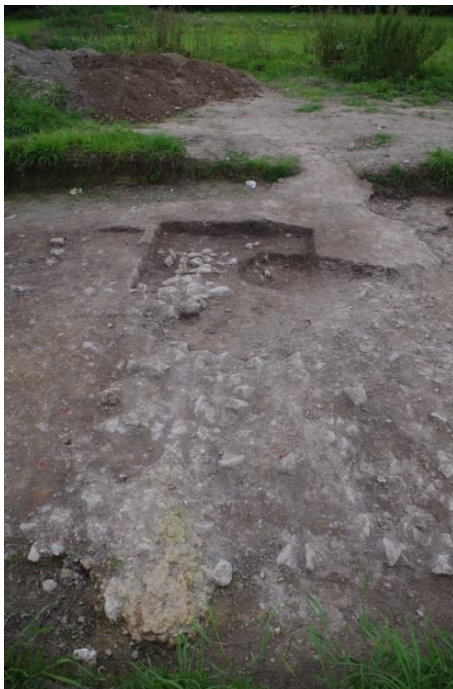
Stone and mortar dump over possible midden to the NE of W1042 and buttress B1293

Just to the NE of B1293, so outside the villa walls, was a spread of ragstone fragments, that was originally interpreted as a possible fallen wall to an ancillary building. Our interpretation has changed to the continuation of the dumped material mentioned above. However, during the investigation of this area it was noted that there was a large concentration of animal bone. This may have been a midden, and possibly related to room 6.

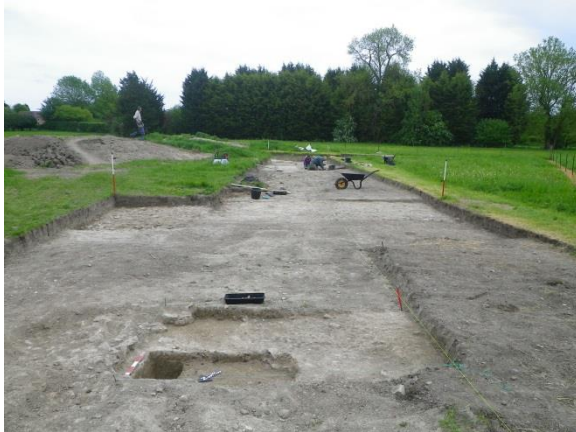
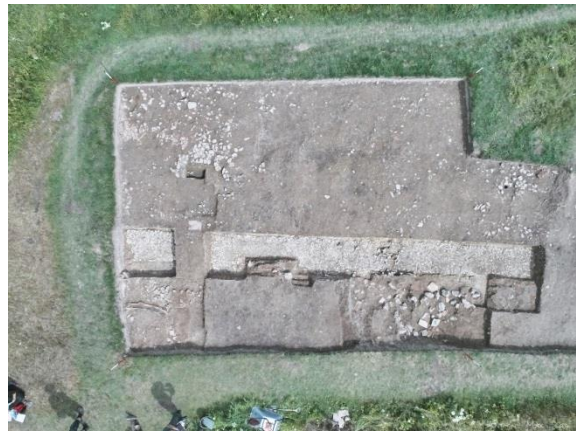
Roman ground surface to the NE of rooms 1-3. Note rubble layer by left hand ranging pole.

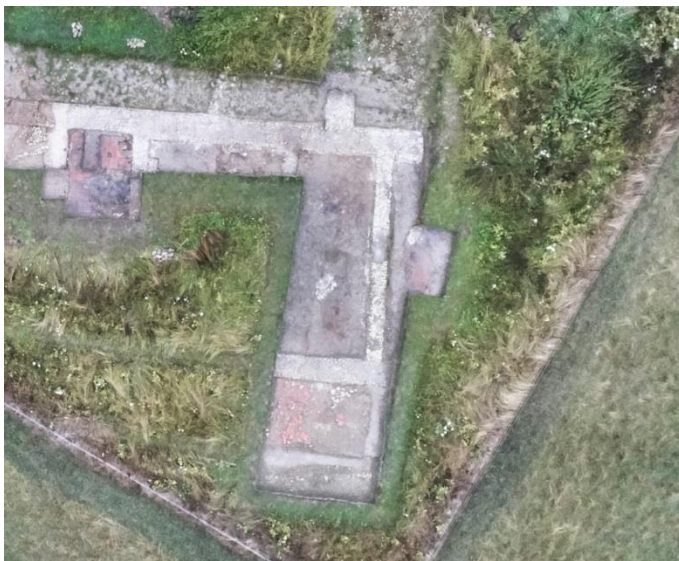
Room 7 in 2018. The rectangular cut into the grass centre right is the tessellated floor of room 8. The now overgrown midden area is top centre.

At the moment it is unclear whether this is a room or a corridor. An area of plain *tessellated* floor was uncovered. This has been slightly damaged by later agricultural activity. The *tesserae* extend 1.22m SE, and 2.3m NE/SW. Not enough of the adjacent area has been uncovered to give the extent of the space they originally occupied. They are bedded onto a layer of *op.sig*, which – outside the *tessellated* area – is very degraded. It is likely that they were not removed during demolition due to being covered with a thin layer (5-10mm) of redeposited natural that had been trodden down to create a hard crust.

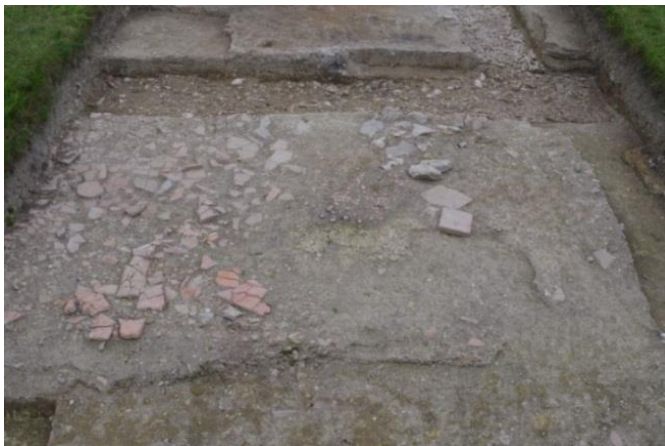
Corridor (Room 9) at SW end of room 7 with W1026. Note worn tiles on the left.

The corridor to the east range is 2.8m wide. It has not been fully investigated, but in the three areas where it *has* been excavated, a stratigraphic pattern has emerged. Below the topsoil and the pre-rubble layers was a layer very similar to (1003), so much so, that we initially started to remove it. It was very quickly noted that the rubble was more firm and level than on other areas of the site. Each area uncovered also contained patches of in-situ *tesselation*, which were interpreted as the original floor. These were set onto a bedding layer of *op.sig*. Also set into the same layer were various fragments of cbm, creating a rough pavement. That this had been their function was determined by the edges of some of the sherds, which had become worn, presumably through being walked on.

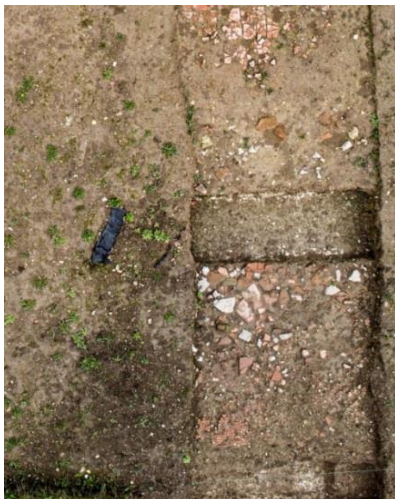
Corridor (Room 9) at SW end of room 6. W1026 is centre right, and W1283 is bottom right

The robbed out wall trench separating the corridor from the courtyard, W1283, is 0.74m wide, but contains no chalk foundation, or indication of post pads. There is also no trace of a wooden sill beam. The construction and appearance of this wall has to remain speculative for the moment.

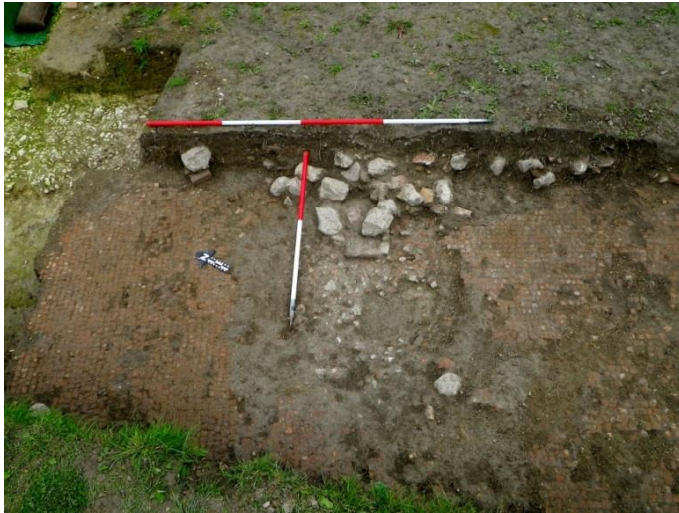
Tessellated area at the junction of the two building ranges. (Corridor room 9 on right, corridor room 14 on left) W1026 at top left (large scale 2m)

At the putative junction between the main and the east ranges of the villa, the *tessellated* corridor floor was mainly intact. A layer of rubble (1003) consisting largely of building stone, covered the tesserae. At areas along the edge of the floor it was observed that a sandy mortar had been used as a bedding material, instead of the usual *op.sig.*

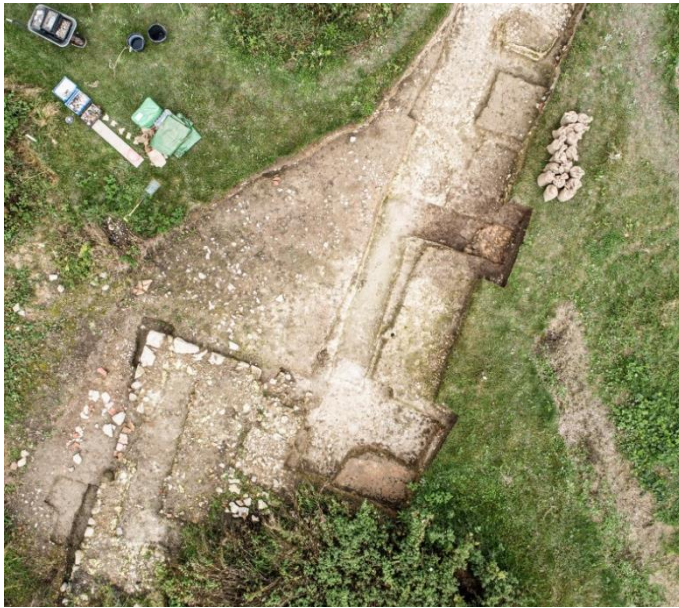
Room 12 (bottom left) and yard (centre left)

Although it respects the NW/SE wall line of rooms 11 and 13, room 12 is – at the moment – a unique design compared to the rest of the building. The walls, W1108-10, are narrower (0.57m wide) and much shallower (around 200mm depth of foundation). They consist of a facing layer of roughly dressed ragstone blocks, containing a mortar and stone core, with a high chalk content. The dimensions are indicative of a single storey building, although

There was not much rubble (1003) overlaying this floor, but at least 3 bucket loads of oyster shells were distributed across the surface, leading to the conclusion that this room had been a food preparation area.

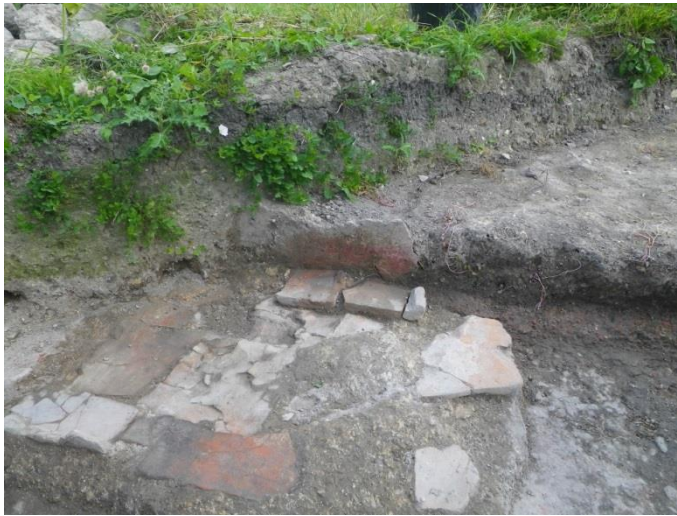
In-situ painted wall plaster, by rough tiled section of floor in room 13

The painted wall plaster was behind an area of untidily laid rough tiles set into mortar, which itself had been laid onto the *op.sig* floor. At the moment there is no interpretation for these, as they do not seem to be part of a later floor surface.

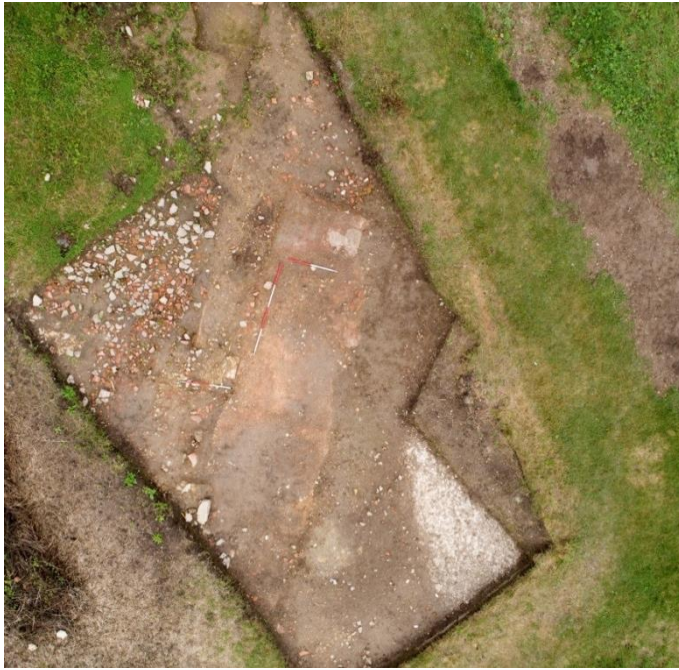
Room 14: Front corridor/verandah (centre) with rubble over main range (left), and crushed chalk courtyard surface (bottom right). Large scale 2m

In the area outside this corridor, which we are referring to as the 'front courtyard/garden' a layer of crushed chalk has been uncovered. This appears to overlay a mortar rich layer, which in turn covers undisturbed soil. This area will require further investigation.

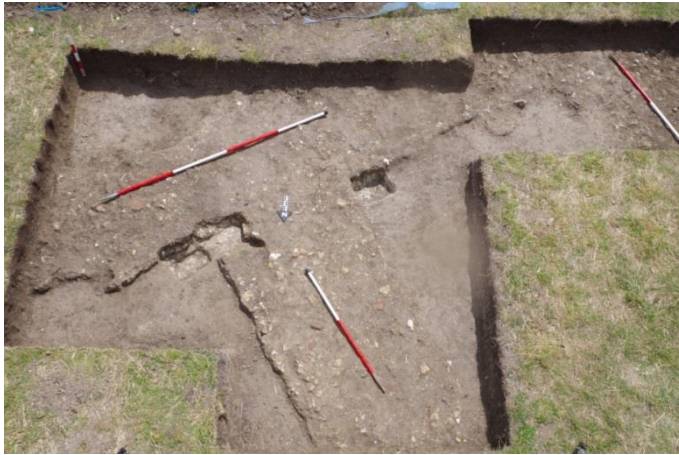
The SE end of the east range, showing the main wall (centre), part of a room (left) and the corridor (right). Note the clean floor areas. Large scale 2m

foundation of this contrasts with the lack of chalk found in the corridor wall trench further into the east range of the villa.

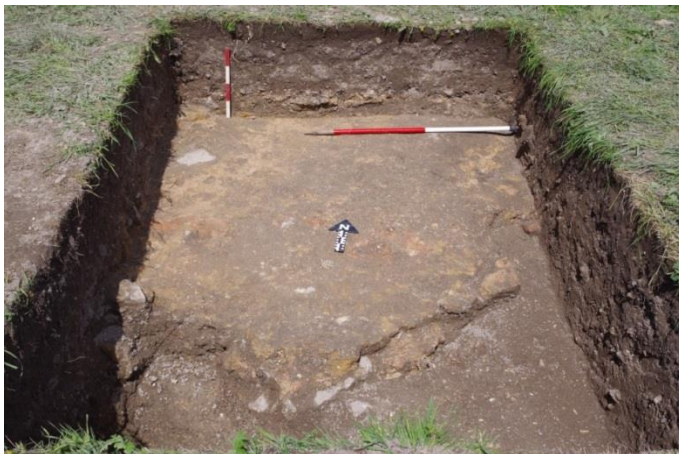
Op.sig sub-floor in trench 4. The robbed out main wall is bottom right. Large scale 2m

Where a large stone *had* been removed, the void created was filled with rubbish, including much painted wall plaster, and some Roman pot sherds. The adjoining floor consisted of a bedding layer of *op. sig.* at a depth of 0.6m. Overlaying this was around 30mm of grey silt, implying that the area had been open for a while, possibly being flooded, before being buried under rubble (1002-03) then topsoil.

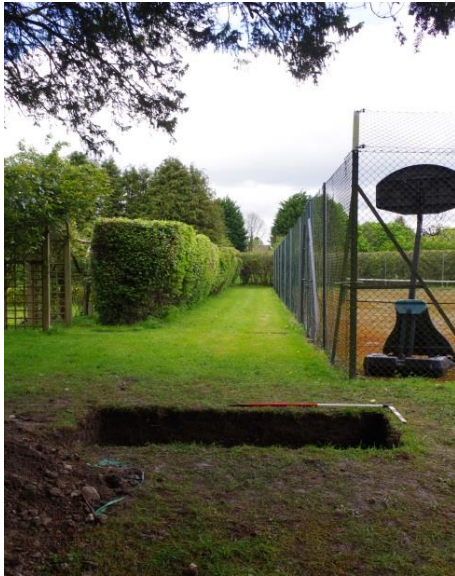
Trench 1 at SW corner of tennis court

When the trench was excavated, the first half metre consisted of soil piled up to level the ground when the tennis court was constructed in the late 1950's. This topsoil contained mainly 19th century material, with a few pieces of upbraided Roman cbm. The true modern ground level was represented by the roots of an adjacent yew tree.

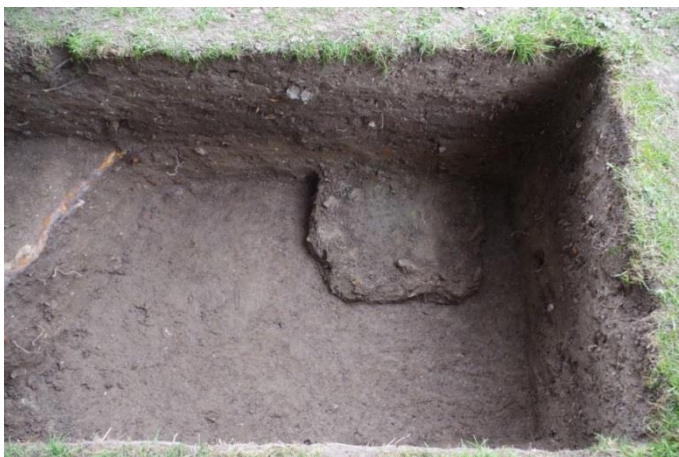
Trench 1, showing possible wall foundation (No scale is available, as photography was planned for the following day, by which time the trench was full of water, but trench is 1m front to back).

A sondage dug next to the putative wall end revealed the water table at 1.15m. The trench was around 5m away from a large pond/lake, probably constructed in the Tudor period, and fed by at least five springs via man-made streams and conduits. At the end of day two there was heavy rain, and the trench flooded to a depth of at least 0.9m. We were unable to stop any further ingress of water, so consequently it was backfilled.

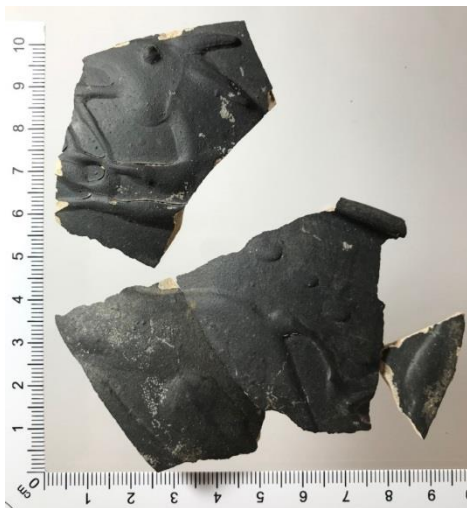
As mentioned in the main body of text, we have some sherds of fine colour coated ware. These stem from several origins, the commonest probably being Nene Valley. In particular we have several sherds from a 'hunting cup', decorated in relief with a hare being chased by hounds.

This is datable to the late 2nd century, which is earlier than the majority of material we have from the site, and predates the earliest coin by about 60 years.

Nene Valley hunting cup

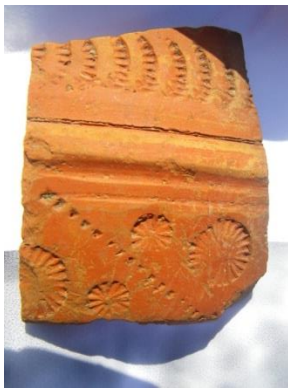
What has been more common over the site is Oxfordshire ware, a red slipware imitating Samian, but not having the same highly fired fabric, and also a slip that will rub off when wet. This is still, however, for its time a relatively high class table ware.

Oxfordshire ware (drawing by C Blair-Myers)

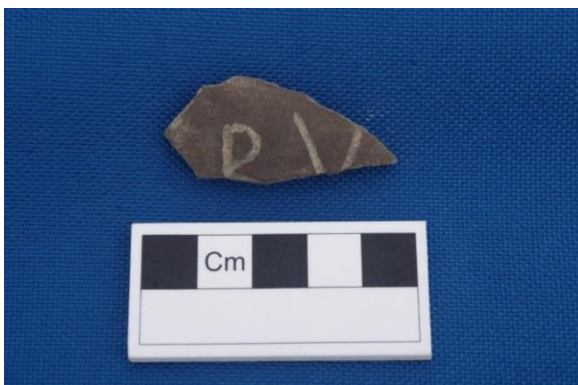
One piece of greyware contains some graffiti scratched into it, but not enough survives to be able to identify the word, which may be a person's name.

Graffitied pot sherd

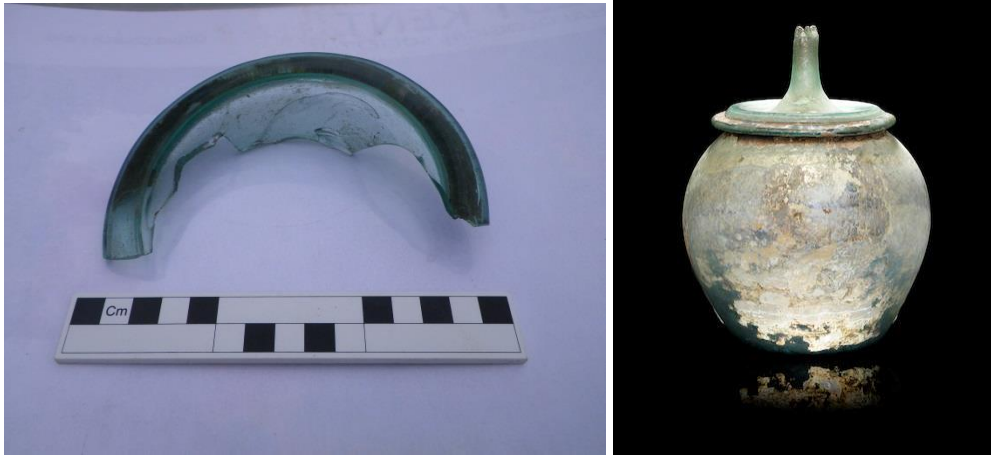
Aside from some pieces of vessel glass, we have the rim of a *cinerary* urn, which came from (1002) above room 12. No other trace of this vessel was found.

Cinerary urn rim, possibly from a vessel such as on the right

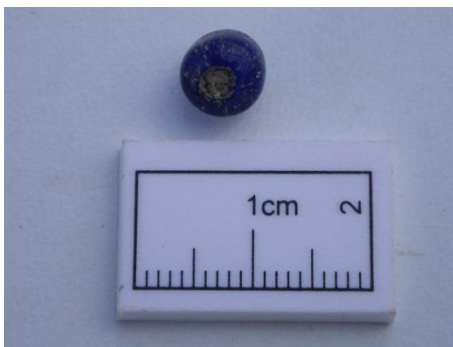
Three blue glass beads have been found. They appear to be from the same item of personal jewellery – possibly a bracelet or earrings – but were scattered across the site, an indication of the problems of site provenance following the kind of demolition seen at Church Field.

Glass bead, found in trench 3, 2015

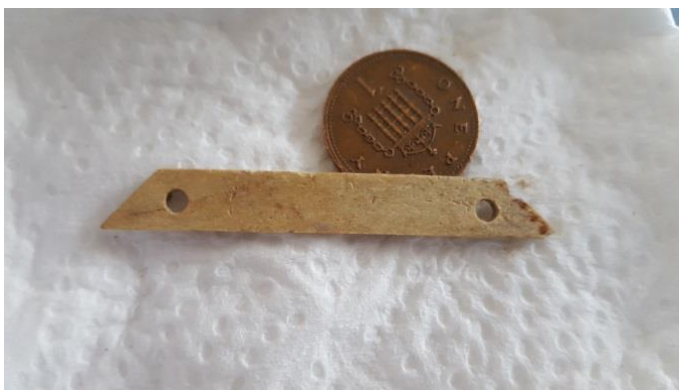
We have examples of worked bone implements: decorations from the possible lid of a box, a possible comb, and several hair pins; also some antler, that may have been intended for knife handles.

Decorated bone, possibly from a box lid

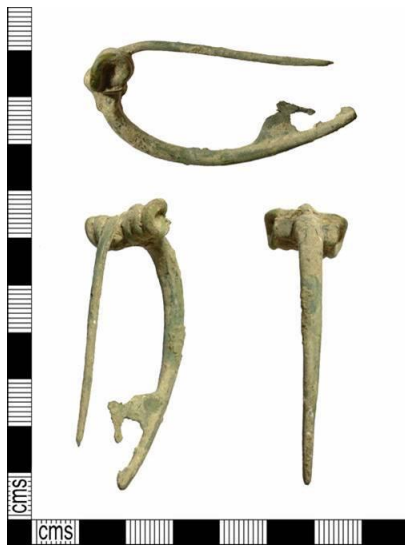
Aside from the large coin archive, much other metalwork has been found on the site. Most of this was in the form of nails, or offcuts of metal, but some personal items of jewellery and domestic life were recovered. These were spread across the site, and included an early 1st century copper alloy *fibula*.

Late Iron Age Fibula

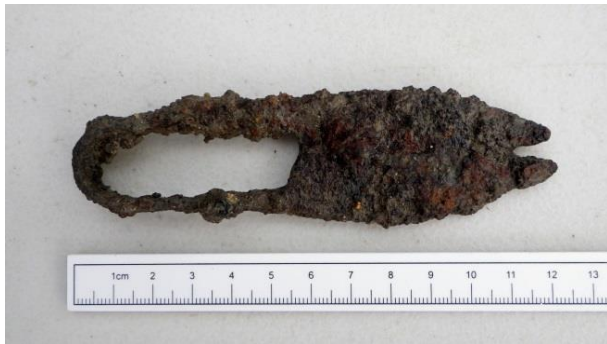
Other identifiable metal items include a steel weight and a pair of shears, probably used for male personal grooming.

Iron shears

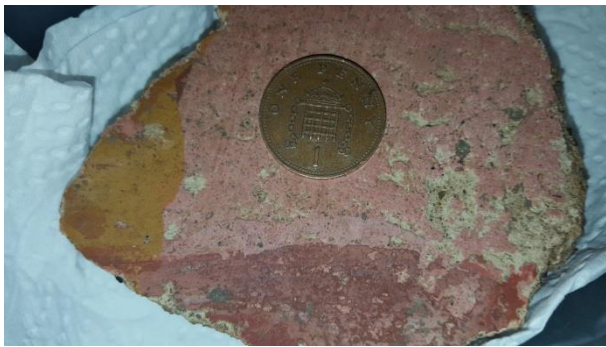
This has been distributed across the site, often in small dumps, implying it was shovelled into a container and tipped out away from its place of origin. There has been a selection of colours and shade, but predominantly off-white, and maroon, and sometimes (by way of a change) off-white with maroon striped across it. This presumably represents some kind of decoration. So far we have several fragments containing blue, pink, two shades of green, and yellow.

Painted plaster recovered from east range.

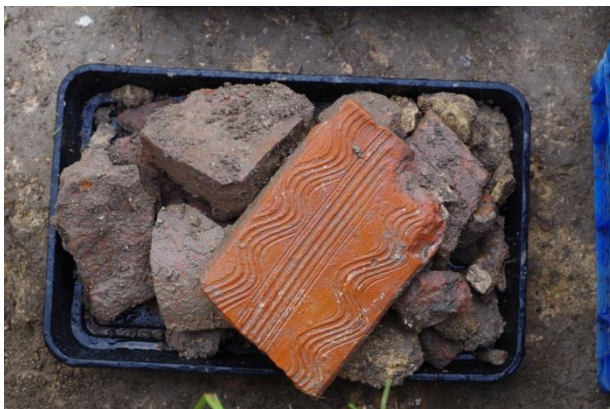
Flue tile from main range

Among the many sherds of *tegulae* and *imbrices* across the site, there were many flue tile sherds from the hypocaust systems. These were often heat and smoke stained, and displayed a variety of combing patterns on the surface, applied to be able to key in plaster once they were in place within the walls.

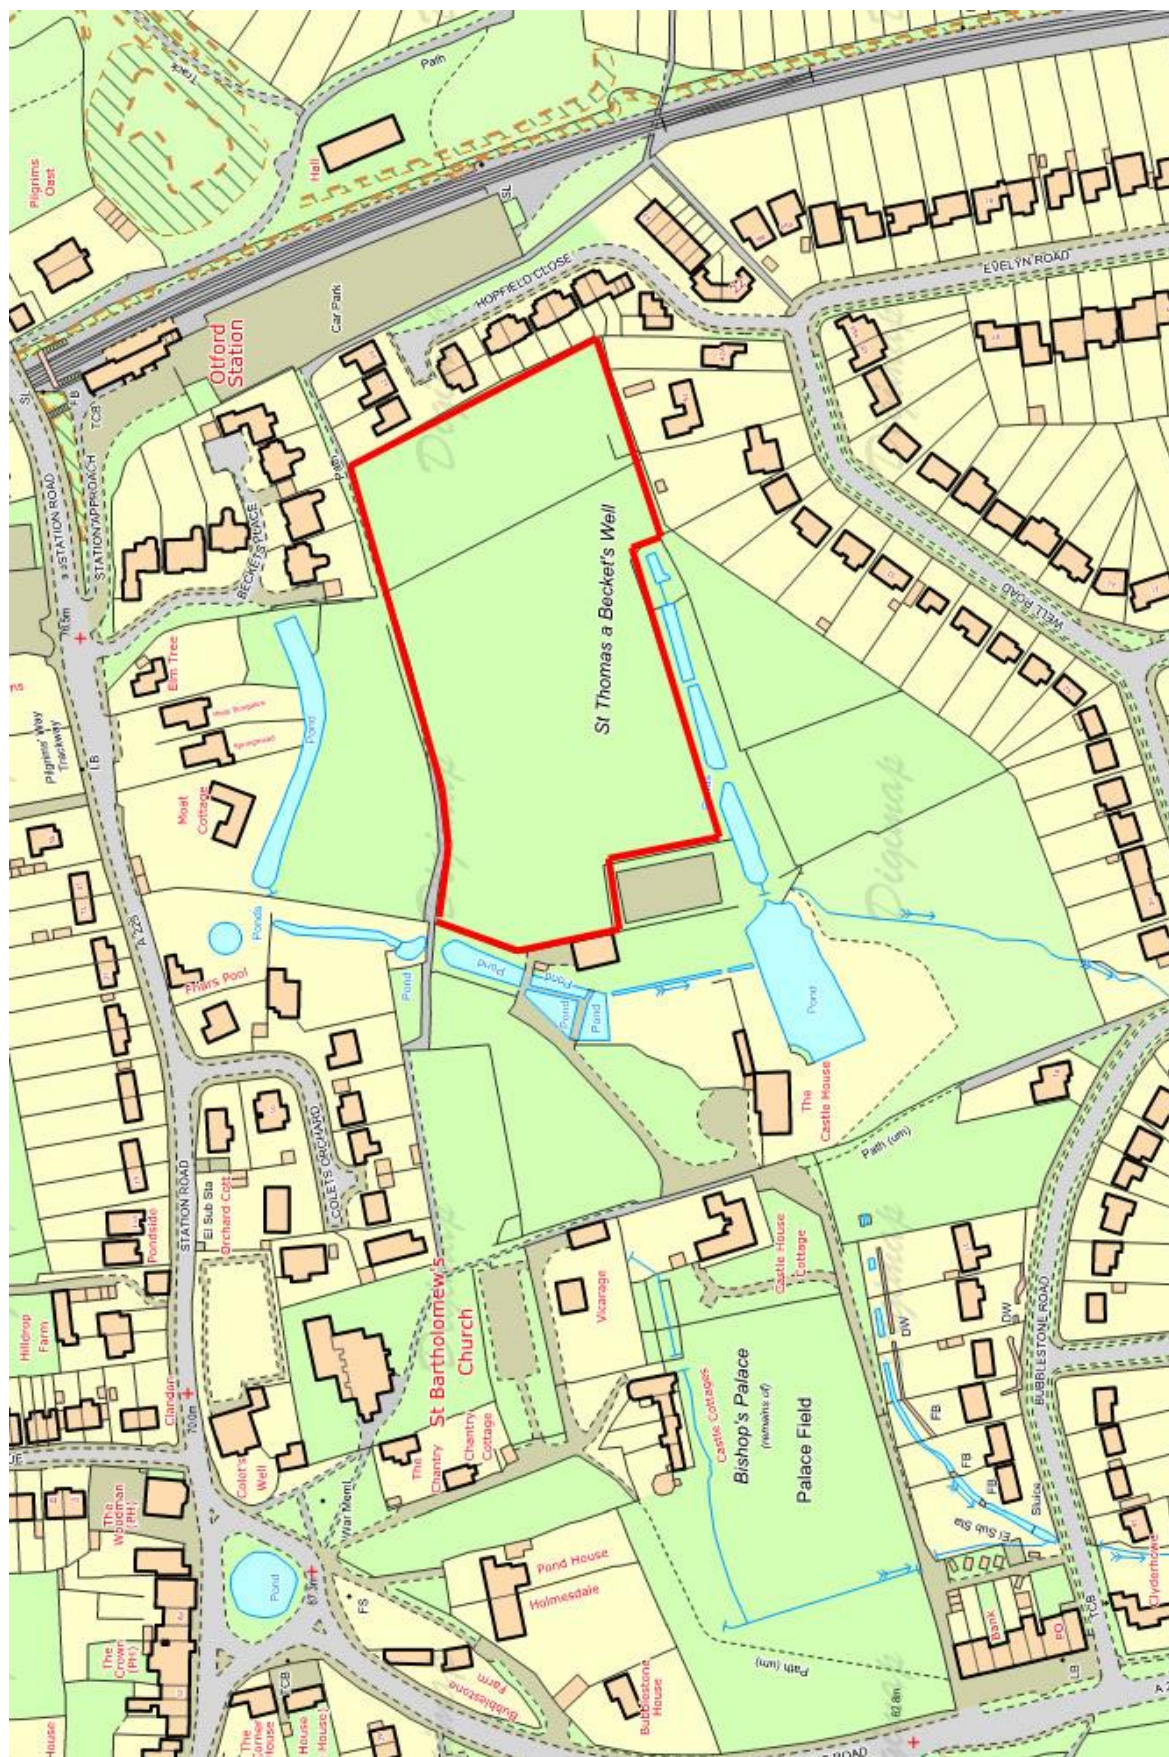
Figure 1.

The earth resistance survey was conducted over the land indicated in Figure 1 using a Geoscan RM15 resistivity meter with a twin probe array spaced at .5 metre. Readings were taken at 1metre x 1 metre intervals.

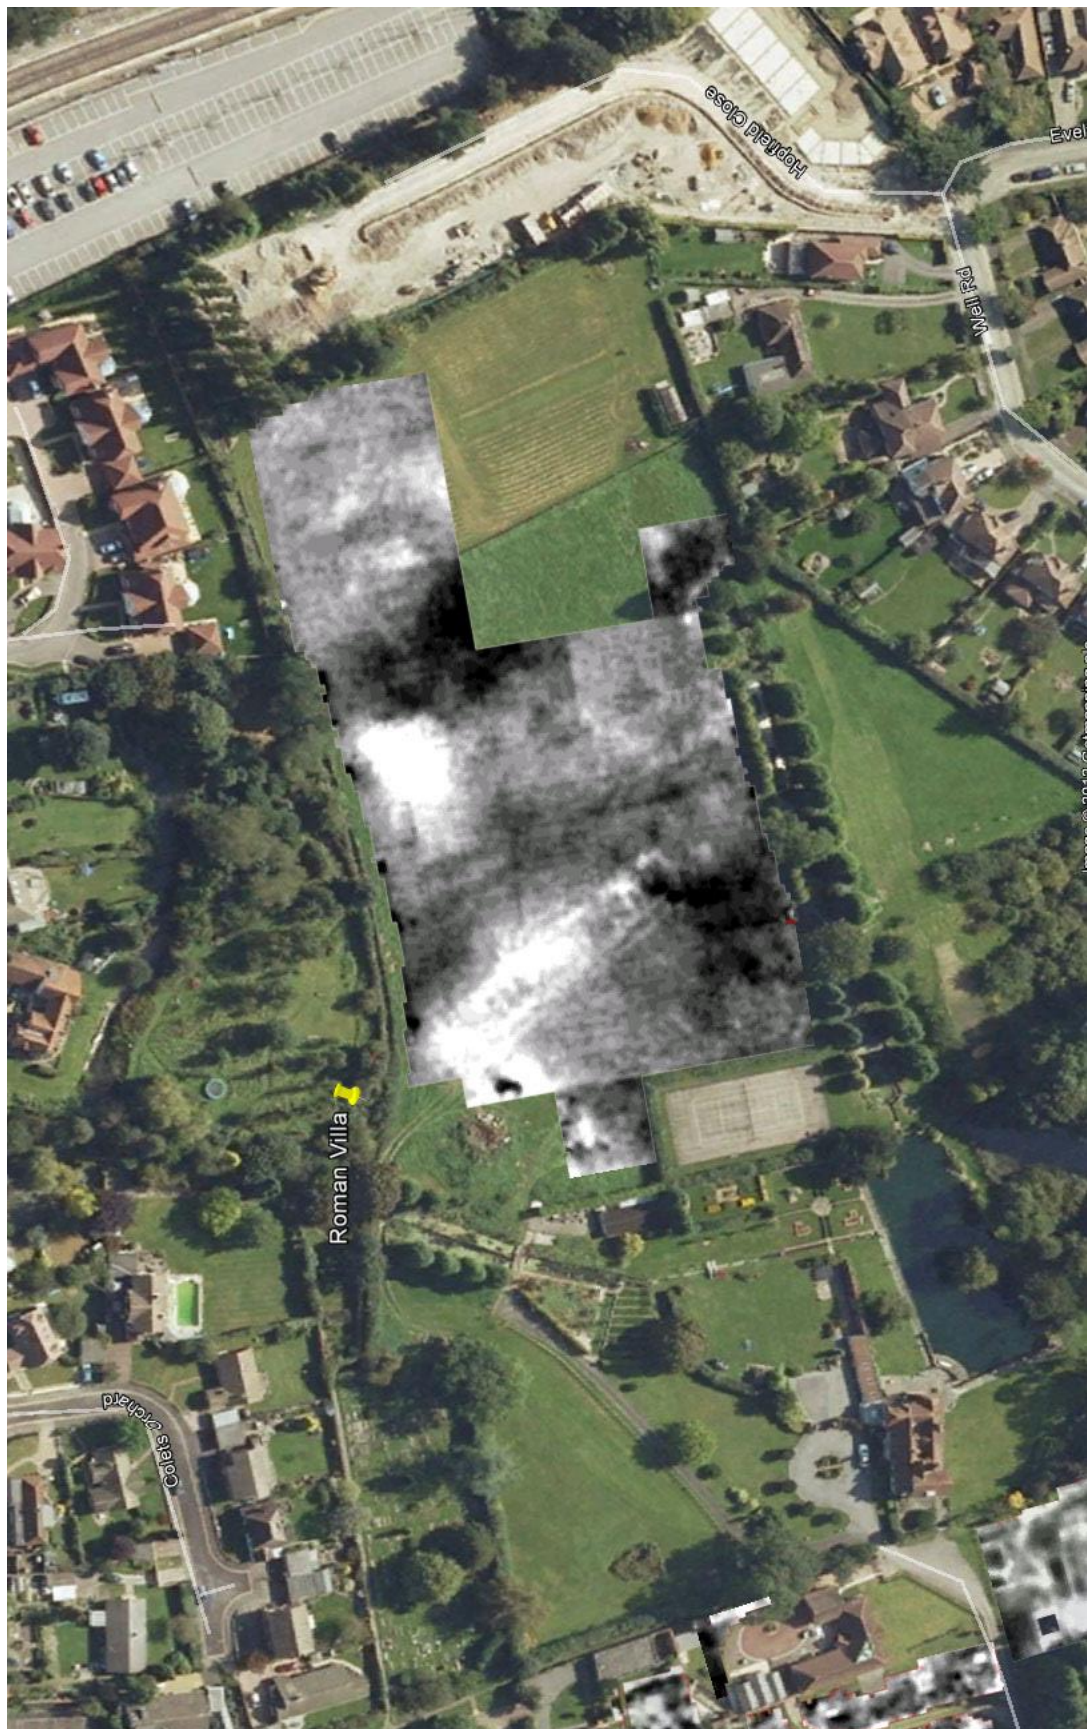
Figure 4.

The surveyed area can be seen in Figure 4 overlaid on Google earth to show survey in context.
