ARCHAEOLOGICAL WATCHING BRIEF AT EYOT HOUSE, CHURCH STREET, SHOREHAM, SEVENOAKS, KENT TN14 7SB

Planning Reference: SE/20/00795

DAS Site Code: EH20-WB

Report Number DAS 006/20/EH20-WB

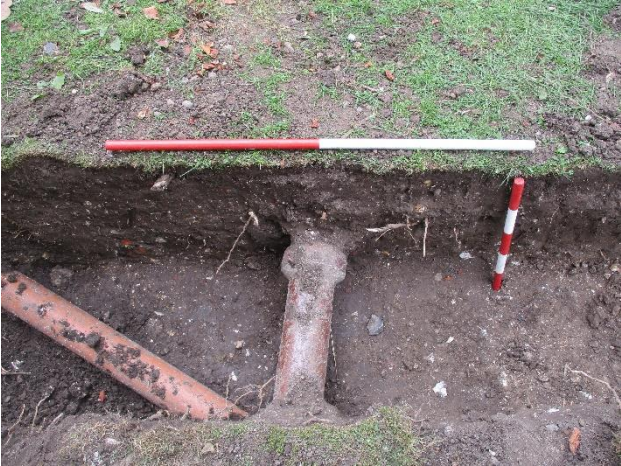
<p>12.1</p> <p>Trench 1 - Looking north at drains and 1001 & 1002</p>

- 6.7. There are drains truncating Trench 1 (**12.1, 12.2 & 12.3**); the original soil pipe shows no sign of a drainage cut, implying this drain was installed during construction, and 1002 is, primarily, made-up group deposited during/after that event. It is difficult to see the cut profiles of the later (plastic) drains.
- 6.8. The mixture and date-range of domestic debris contained in 1002 would account for the likely residual earlier (late-nineteenth century) artefacts intermingled with more modern (early to mid-twentieth-century) artefacts. Therefore, 1002 has a likely date range from c.1900 AD to c.1960 AD.

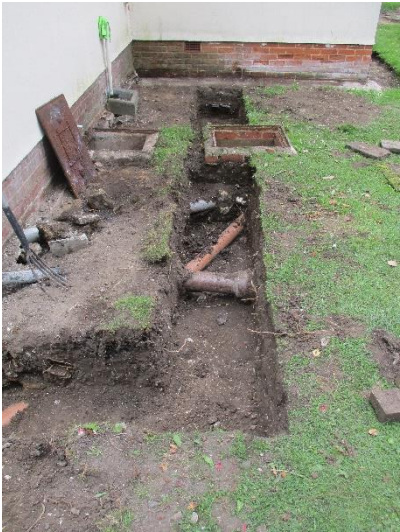
<p>12.2</p> <p>Trench 1 - Looking west at drains cut into 1002.</p>

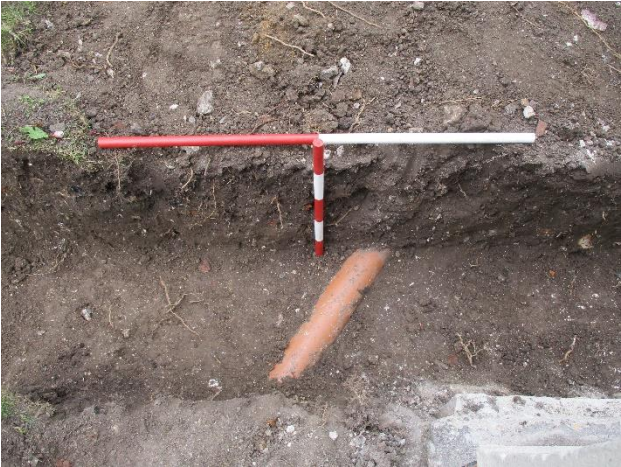
<p>12.3</p> <p>Trench 1 - Looking west at S1.</p>

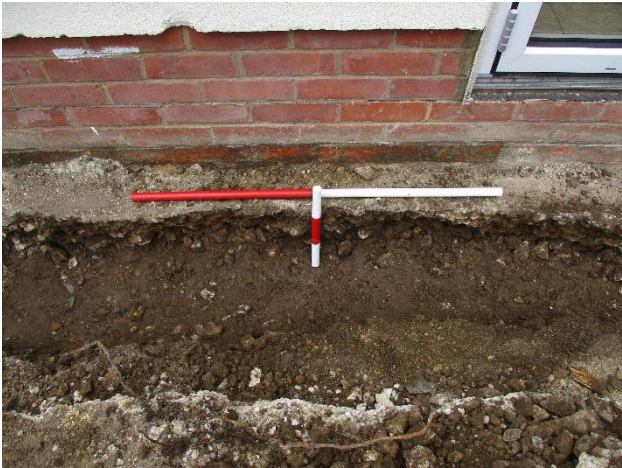
<p>12.4</p> <p>Trench 2 - Looking north at 1009 & 1010</p>

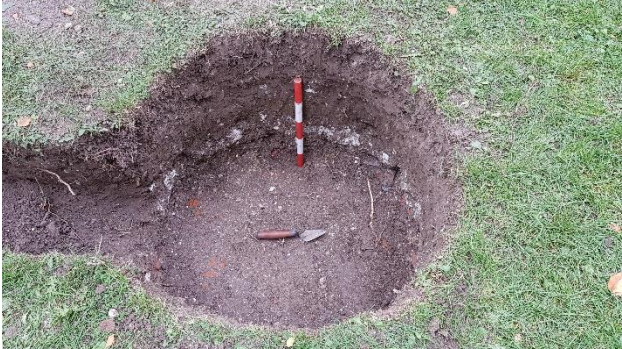
<p>12.5</p> <p>Trench 3 - Looking west at circular drain cut (mid-excavation) showing chalk capping layer 1006 and demolition layer 1007 emerging.</p>

- 6.12. 1005 sits above 0.1m of 1006, a chalk dump made up of redeposited chalk pieces of varying sizes. 1006 caps 1007, a demolition dump of undetermined depth, composed of compacted flint nodules, chalk, brick and tile pieces in a dirty brown sandy clay matrix; numerous inclusion and concentrations of domestic rubbish (pottery, glass, metalwork and animal bone) (**12.5 & 12.6**).

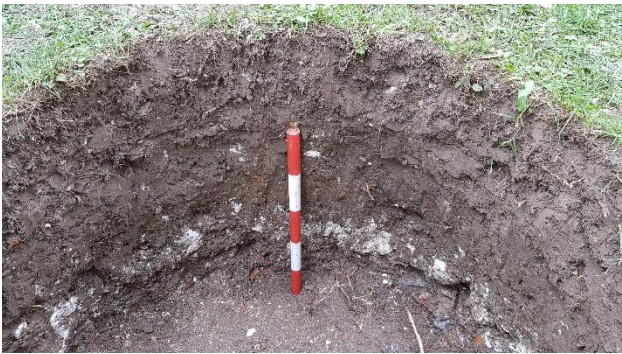
<p>12.6</p> <p>Trench 3 - Looking west at circular drain cut (mid-excavation) showing chalk capping layer 1006 and demolition layer 1007 emerging.</p>

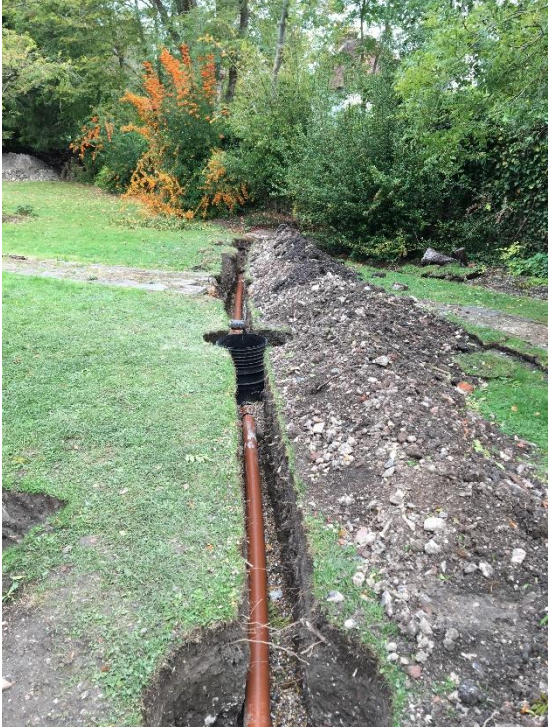
<p>12.7</p> <p>Trench 3 - Looking north at full extent; although 1006 & 1007 continue throughout trench extent, no further evidence of building featured in Figure 12 remain.</p>

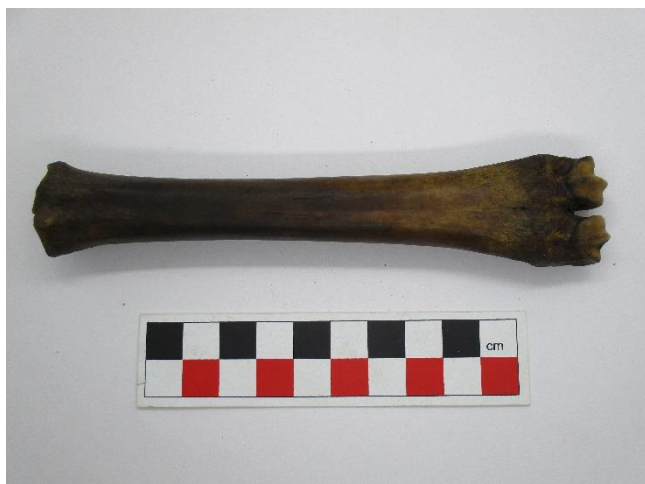
<p>13.3</p> <p>1005 - Sheep metacarpal; exhibits no butchery marks and may indicate sheep farming in the immediate vicinity.</p>

- 7.4.2. 1005 – Pottery from context 1005 is generally earlier than 1002, comprising late-nineteenth-century porcelain and stoneware. The exception is **13.2**, a residual sherd of Surrey Whiteware c.1350-1500 AD. A single and complete sheep metacarpal (**13.3**) is the only bone recovered from 1005, though it exhibits no butchery marks and may indicate sheep farming in the immediate vicinity.

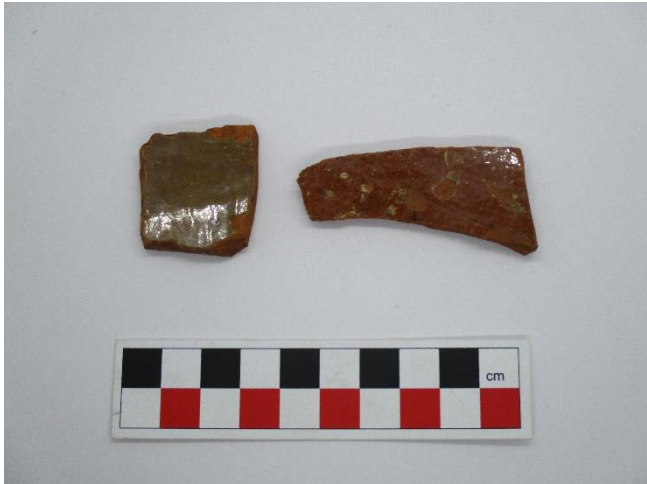
<p>13.4</p> <p>1007 – two sherds of mid-nineteenth century Kentish redware with iron oxide glaze.</p>

- 6.14. The building shown in Figure 13 appears to have been demolished by the time of publication of the 1897 OS Map (Figure 14), providing a potential date of c.1897 AD for contexts 1006 and 1007 (**12.7**). The diagnostic finds (**13.4, 13.6 & 13.7**) from 1007 confirm this hypothesis.

- 7.4.3. 1007 – Pottery from context 1007 is likely earlier than 1005, comprising two sherds (**13.4**) of mid-nineteenth century Kentish redware with iron oxide glaze. Tobacco pipe stems of similar date are also present. Surprisingly, a flint flake (**13.5**), exhibiting bulb, striking platform and chalk patina to both ventral and dorsal faces, was recovered. The lithic is intrusive but is a stark reminder of Shoreham's prehistoric past. Brick (**13.6**) and roof tile (**13.7**) pieces were recovered and suggestive of demolition material associated with the building featured in Figure

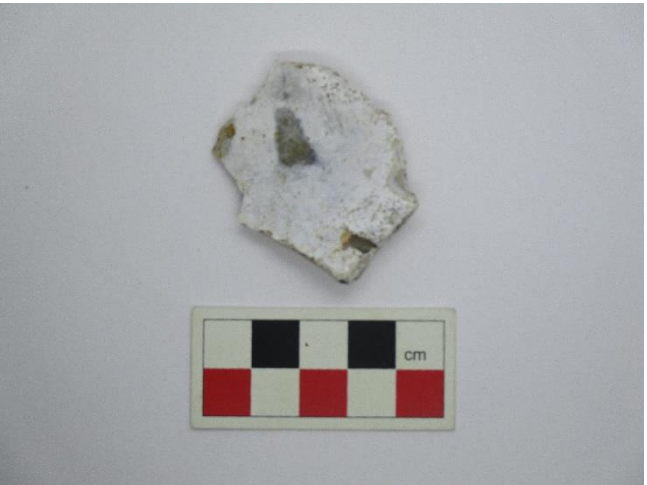
<p>13.5</p> <p>1007 - flint flake exhibiting bulb, striking platform and chalk patina to both ventral and dorsal faces.</p>

8.1. The results of the watching brief revealed a stratigraphic sequence confirming the Eyot Houses and site past, perhaps even from c.1500 BC to Present Day. A flint flake of possible Late Prehistoric origin is suggestive of Shoreham's Prehistoric settlement(s). A sherd of Surrey whiteware (c.1300 – 1500 AD), part of a fineware costrel or bowl, indicative of medieval wealth, is perhaps associated with the nearby Church of St Peter & St Paul or other building is similar standing/status. The remainder of the excavation pointed to the presence of demolition material associated with a former building – of unknown purpose - to the northeast of Eyot House. The stratigraphic sequences of the trenches confirmed the use of the land from c.1890s AD to the present day. Given the proximity of the River Darent, it is likely that, before Eyot House been constructed, the land was likely used for pasture.

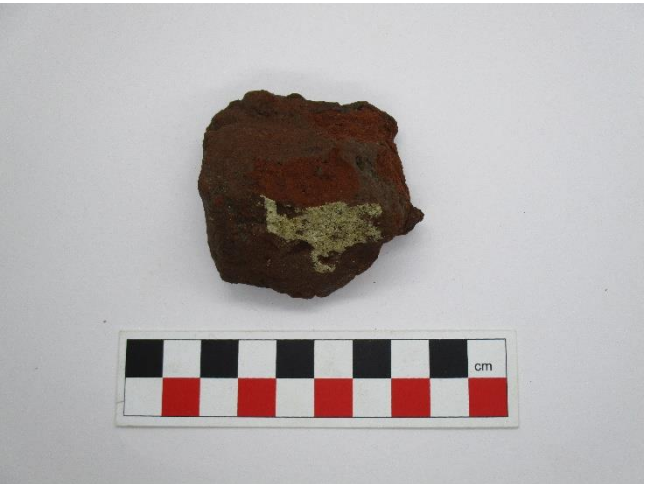
<p>13.6</p> <p>1007 – A brick piece from demolition layer.</p>

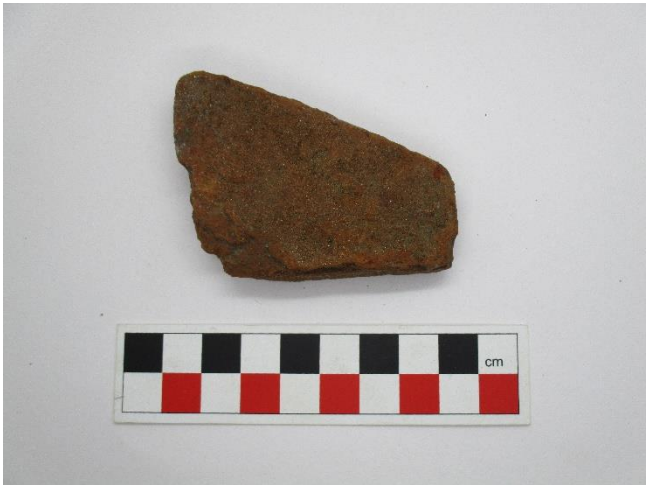
<p>13.7</p> <p>1007 – Roof tile piece from demolition layer.</p>

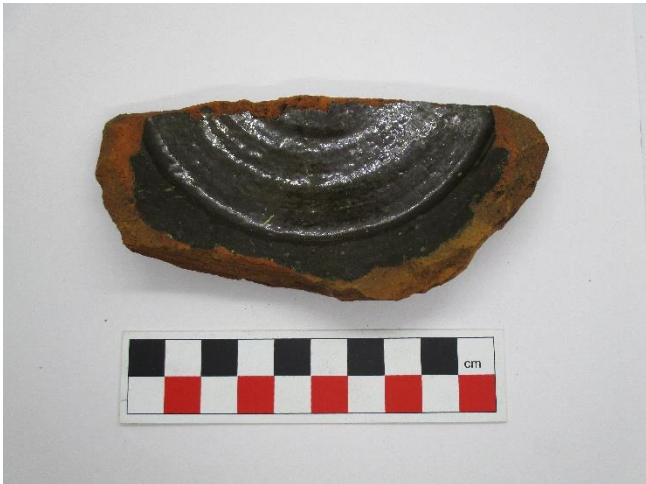
<p>13.8</p> <p>1008– Red Earthenware bowl base with manganese/iron glaze c.1800-1850 AD.</p>

7.4.4.1008 – Pottery from 1008 is contemporary with 1005, comprising late-nineteenth-century porcelain and earthenware. **13.8**, a sherd of Red Earthenware bowl base with manganese/iron glaze c.1800-1850 AD is perhaps slightly earlier than expected.
