ARCHAEOLOGICAL WATCHING BRIEF AT THE FORMER VETERINARY HOSPITAL, MAIDSTONE ROAD, ASHFORD, KENT

Planning Reference: 20/00425/AS

DAS Site Code: VH20-WB

Report Number DAS 007/20/VH20-WB

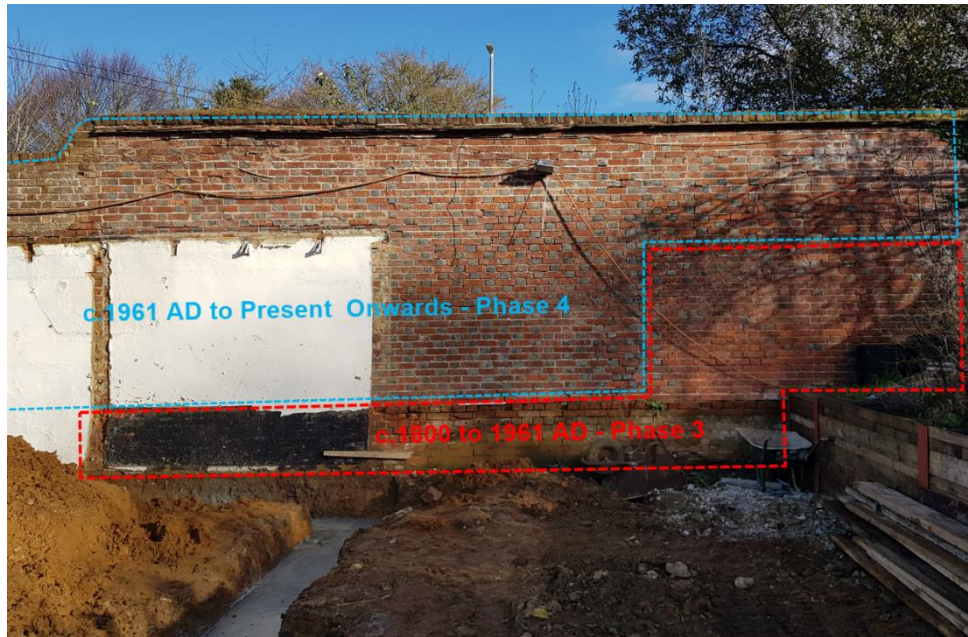
(Figure 9 – Looking northeast at wall 1005)

- 6.10. The later, upper portion of boundary wall 1005 displays sections of Flemish bond brickwork (c.1961 AD), whereas the lower, earlier portion display a typical English Bond, indicating phased adaptations or repairs to the wall from c.1800 to 1961 AD.

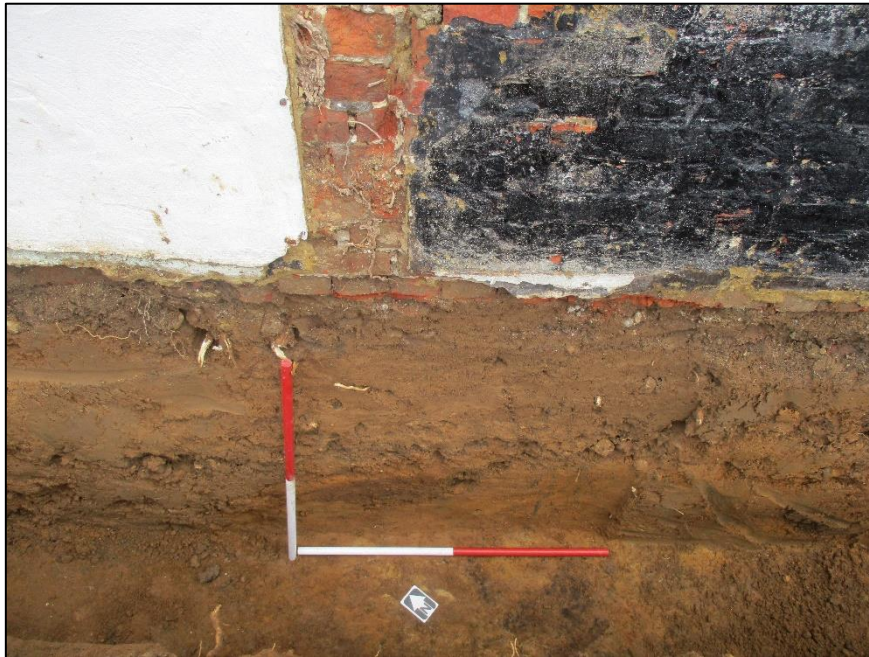
(Figure 11 – Wall 1005 sat on 1003, with 1004 brickearth visible underneath)

- 6.11. The older, lower portion of boundary wall 1005 characterised by the English bond, sits on top of 1003 (Figure 11), up to 0.75m of light brown sandy clay, probably colluvium **(12.4)**. 1003 sits on top of 1004, a coarse yellow/brown sandy clay brickearth; sparse inclusion – coarse pebbles. 1003 and 1004 constitute the geological layers encountered on site **(12.5)**.

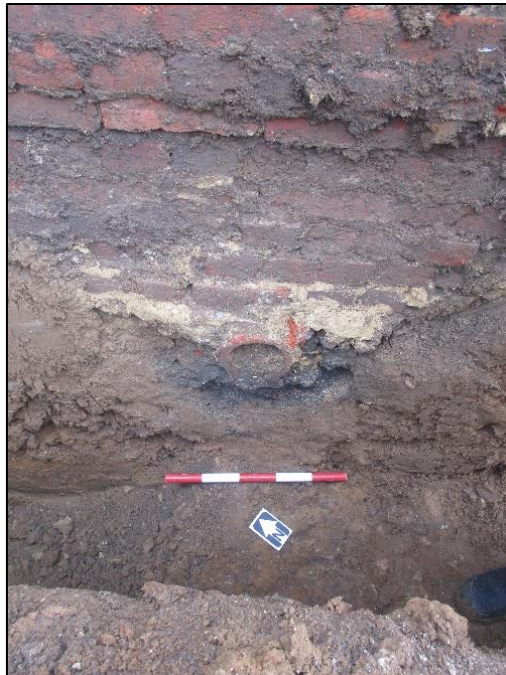
(Figure 12 – Modern drain 1007 undercutting boundary wall 1005)

- 6.12. Toward the northeast corner of Trench 1, a modern drain 1007, sits in cut 006 which, at the time of installation (probably c.1961 AD when the veterinary hospital was built), undercut the older, lower portion of wall 1005. Figure 12 demonstrates that wall 1005 was damaged and repaired during the installation, and drain 1007 was bedded into 1008, a black/grey sandy grit.

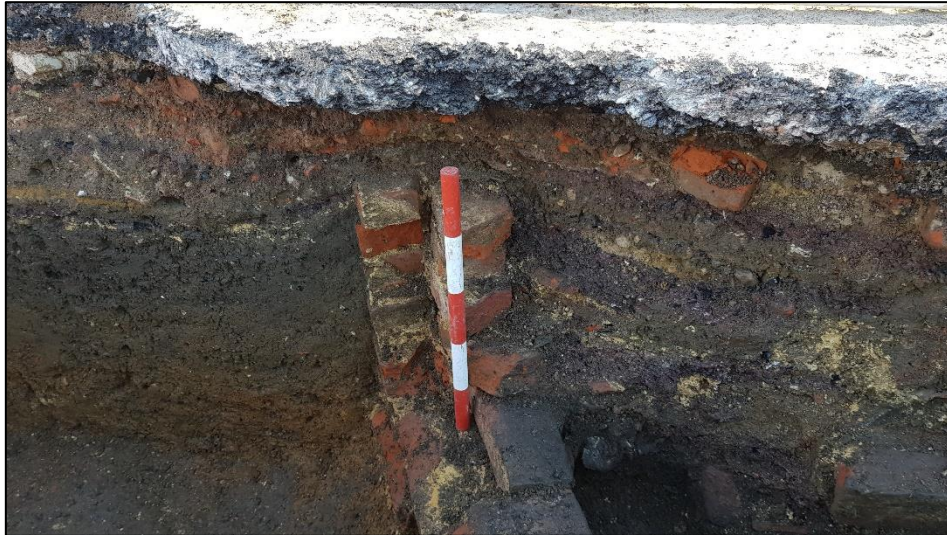
(Fig 15 – Section 3, Trench 2)

- 6.15. The following details the Phase 4 stratigraphy across Section 3 that is not curtailed by brick wall 1033: 1044, 0.1m of asphalt hard standing sits on 0.05m of 1043, a brown sand and pebble matrix, used as bedding for 1044. Below 1043 is 1042, an earlier hard standing made up of brick and yellow mortar. 1042 sits above 1041, brown sand used as bedding for 1042. Below 1041 is 1040, a thin layer of clinker, which sits above 1039, 0.1 to 0.15m of green/brown silty sand containing crushed brick. Under 1039 is 1038, up to 0.1m of yellow sand and crushed brick. 1038 sits above 1037, a thin lens of green/brown silty sand. Below 1037 is 1036, up to 0.1m of clinker. 1036 sits above 1035, a thin layer of yellow sand.

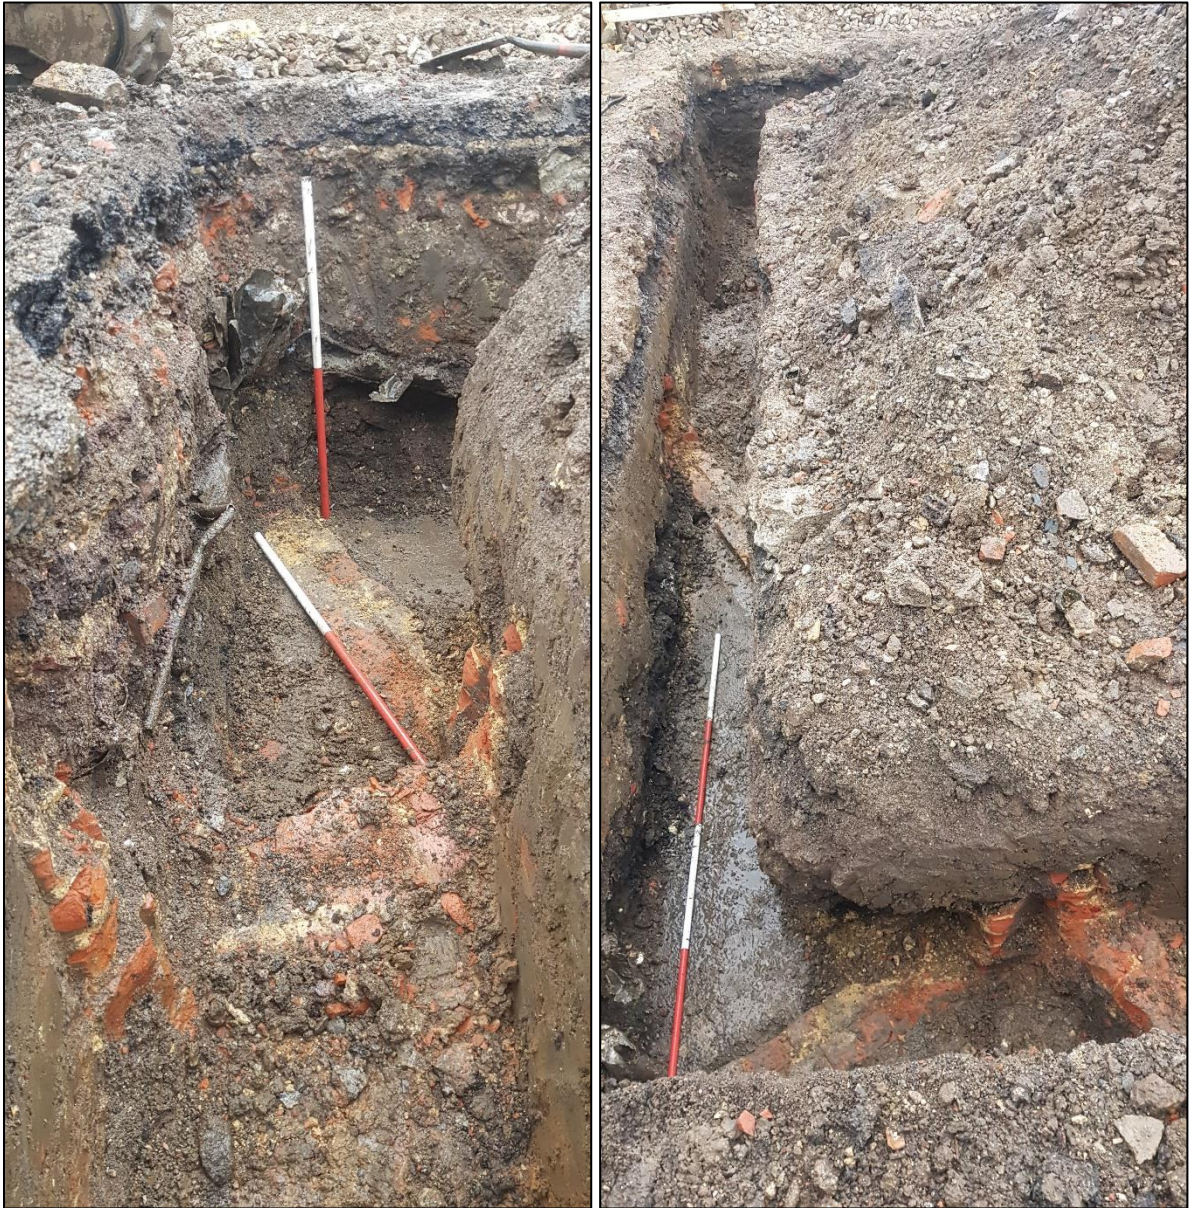
(Figure 20 left, looking southwest at wall 1053 returning off wall 1033; Figure 21 right, looking west at wall 1033 in foreground and walls 1053 and 1056 surrounding 1054, forming outbuilding 1060).

6.20. A return wall heading south off wall 1033 was evident – same brick and mortar construction as walls 1033 and 1056. This provided further evidence for the footprint of outbuilding 1060 (Fig 18).

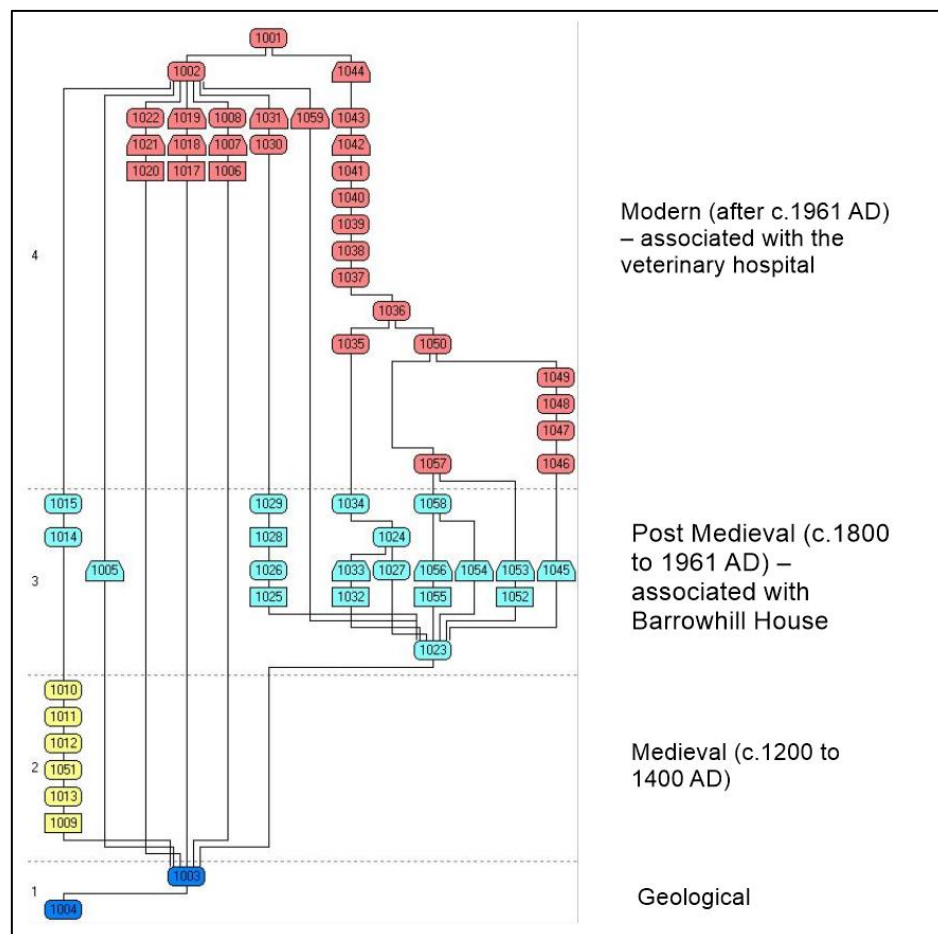
(Fig 22 – Stratigraphic matrix for VH20-WB)

8.3. The following matrix diagram illustrates the stratigraphic sequences and phasing:

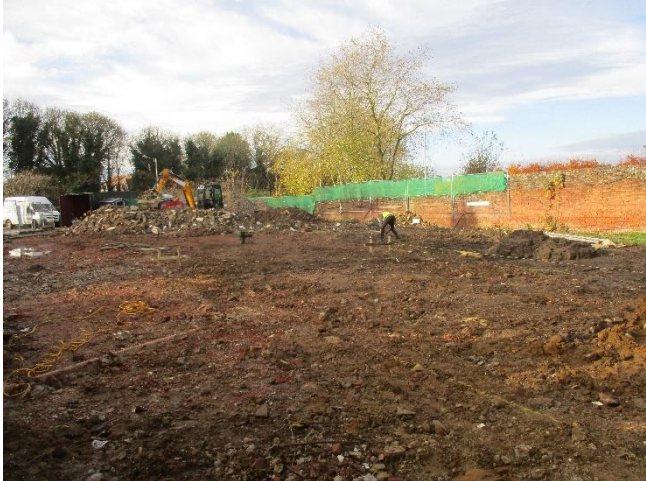
| Image | Number & Description |
|---|---|
| | <p>12.1</p> <p>Site looking northwest following demolition of the veterinary hospital and before Trench 1 & 2 excavations.</p> |

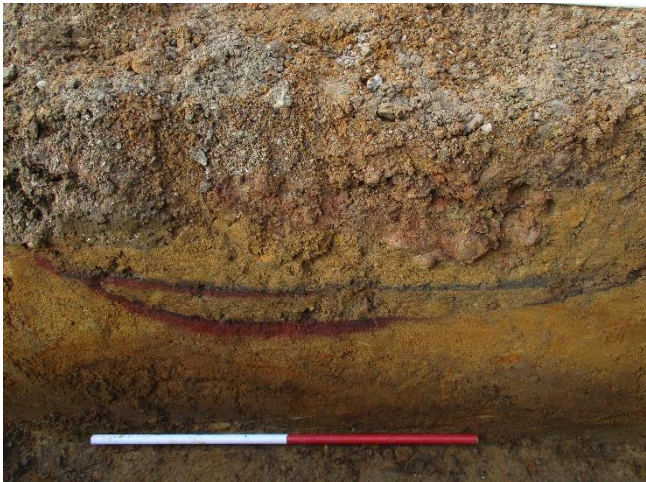
| Image | Number & Description |
|---|---|
| | <p>12.2</p> <p>Trench 1, Section 1 looking northeast at a medieval ditch.</p> |

- 6.7. Section 1 (**12.2**) illustrates 0.1m to 0.2m of 1002, a dirty brown sandy clay subsoils containing numerous inclusions – brick, tile, glass, sits above 0.1m of 1015, a reddish-brown silty clay. Below 1015 is 0.1m to 0.2m of 1014, a yellow-grey silty clay. 014 sits above a thin band of 1010, 20mm of dark grey mottled silty clay. Below 1010 is 1011, up to 30mm of dark orange/brown friable sandy silt. 1011 sits above 1012, up to 50mm of yellow/brown mottled clayey silt. Below 1012 is 1051, up to 20mm of dark grey mottled silty clay. 1051 sits above 1013, 0.05m of dark orange/brown friable sandy silt from which a single sherd of Kentish sandy ware (c.1200 to 1400 AD) was recovered (**13.1**). 1013 is the primary fill of ditch cut 1009 which, in turn, is cut into the top of 1004, a coarse yellow/brown sandy clay brickearth; sparse inclusion – coarse pebbles. 1009 is a drainage ditch sloping gradually from south to north for which contexts 1010 to 1013 are likely medieval layers.

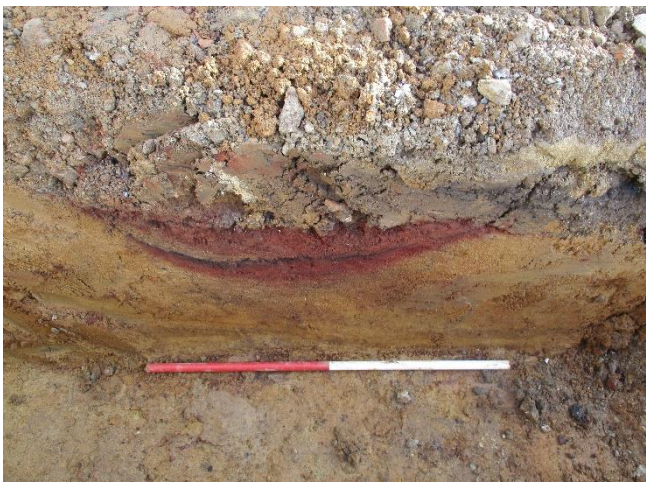
| Image | Number & Description |
|---|---|
| | <p>12.3</p> <p>Trench 1, Section 2 looking southwest at a medieval ditch</p> |

- 6.8. Section 2 (**12.3**) illustrates 0.05m of 1002, a dirty brown sandy clay subsoil containing numerous inclusions – brick, tile, glass, sits above 0.2m of 1014, a yellow-grey silty clay. 014 sits above 0.1m of 1011; a dark grey mottled silty clay. 1011 sits above 1012, up to 50mm of yellow/brown mottled clayey silt. Below 1012 is 1051, up to 20mm of dark grey mottled silty clay. 1051 sits above 1013, 0.1m of dark orange/brown friable sandy silt. 1013 is the primary fill of ditch cut 1009 which, in turn, is cut into the top of 1004, coarse yellow/brown sandy clay brickearth; sparse inclusion – coarse pebbles.
- 6.9. Toward the northeast of Trench 1 is a brick boundary wall, 1005, a portion of the base of is likely to have formed part of the original grounds of Barrowhill House, then adapted (higher) following the construction of the veterinary hospital in the 1960s.

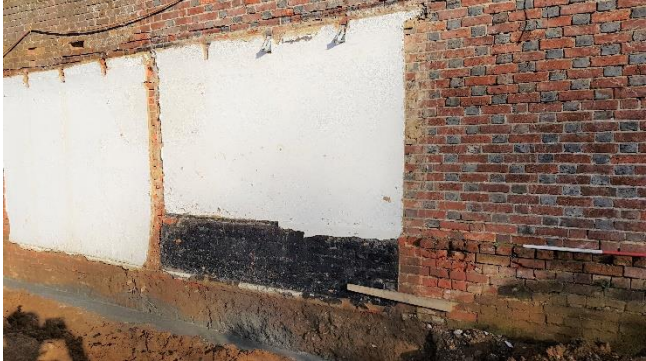
| Image | Number & Description |
|---|--|
| | <p>12.4</p> <p>Trench 1 looking northwest at multi-phase brickwork of boundary wall 1005.</p> |

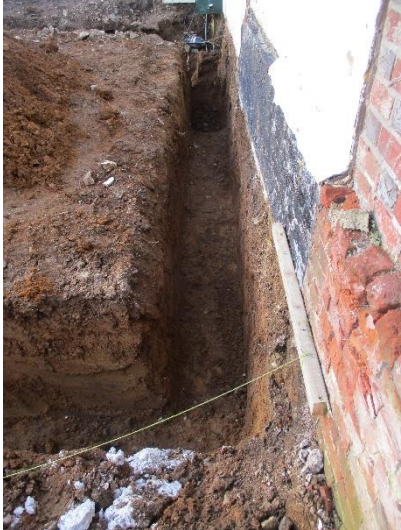
| Image | Number & Description |
|---|--|
| | <p>12.5</p> <p>Trench 1 looking northwest onto 1004 at the base of the trench, and boundary wall 1005 to the right.</p> |

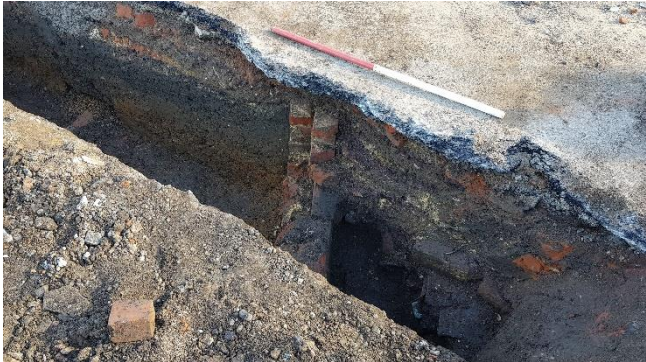
| Image | Number & Description |
|---|--|
| | <p>12.6</p> <p>Trench 2, looking east at Section 3.</p> |

- 6.14. Section 3 (**12.6**) illustrates a complex stratigraphy of Barrowhill House's past, as an early Victorian residential property with gardens/orchard and outbuildings, to the same land converted for use by the veterinary hospital, sometime in the 1960s. Key to

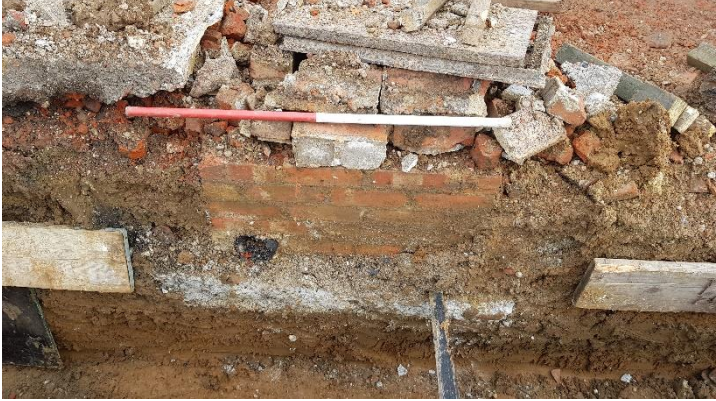
| Image | Number & Description |
|---|--|
| | <p>12.7</p> <p>Trench 2, looking southeast at drain structure 1019.</p> |

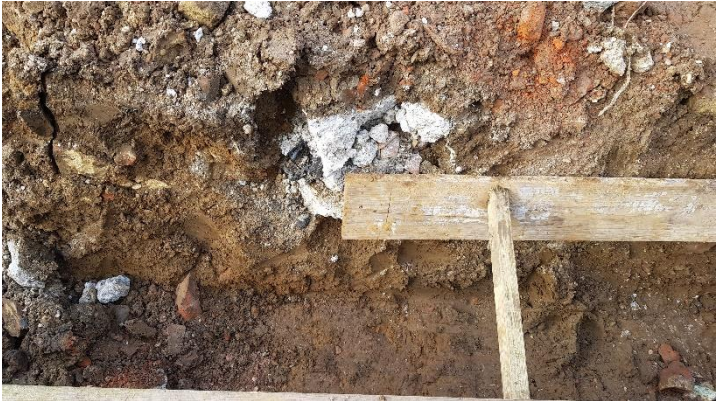
| Image | Number & Description |
|---|--|
| | <p>12.8</p> <p>Trench 2, looking northwest at drain 1022.</p> |

- 6.21. Along the west length of Trench 2 are a series of features visible in section. Approximately 5.0m from the northeast corner of Trench 2 visible in the west-facing section face is cut 1017, filled with 1018, 0.2m of a concrete foundation. Above 1018 is five-course of brick housing drain 1019. 1019 likely served as drainage for the veterinary hospital **(12.7)**.
- 6.22. Approximately 10.0m from the northeast corner of Trench 2 visible in the east-facing section face is cut 1020 for drain 1022 which is surrounded by concrete fill 1021. 1022 likely served as drainage for the veterinary hospital **(12.8)**.

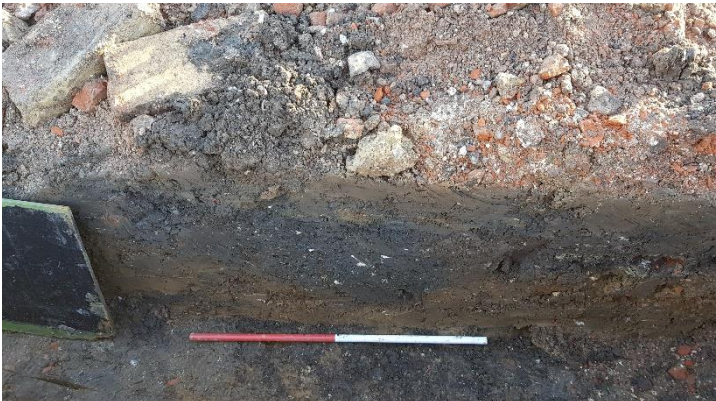
| Image | Number & Description |
|---|--|
| | <p>12.9</p> <p>Trench 2, looking southeast at ditch feature 1025.</p> |

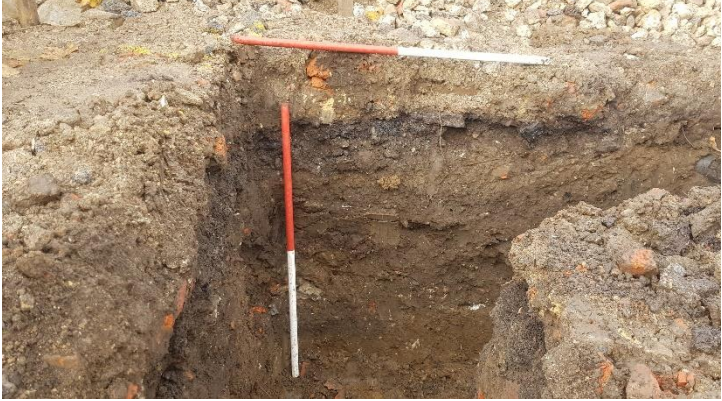
| Image | Number & Description |
|--|--|
| | <p>12.10</p> <p>Trench 2, looking north-west at stratigraphy in the southwest corner.</p> |

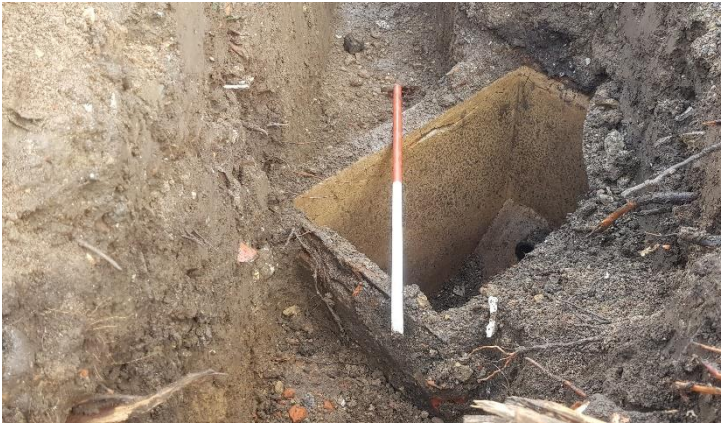
| Image | Number & Description |
|--|--|
| | <p>12.11</p> <p>Trench 2, looking northeast at drain structure 1059.</p> |
