**Archaeological Watching Brief Report
St. Paulinus Church, Perry Street, Crayford,
London Borough of Bexley**

**Project No: 7953
Site Code: SCU 16**

**ASE Report No. 2016032
OASIS ID: archaeol6-240249**

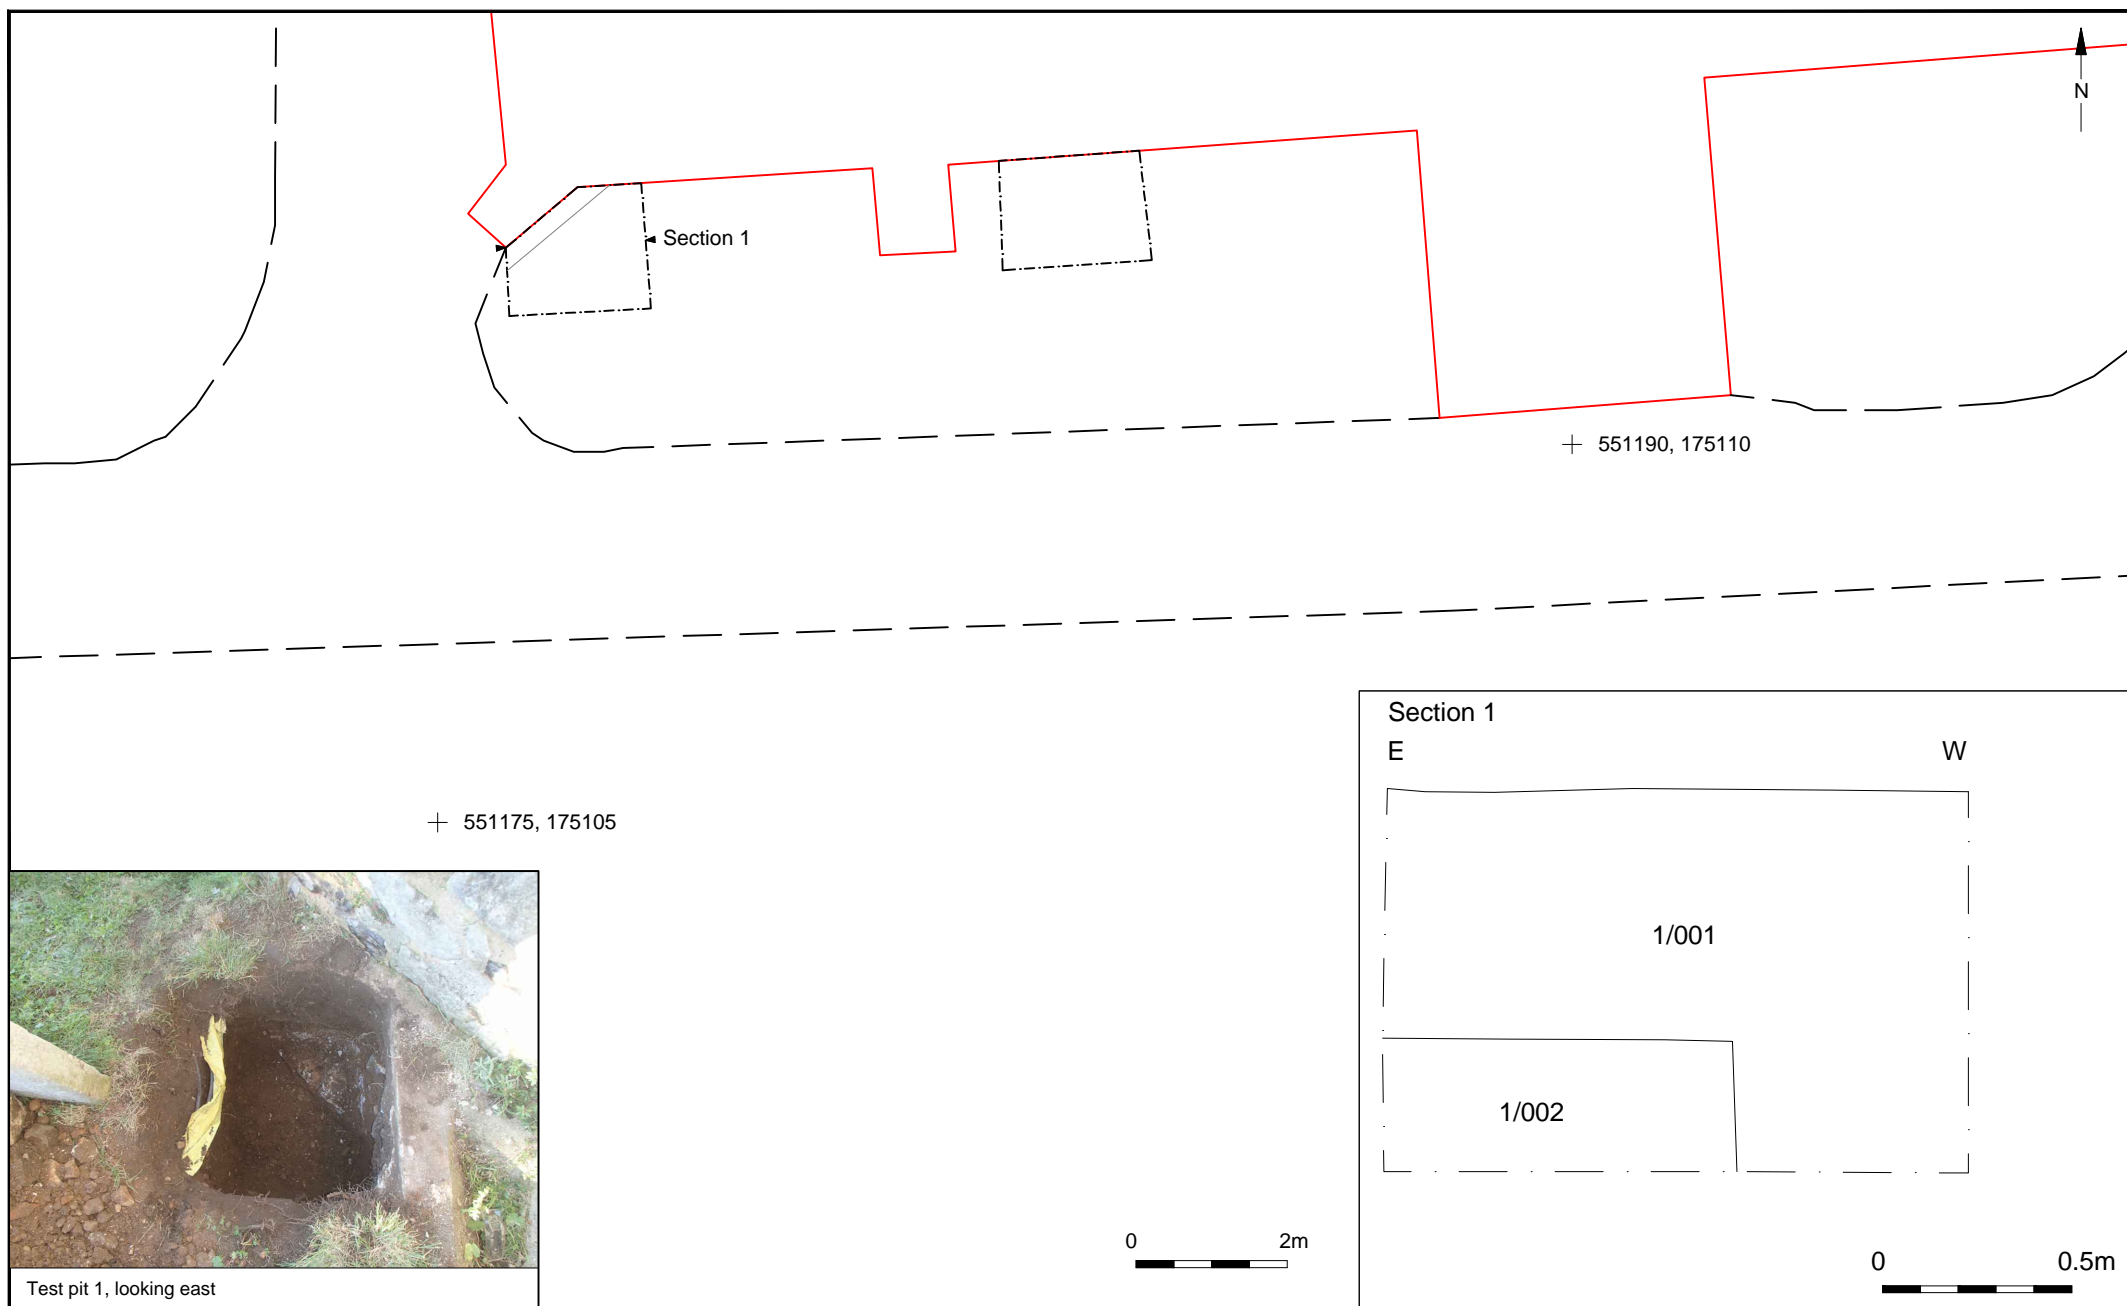
Test Pit 1 : Plan, section and photograph

- 4.2.1 Test-pit 1 was excavated adjacent to the south-west corner buttress of the church tower. It measured 600mm by 600mm by 1m deep. The overburden consisted of a mid-greyish brown to mid-orangey brown silty clay graveyard soil, context [1/001], which extended to the base of the test-pit.
- 4.2.2 The chalk footing of the adjacent buttress extended into the north-west corner of the test-pit, encountered 680mm below the current surface, [1/002]. It proved impossible to investigate the masonry in the confined space of the test-pit. A small assemblage of artefacts were recovered from the overburden and was retained for analysis. A small quantity of human bone was recovered and was reinterred when the test-pit was backfilled.

- 6.4 The chalk foundation of one of the church tower buttresses was encountered in Test-pit 1, but given the narrow confines of the test-pit little can be said of this feature – even the depth and extent remain uncertain.

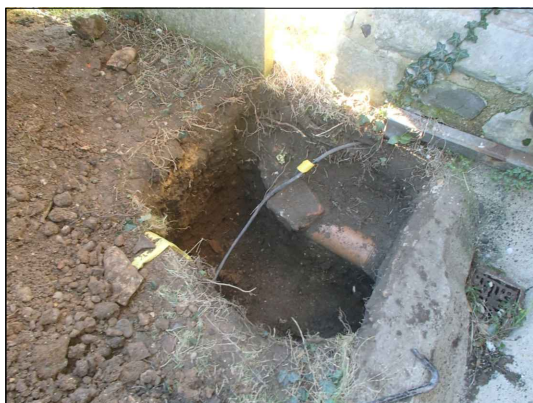
- 4.3.1 Test-pit 2 measured 700mm by 700mm by 850mm deep. The only deposit encountered was the graveyard soil previously seen in Test-pit 1, recorded as context [2/001]. The area had been disturbed by excavations for the laying of a concrete drain and an electrical cable.
- 4.3.2 Again a small assemblage of artefacts, including medieval pottery were recovered from the overburden and was retained for analysis. A small quantity of human bone was recovered and was reinterred when the test-pit was backfilled.

Test pit 2, looking north west

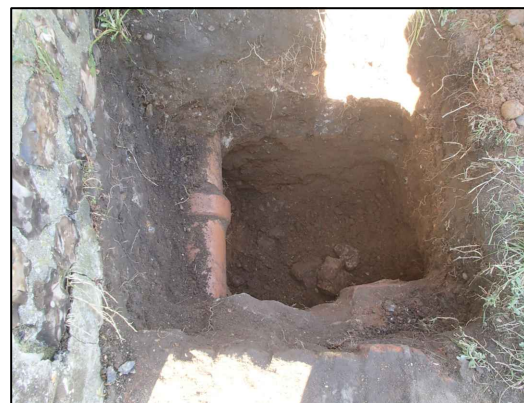
- 4.4.1 Test-pit 3 measured 600mm by 600mm by 1m deep. The only deposit encountered was the graveyard soil previously seen in Test-pit 1, recorded as context [3/001]. The area had been disturbed by excavations for the laying of a concrete drain.
- 4.4.2 The only material recovered from the test-pit were fragments of ceramic building material. A small quantity of human bone was recovered and was reinterred when the test-pit was backfilled.

Test Pit 3 , looking north
