**An Archaeological Evaluation
at 25 Knightrider Street, Maidstone, Kent**

**NGR: 576152 155349
(TQ 76152 55349)**

**ASE Project No: 160100
Site Code: KNI16**

**ASE Report No: 2016099
OASIS id: archaeol6-245234**

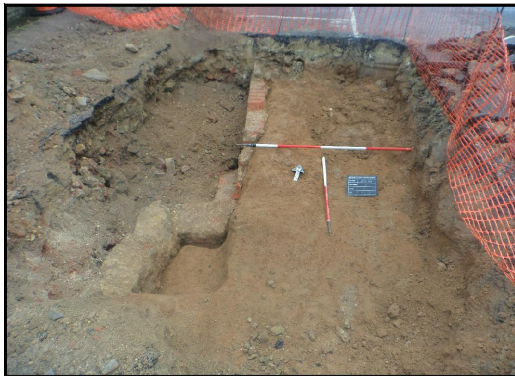
- 5.2.1 Trench 1 was north-west to south-east aligned, measured 5m long by 3.60m wide and was excavated to a maximum depth of 1.86m below ground surface level, at 10.67m AOD. All contexts recorded in Trench 1 have been summarised in Table 3, below.

Trench 1 looking north

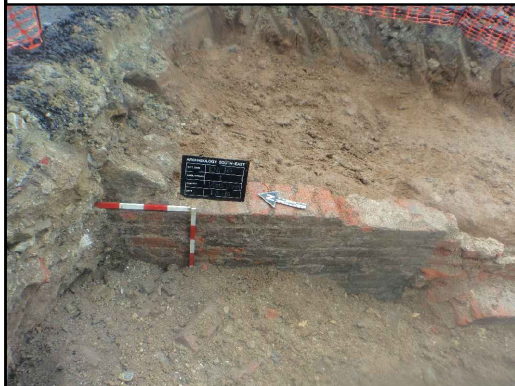
- 5.2.8 The second wall [1/009] was north-west to south-east aligned and its western side sat directly on top of the eastern wall of the cellar [1/003], however a bedding trench [1/011] was recorded on its eastern side, which extended

beyond the cellars eastern edge. This wall was also primarily of ragstone construction, with some brick, and as exposed in the trench, was in a very fragmentary condition, extending only a short distance from the northern limit of the trench. However it had clearly originally been quite substantial, with a width of 0.60m. Both of these later walls survived to a level just below the tarmac surface (12.2m AOD), indicating that they were presumably still extant until the buildings demolition in the 1960s.

1/003 and 1/009 looking east

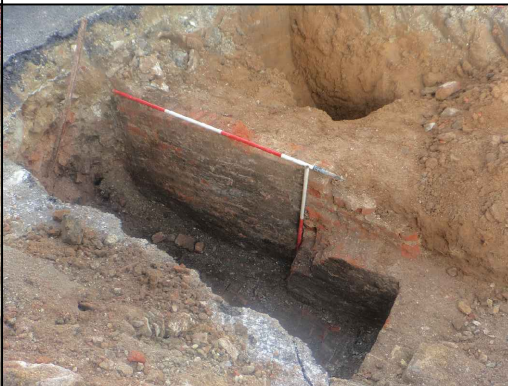
- 5.2.3 The geological substrate was truncated by the cut for a brick-built cellar [1/010], which dominated the western side of the trench. Housed within the cut were two walls [1/003] and [1/007], which respectively formed the eastern and south-eastern corners of the cellar, as well as a brick floor [1/008].

1/003 fully excavated to cellar floor 1/008

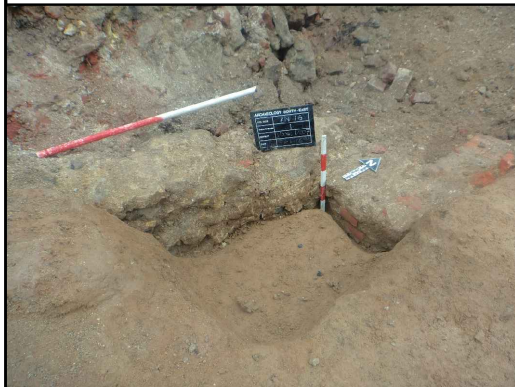
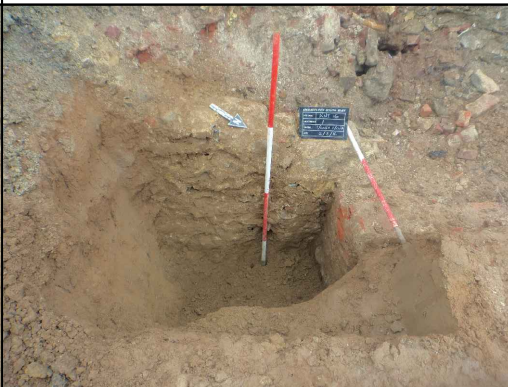
- 5.2.4 The faces of wall [1/007] were covered in a buff sandy mortar render obscuring the coursing style of the brick, which was of likely 18th to early 19th century date. This brick was constructed on a base of rough-cut, undressed ragstone. Wall [1/003] was 14 courses in height with what was similar to an English Garden Wall coursing, but with a double row of headers at its top, and likely dates to the 18th century.

- 5.2.5 Wall [1/007] formed an L-shape and was inset slightly from wall [1/003]. It was also much thicker than [1/003]; in addition while the interior corner of wall [1/007] formed a neat right-angle, the exterior corner and the adjacent section of the foundation cut were more irregular and uneven. The reason for this discrepancy in alignment and thickness between the two walls is unclear. Wall [1/003] may have been set back slightly from [1/007] in order to create a niche or recess for storage, or wall [1/007] may have been inset due to the presence of a structural feature such as a chimney stack, stairwell or some other structural feature of obscure purpose.

- 5.2.7 Two later walls were recorded, which post-dated the construction of the cellars; the first of these, wall [1/006], appeared to have been constructed over the cellar's southern wall [1/007], from which it extended southwards beyond the southern limit of the trench. This wall was constructed for the most part of rough, undressed ragstone blocks of varying size with some red brick, set in a yellow sandy mortar. The brick sampled from this wall was apparently of mixed 18th to 19th century date and some had adhesions of an off-white fine sandy mortar, confirming that this wall was constructed of reused masonry of varying date.

1/006 and 1/007 looking north-west

1/006 and 1/007 looking south-west

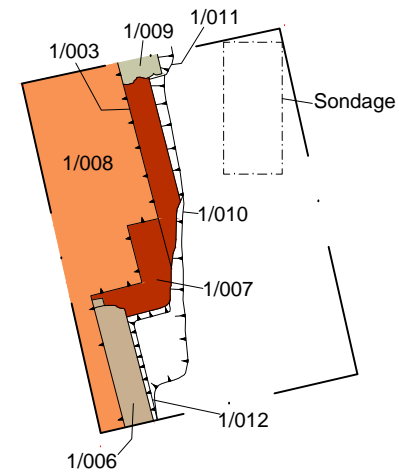
Fig.3

Trench 1 plan and photographs

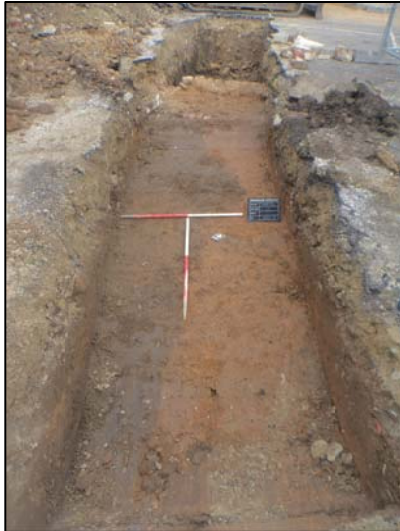
5.4.2 This trench was north-west to south-east aligned, measured 10m long by 1.5m wide and was excavated to a maximum depth of 2m below ground surface level, at 10.70m AOD. All contexts recorded in Trench 3 have been summarised in Table 5, below.

Trench 3 looking north-west

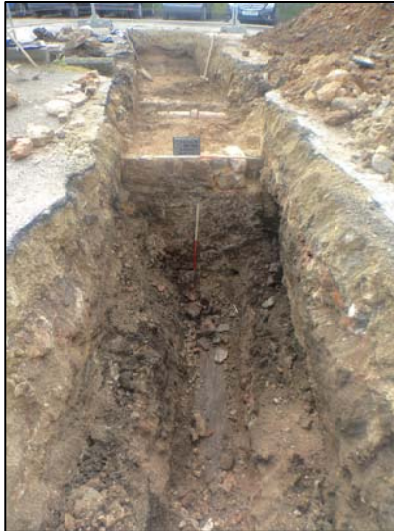
- 5.4.8 The cellar in-fill material [3/007] contained a broad range of building-related rubble, including concrete with embedded metal mesh, of clearly later 19th to 20th century date, as well as a large amount of stone, including four large pieces of architectural stone (two of which conjoin) of likely 16th to early 17th century date. All show signs of re-use and in one instance late post-medieval repair (see section 6.0 below).

Tr. 3 looking south-east with view of 3/007

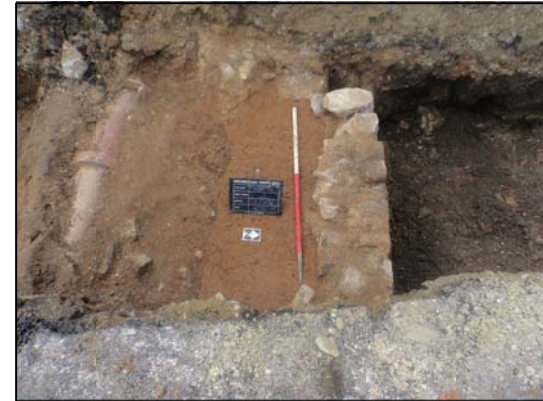
3/008 and 3/017 looking south-west

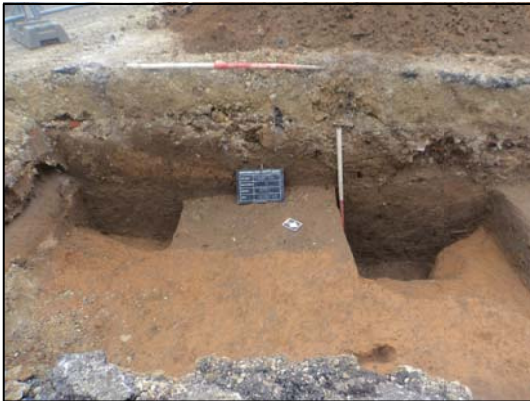
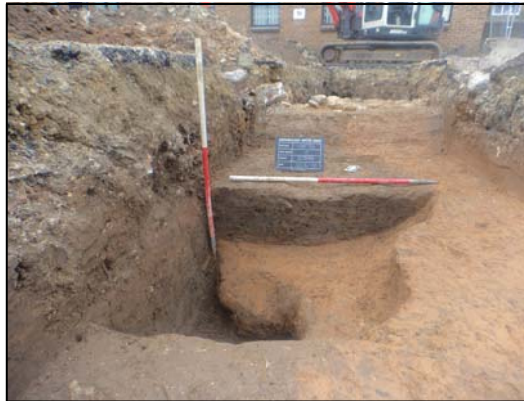
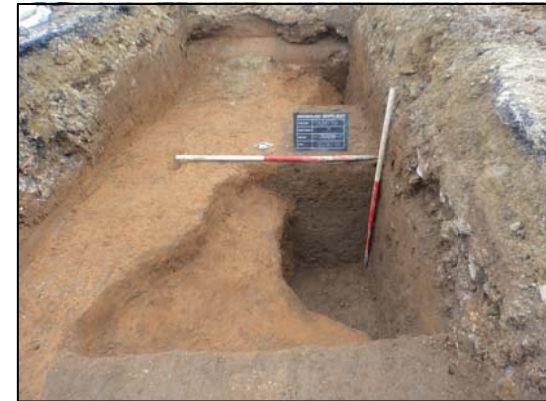
was truncated, at the trench's southern end, by a series of intercutting sub-circular and sub-rectangular pits [3/011], [3/014], [3/004] and [3/016].

- 5.4.4 These pits were all filled with sandy clay silts of varying coarseness ([3/012], [3/015], [3/005] and [3/013]). Patches of greenish discolouration, indicative of the presence of cess were observed in most of these deposits. All of these fills produced fragments of peg and ridge tiles; the earliest pit [3/011] produced a peg tile of likely 13th to 14th century date, which accords well with the dating of four pottery sherds also recovered from its fill. However it also contained a peg tile of possible 16th to 18th century date, which would be presumed to be intrusive (but see sections 6 and 7 below). A single peg tile of 14th to 15th century date was recovered from the next earliest pit [3/014], while tile fragments of likely later 16th to early 18th century date were recovered from the pit [3/004] which in turn cut that. The final pit in the series [3/016] produced tile fragments of 14th to 16th century date and a single cooking pot base sherd with a c. 1275 to 1375 date range.

The earliest features recorded on-site were the series of inter-cutting pits, exposed in the southern end of Trench 3. The likelihood is, based on the presence of urea-staining within their fills, that these were cess pits, excavated to the rear of the vicarage building. All of the recovered pottery from these fills indicates a date range of c. AD 1275 to 1375 for their use; however the tile fragments from the same fills have been identified as having a broader date range (see section 6, above), with types ranging from 13th to early 18th century seemingly represented.

3/004, 3/011, 3/014 and 3/016 looking south-west

3/004, 3/014 and 3/016 looking north-west

3/011 and 3/016 looking south-east
