**Archaeological Watching Brief Report
York Street Roundabout
Dover, Kent**

Ref: I&B/PB1552/304514/R023/D01

**ASE Project No: 160809
Site Code: YSR16**

**ASE Report No: 2016392
OASIS id: archaeol6-266177**

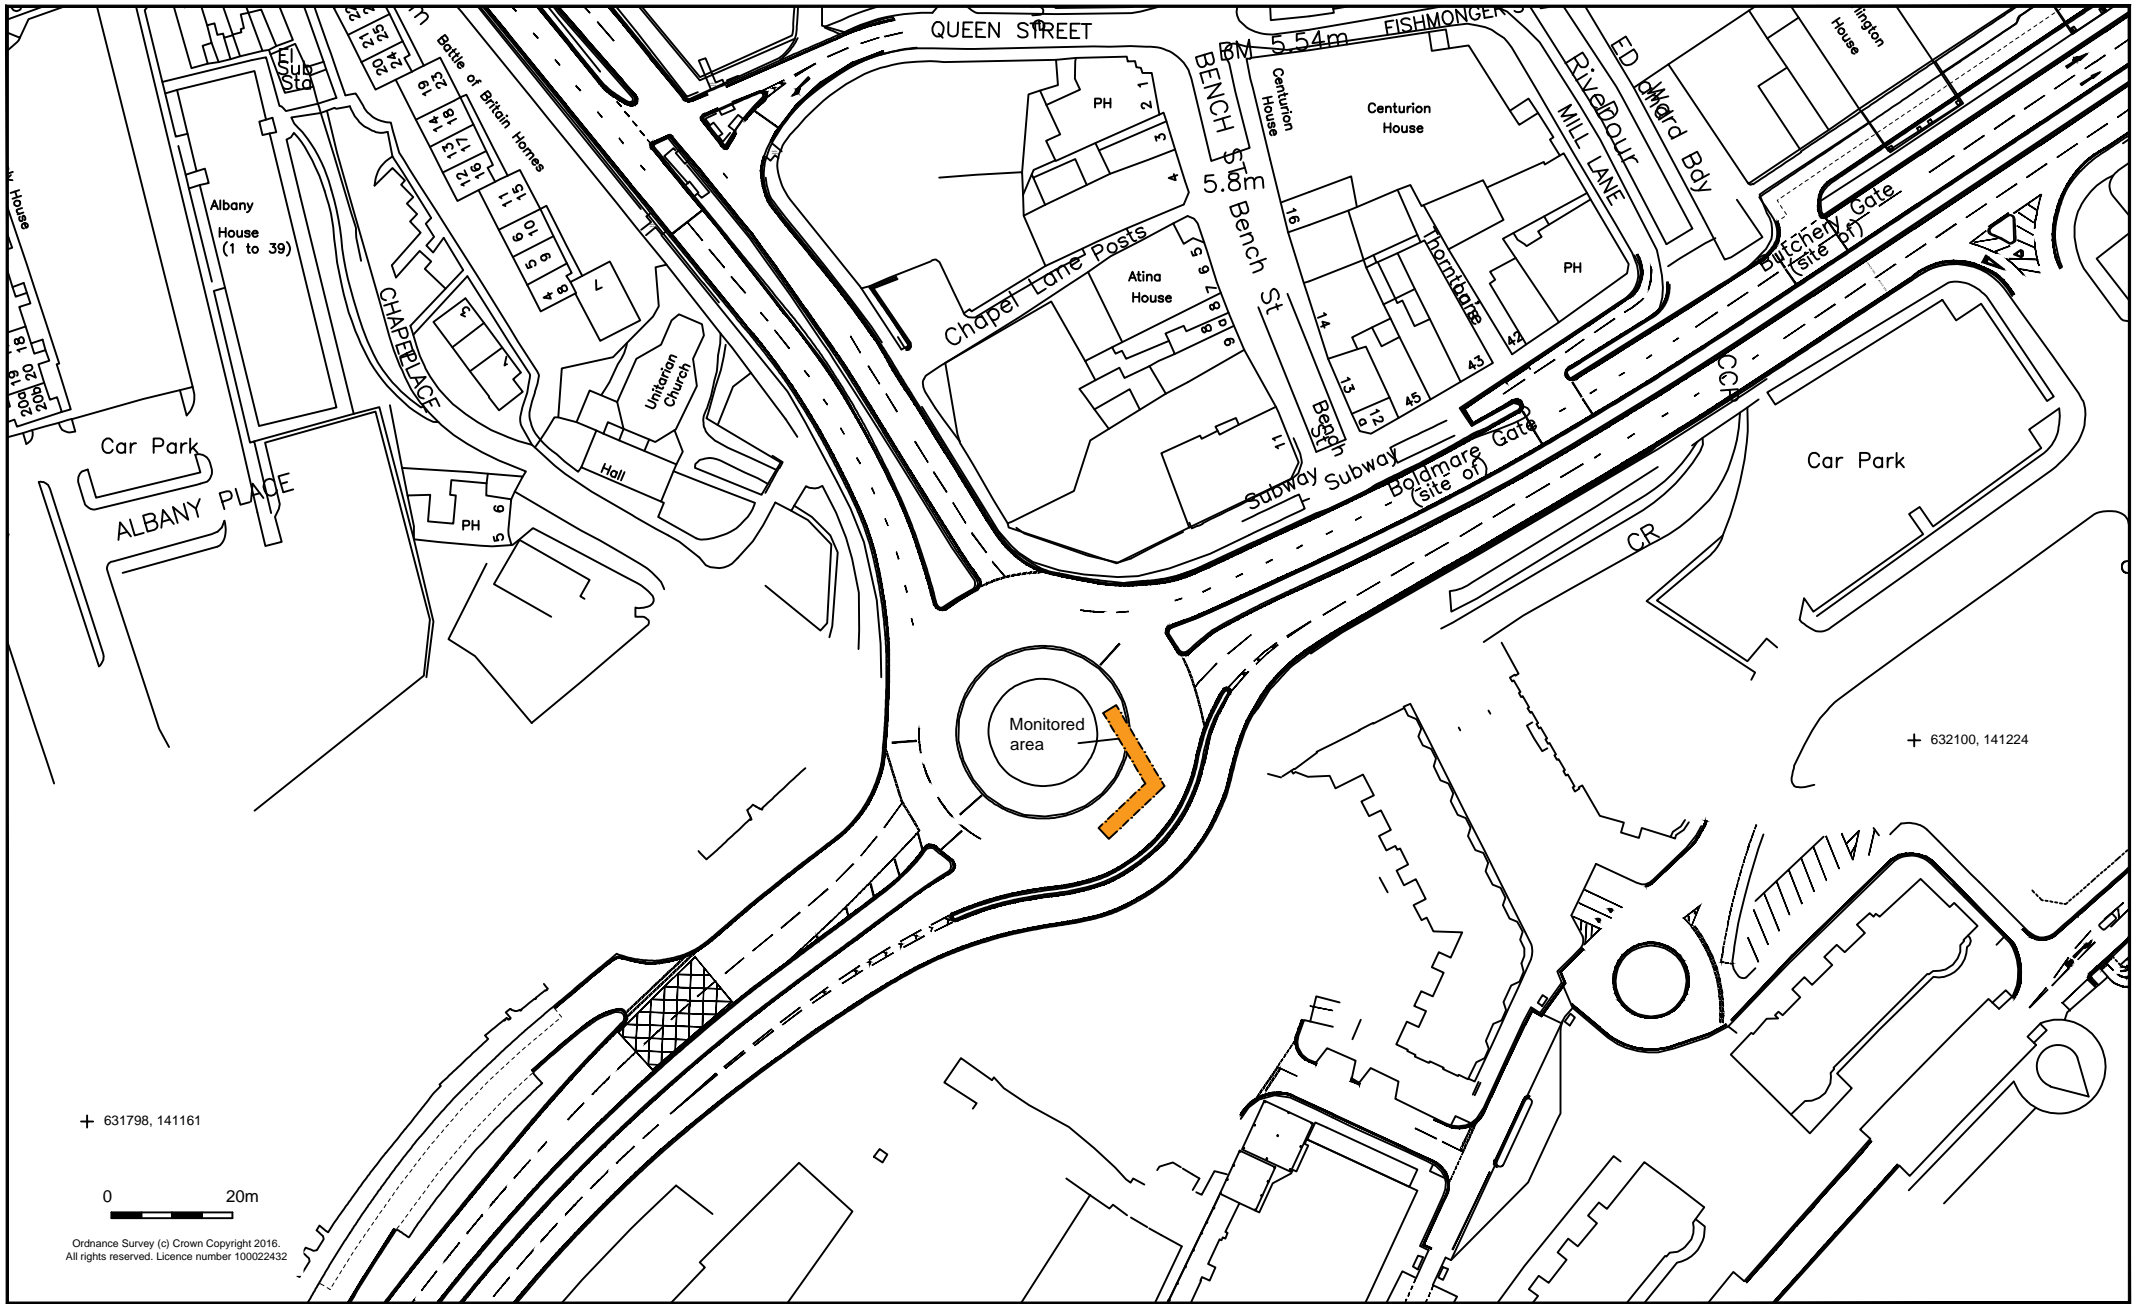
| © Archaeology South-East | | York Street Roundabout, Sewer diversion, Dover Kent | Fig. 2 |

| Project Ref: 160809 | Feb. 2017 | Development plan | |

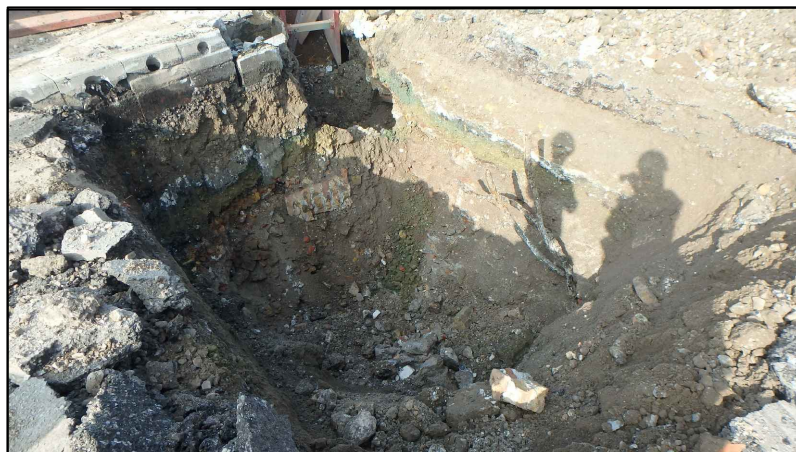
- 4.1.2 Toward the centre of the trench, (7.119m AOD), a similar stratigraphy existed. However, found beneath [45] but amongst [46] was a brick arched structure aligned east to west. This seems to have previously been truncated away to the west leaving the eastern end intact. It consists of a stretcher bond made up of red and yellow bricks running for approximately 1.3m with an unclear amount of courses. The backfill [49] within the structure consisted of a dark grey/black, silty stony deposit with evidence of demolition such as brick and concrete.

Section facing east, looking north

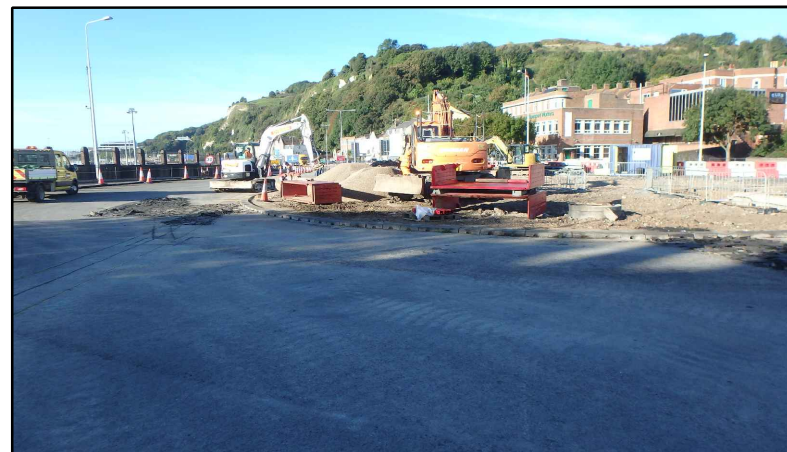
Ground works, looking north west

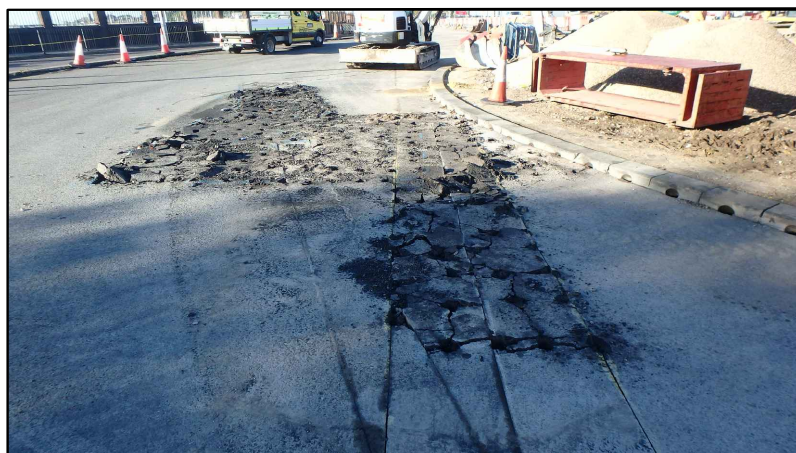
Ground work, looking west
