**Archaeological Watching Brief Report
Scotney Castle, Hastings Road
Lamberhurst, Kent**

**Scheduled Monument No: SM 24400, HA 1009005, Ref: S00144203
Tunbridge Wells Borough Council Planning Ref: 16/504474/FULL**

**ASE Project No: 160638
Site Code: SOT 16
ASE Report No: 2016355
OASIS id: archaeol6-268623**

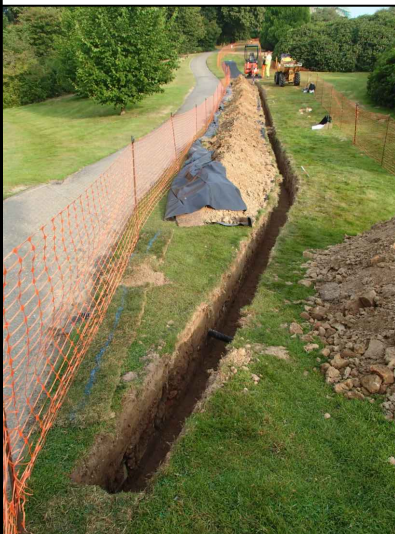
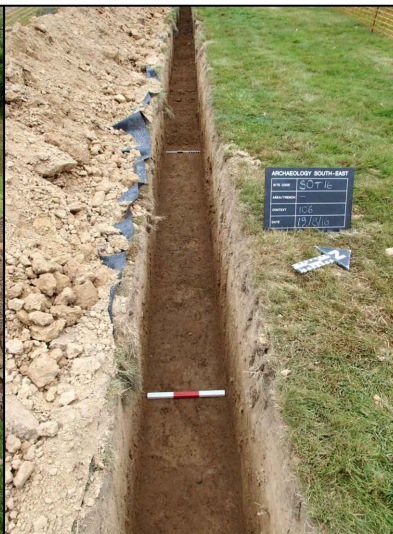
Fig. 3

Pit 106, looking north-west

Detail plan of garden area, 106

- 4.1.4 A pit [106] was identified beneath the subsoil [101] at a depth of c. 43.8m

AOD. Only the top 5cm were excavated by machine as the cable trench was excavated. It was filled with [107], which was a mid- brownish grey, silty sandy clay, with areas of grey mottling (Figure 3). No finds were recovered.

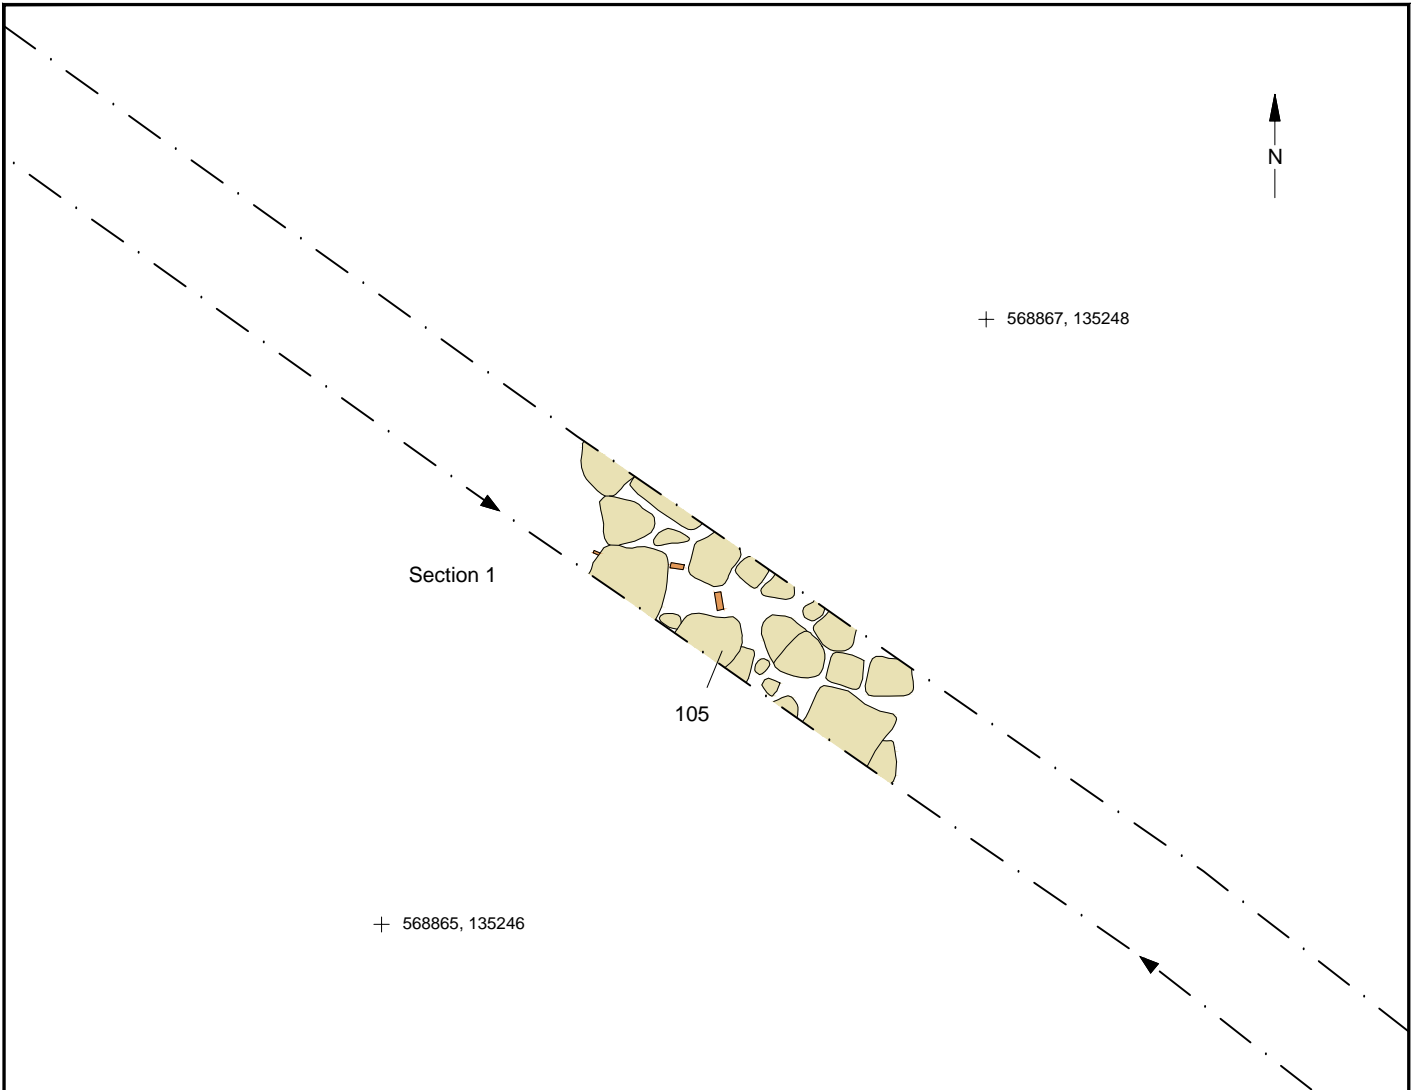
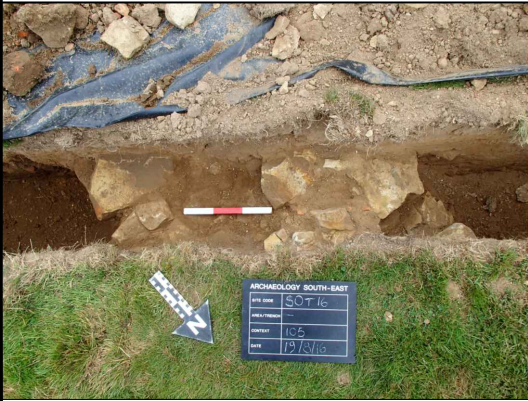
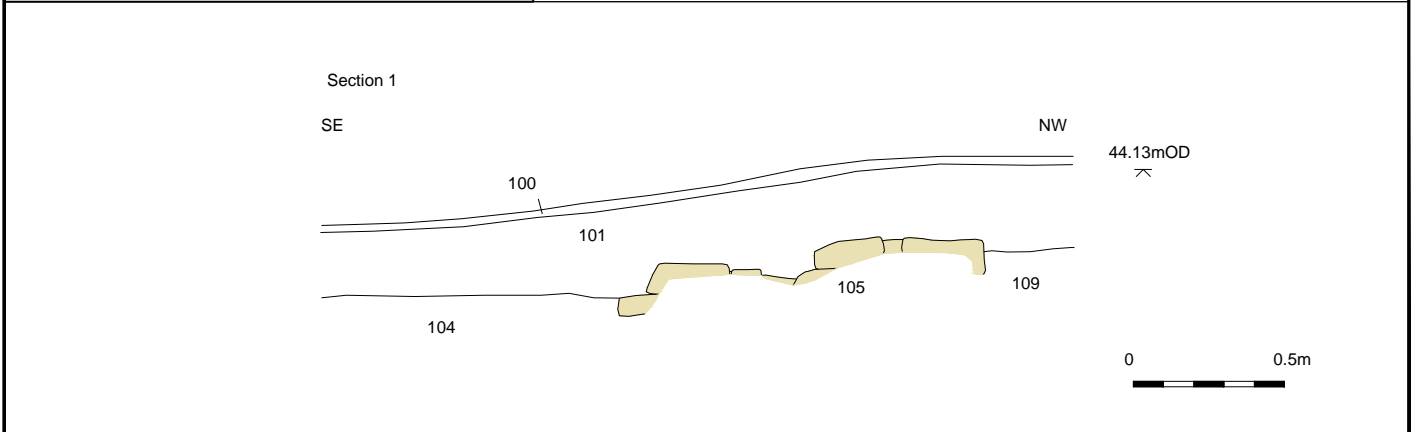
© Archaeology South-East		Scotney Castle	Fig. 4
Project Ref: 160638	Nov 2016	Detail plan of garden area, 105	
Report Ref: 2016355	Drawn by: AR

Masonry 105, looking north-west

- 4.1.2 A mid-brown sandy clay deposit [102] containing brick, tile and green sandstone was identified beneath the subsoil [101] at a depth of 40.05m AOD. It is a disused pathway across the gardens which appears on an earlier map of the grounds, dating from 1877 (Figure 4).

- 4.1.3 A layer of unbonded, loose sandstone blocks, interspersed with tile fragments [105] was also identified beneath the subsoil [101] at a depth of 41.74m AOD. Some of the material had accretions of mortar, perhaps indicating that the material had previously been used in some structure and was reused here. The land rises c.0.07m to the north-west of this feature, indicating that it marks the edge of a raised area. A levelling deposit [104] to the north-west of this; a mid- brown silty sand with frequent CBM and sandstone fragments, was recorded, whilst to the south-east of [105] another levelling layer, a mid-brown silty sand [109] was recorded (Figure 4).

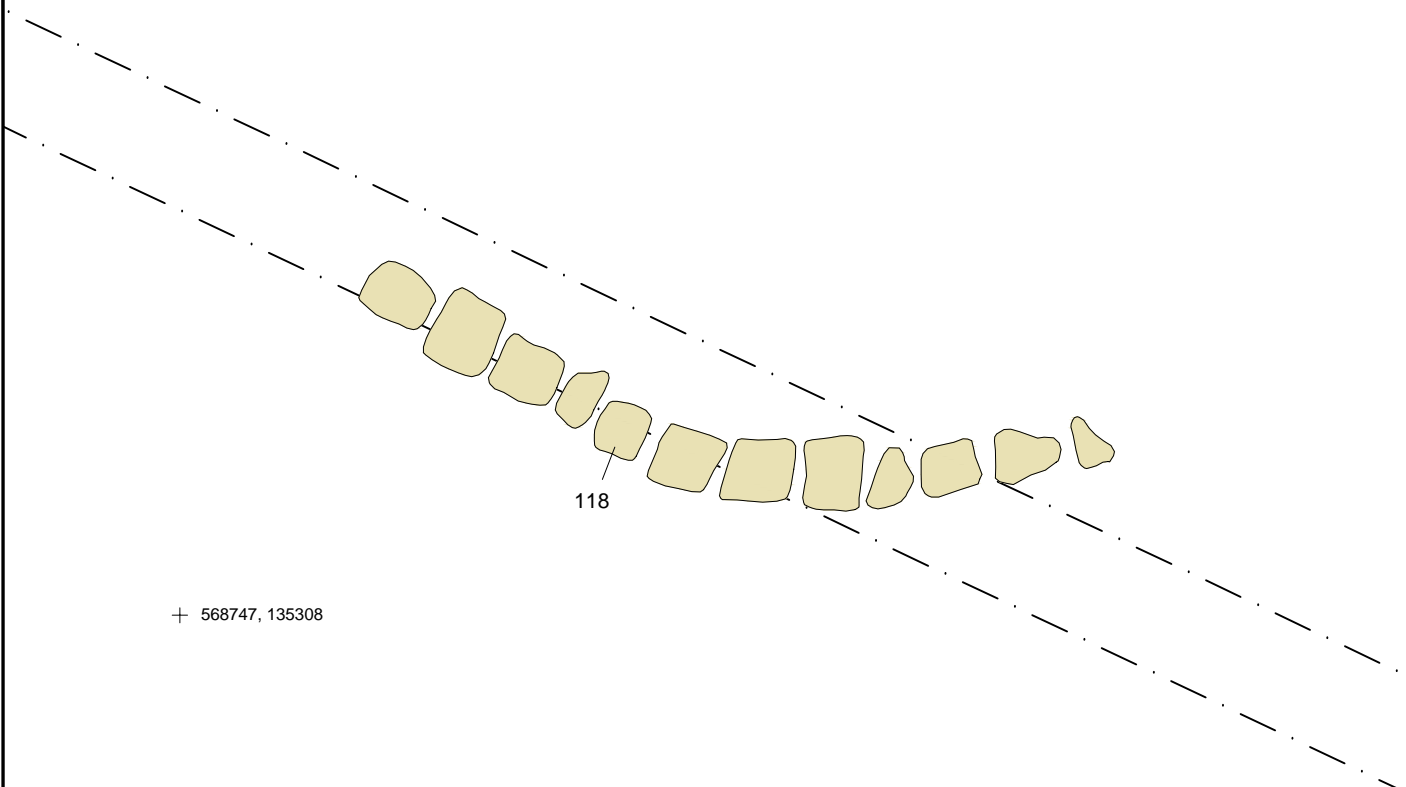
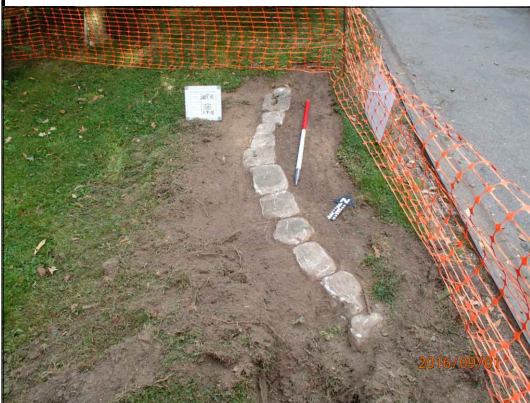
© Archaeology South-East		Scotney Castle	Fig. 6
Project Ref: 160638	Nov 2016	Detail plan of 118	
Report Ref: 2016355	Drawn by: AR

118 looking north-west

- 4.1.9 A curved line of unmortared stones [118] was discovered just below the topsoil. The limestone blocks vary slightly in size and are roughly worked. They were sitting directly on the natural geology [103]. It was 2.6m in length and 0.4m wide. Modern finds were identified in the adjacent topsoil. This masonry probably represents a modern garden feature (Figure 6).
