**ARCHAEOLOGICAL INVESTIGATIONS AT
SANDWICH TOWN TIDAL DEFENCE SCHEME**

**A POST-EXCAVATION ASSESSMENT AND
UPDATED PROJECT DESIGN REPORT**

**ASE Project No: 5514
Site Code: TDS 13**

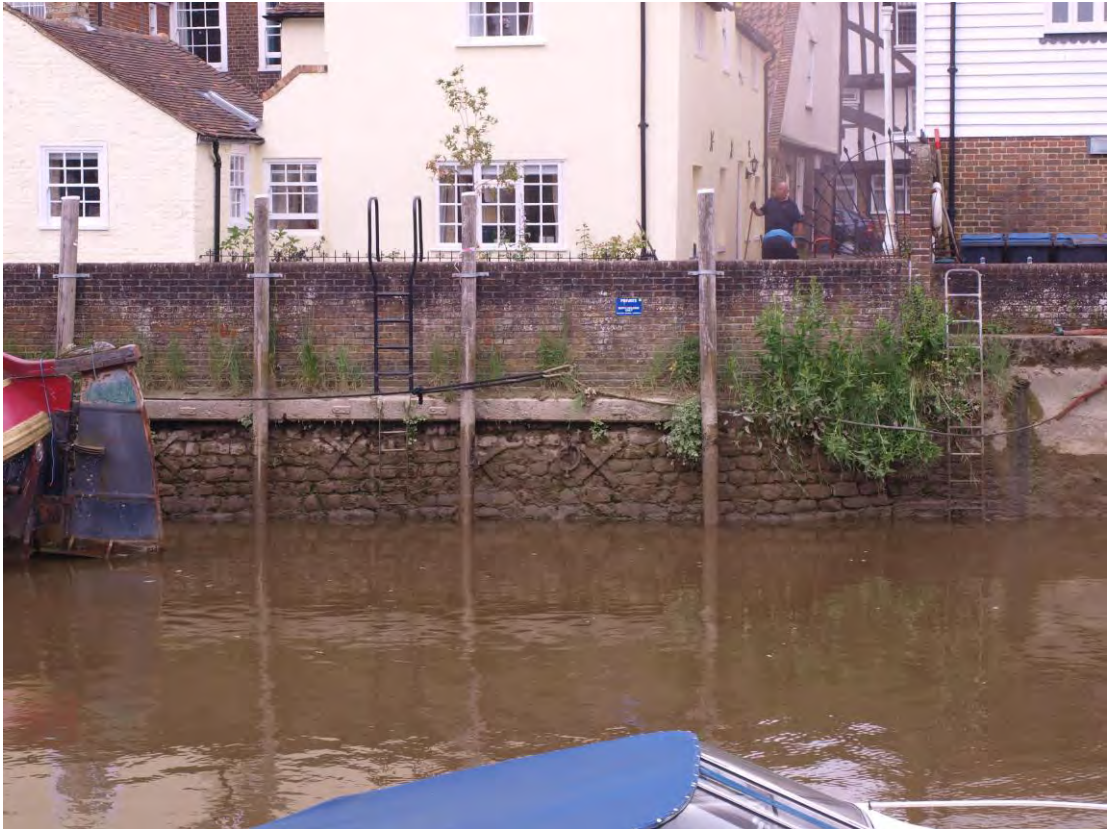
Plate 1: Section 1 of the river wall showing stone walling to the rear of Dolphin Quay

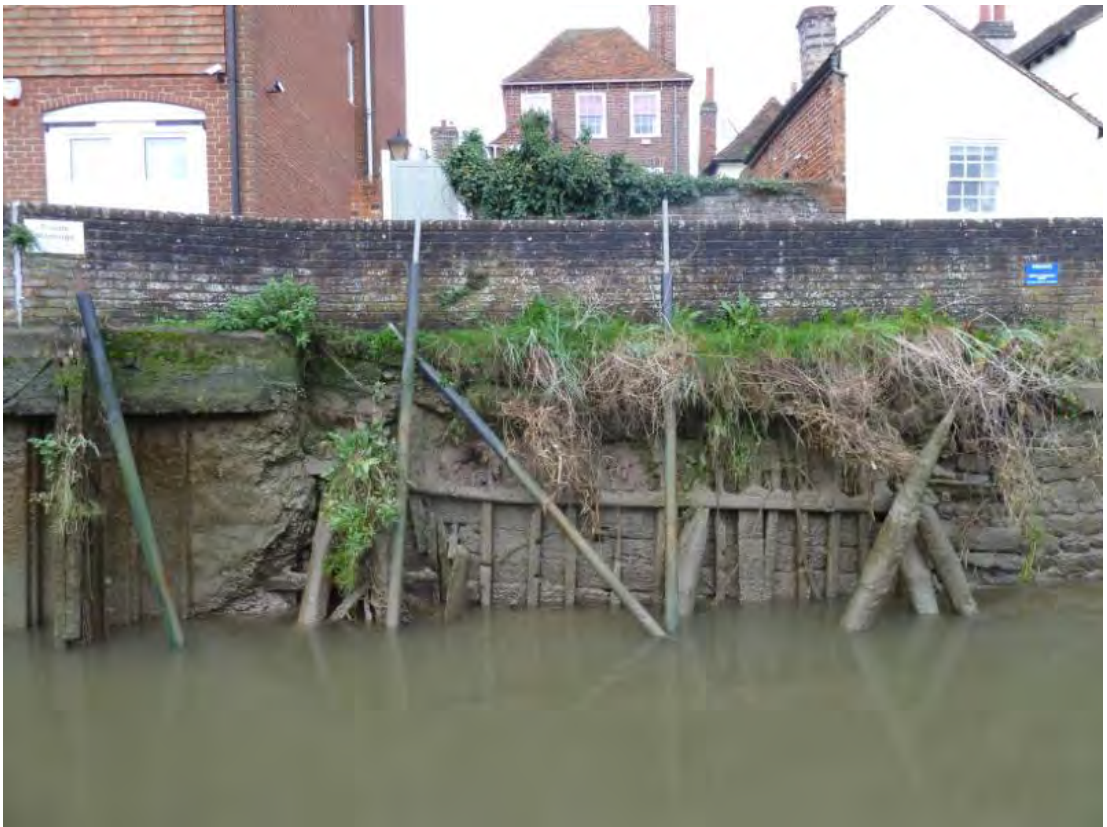
Plate 2: Timber-revetted section of wall to the rear of No. 30

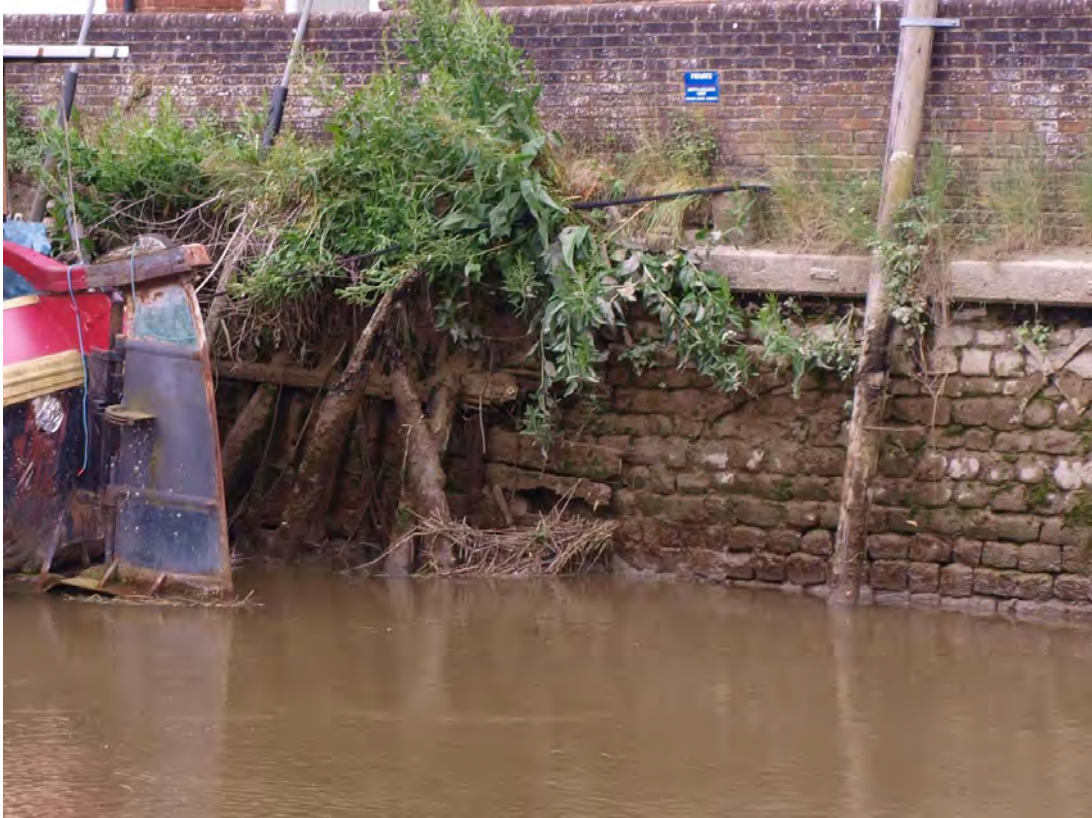
Plate 3: View showing the timber structure overlying the earlier stone walling

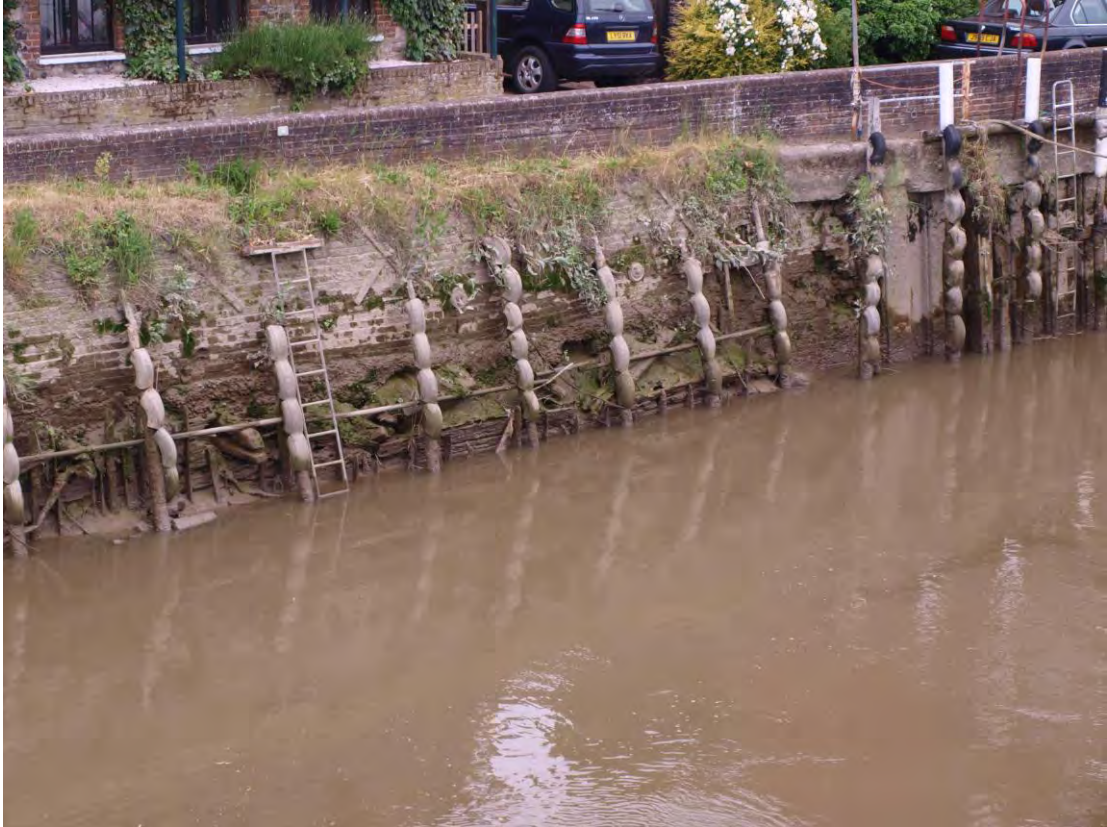
Plate 9: Timber revetment visible at low tide

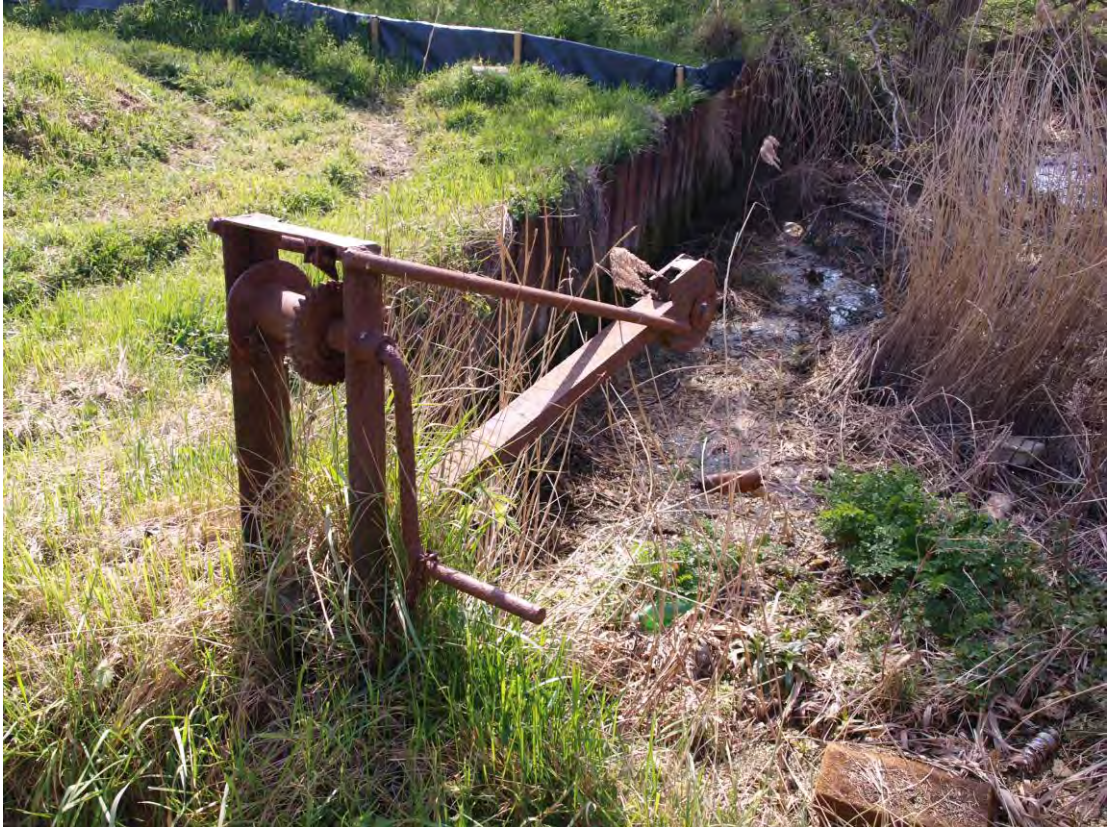
Plate 15: Winch mechanism for sluice

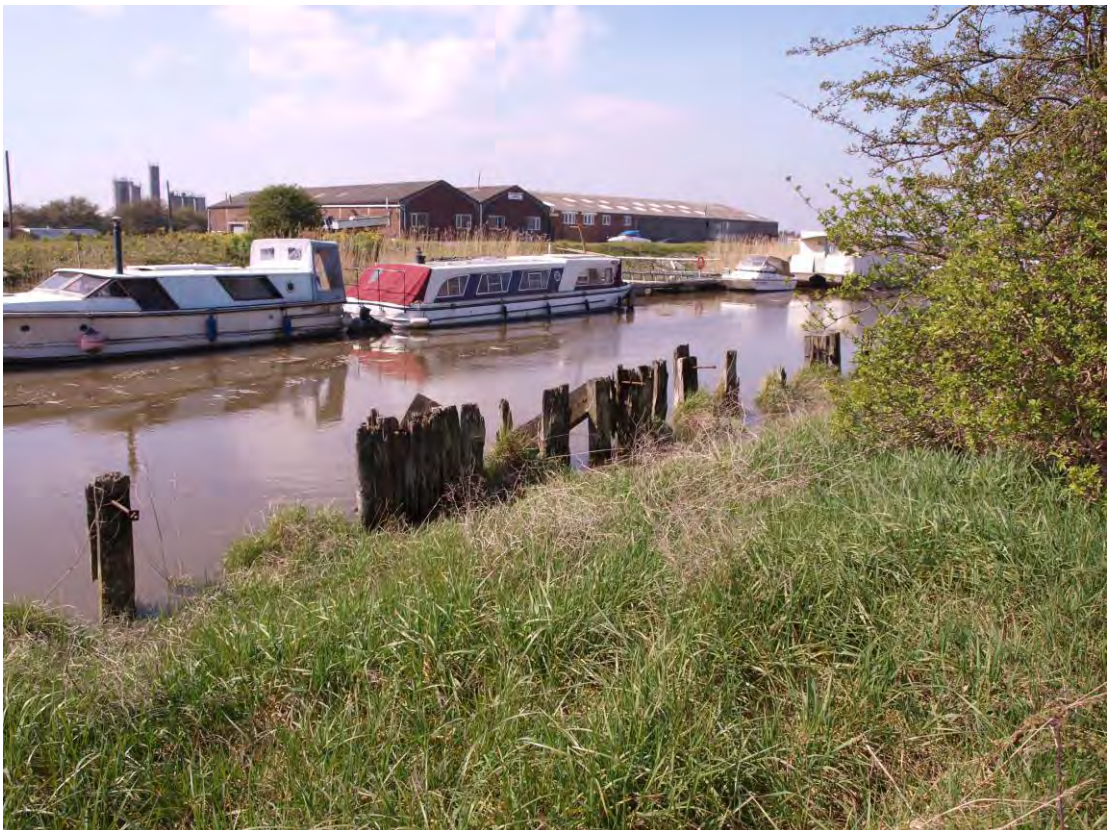
Plate 16: Upstanding wharf structure as viewed from the site
